## Arboricultural Assessment

Monterey cypress (*Hesperocyparis macrocarpa*)  
1817 Great North Road Avondale

Version 1  
December 2020

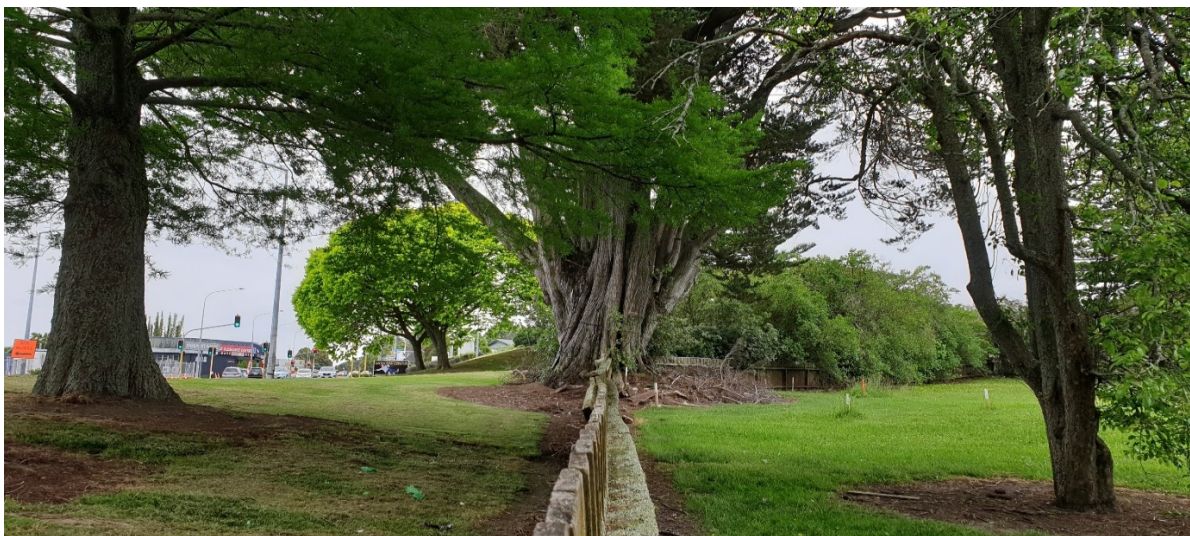
The macrocarpa has no exposed roots for visual inspection. However, there is a relatively large sweeping buttress roots which infer a strengthening of the shallow spreading root zone typical of this species. The largest buttress root is located to the West, here it is expected that the largest structural root mass is located.

**Photograph 6:** Trunk with fluted and ribbing morphology, indicating a transfer of load from stems through the trunk to the root zone.

Typical of the macrocarpa species the trunk is fluted with many ribs which are an indication of a transfer of loading and strengthening as the tree has developed, *see photograph 6*.

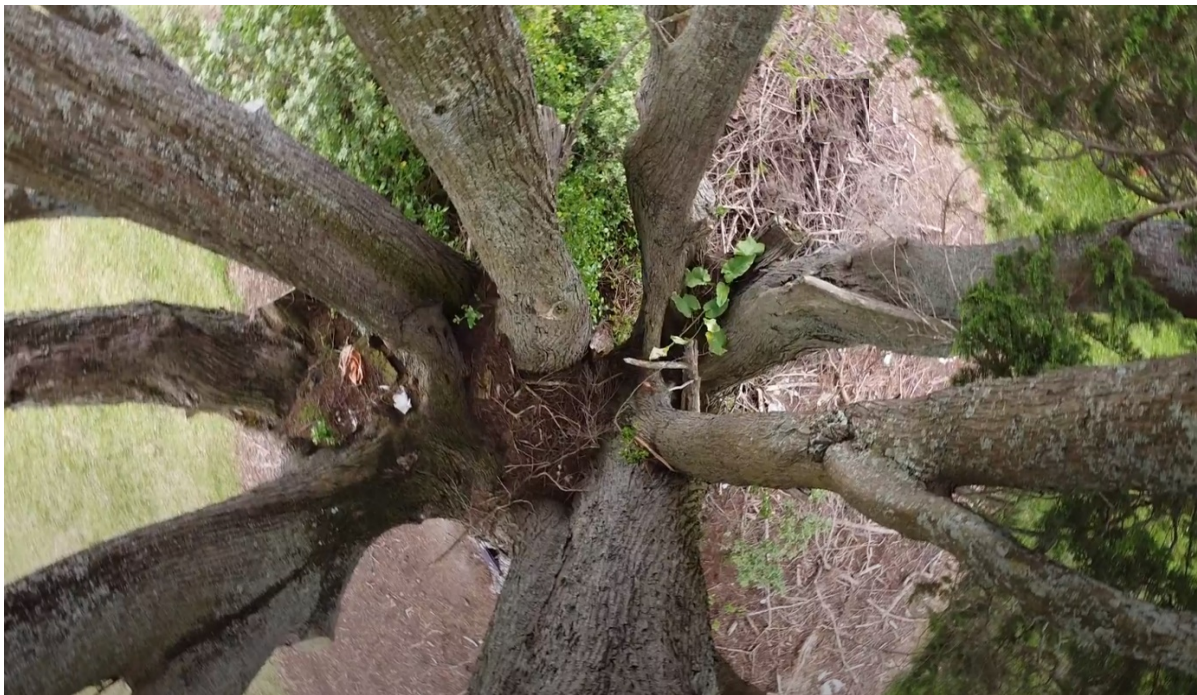
There are eight stems (300mm to 700mm estimated diameter) furcating from the trunk at a height of between 3 to 4m from ground level, *see photograph 7*.

*Photograph 7: Eight scaffold stems (300mm to 700mm estimated diameter) from 3m height.*

The multi-stemmed nature of the tree is usually formed following destruction of the terminal shoot. The terminal leader could have been cut, damaged by frost, pests or wind loading within the formative years of the macrocarpa life. With resources being channelled into more than one main stem or sink then multi-stemmed trees may be able to display greater photosynthetic surface area. There is one dominant main stem extending the full height of the tree which is slightly inclined into the property of 1817 Great North Road. The largest dominant stem appears to have an indented cortical/bark strip approximately 5m in length from the main stem union to the first significant branch union. On both sides of the strip are two raised and ribbed masses, indicating a positive reactionary wood growth around a section of decay. It should be noted that this stem also has been subjected

to branch loss at the top of the canopy. Therefore, it would be prudent to investigate this decay further, a destructive test using a resistograph should ascertain the extent of canker and defensive compartmentalisation without compromising the tree further.

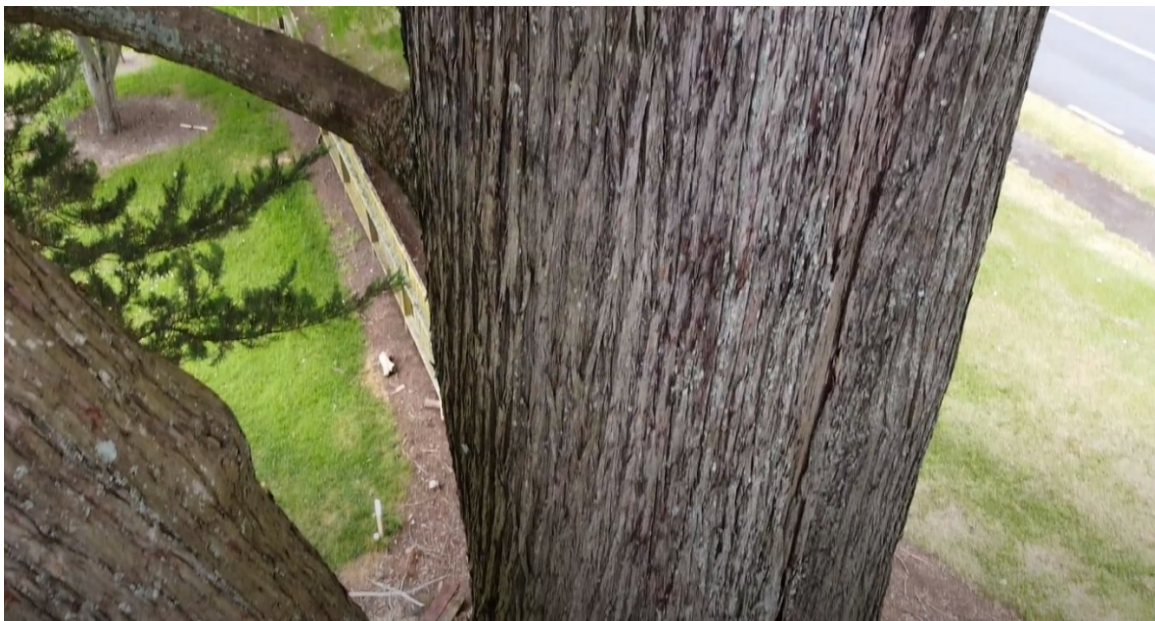
Aside from the vertical strip of decay, there is evidence of pruning works which indicates historic dieback or storm damage. A climbing inspection of the tree using a 360 camera shows that the internal canopy branch unions are of a good form, *see photograph 8*.

*Photograph 8: Although appearing superficial this section of decay could be an indication of canker.*

Macrocarpa are highly susceptible to Seiridium canker which has caused extensive shelterbelt damage throughout New Zealand. The typical symptoms of resin bleeds from active lesions have not been found on this tree, however the lens shaped, and sunken cortex/bark has been noted on the main stem, see *section 3.3.3*. The vertical lens of bark decay is surrounded by what appears to be healthy tissue in the form of reactionary wood.

At this stage it is recommended that there is further investigation into the extent of the stem canker and interpret the results from the MPI investigation due in mid-December 2020.

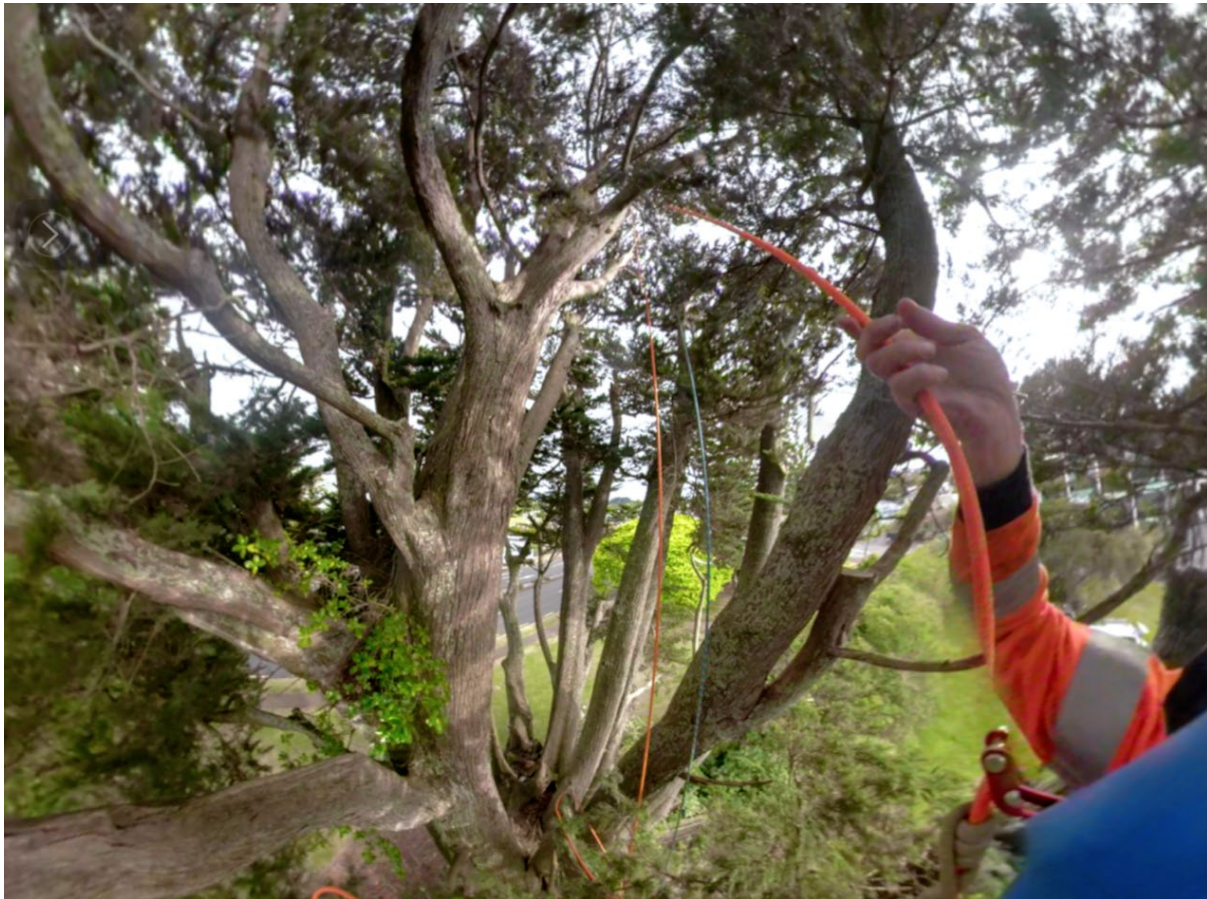
***Photograph 9: Climbing inspection of mid canopy indicates fair to good form of branch unions.***

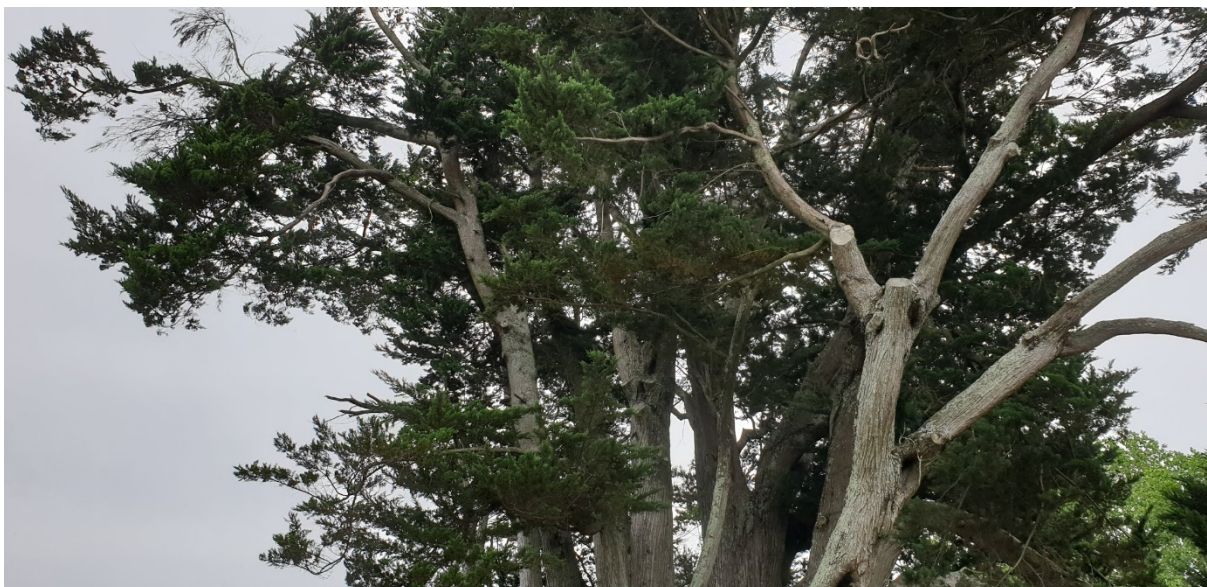
The lower branches have been pruned creating a significant loss of the lower canopy. The loss of lower branches can change the dynamic positive damping effect on the stems during wind loading increasing the likelihood of further storm damage. In the mid canopy there are numerous pruning wounds, some of which do not show callousing, indicating a poor response and a possible lack of overall tree vigour, *see photograph 10*. It is assumed that the significant amount of pruning was carried out to remove branch failures and reduce the hazard exposed by this tree to occupiers within the road reserve. Within the centre mid canopy ther branch unions appear to be structurally sound, *see photograph 9*. In the upper canopy there are 20mm to 50mm diameter branches exhibiting dieback, however this is a relatively small portion of

***Photograph 10: Non calloused pruning wounds in the mid canopy and slight dieback of upper canopy.***

In terms of canopy management, it is recommended that only dead detached branch hangers are removed. The removal of macrocarpa deadwood for disease sanitisation work can be troublesome as they tend retain small amounts of live tissue making deadwood difficult to identify. Pruning back to live tissue will increase the chance of infection and speed up the effects of canker if present on the tree.

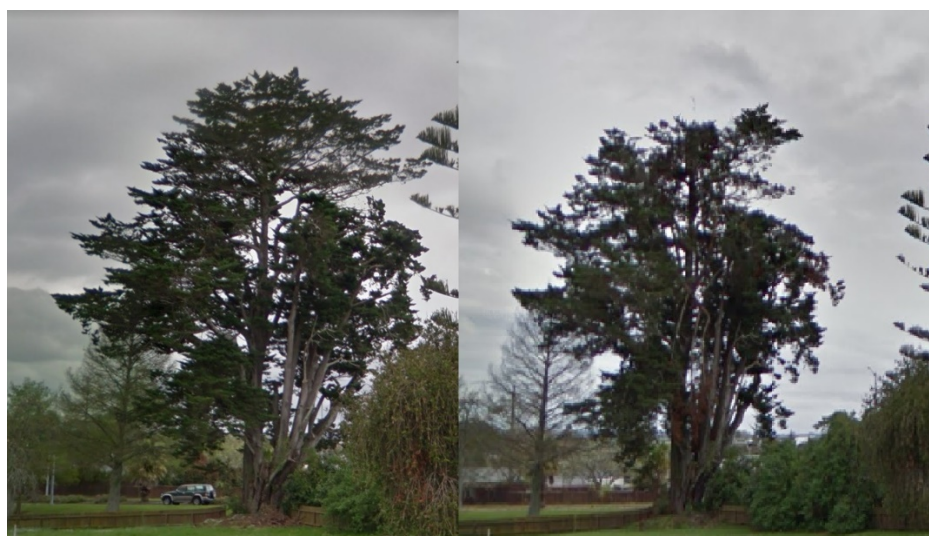
The collapsed top tier of the canopy still has signs of growth on the branch ends of the partially attached but broken branches. The now dead branches still have their attached leaves, indicating that the upper tier canopy did not retrench and did not dieback but suffered a catastrophic event likely due to a storm, *see photographs 10 & 11*. The timing of the top tier collapse is between October 2017 and September 2018 according to the historic google street view images, *see figure 7*. During this period there were some major storms in the Avondale area with most damage to local trees occurring during the 12th April 2018 storm. The direction of failure of the branches within the collapsed canopy indicates a wind loading from the North West direction. The collapse may have gone unnoticed as the canopy would have retained its green look for some time.

**Figure 7: Google street view images from October 2017 (left) followed by upper canopy collapse before September 2018 (right).**

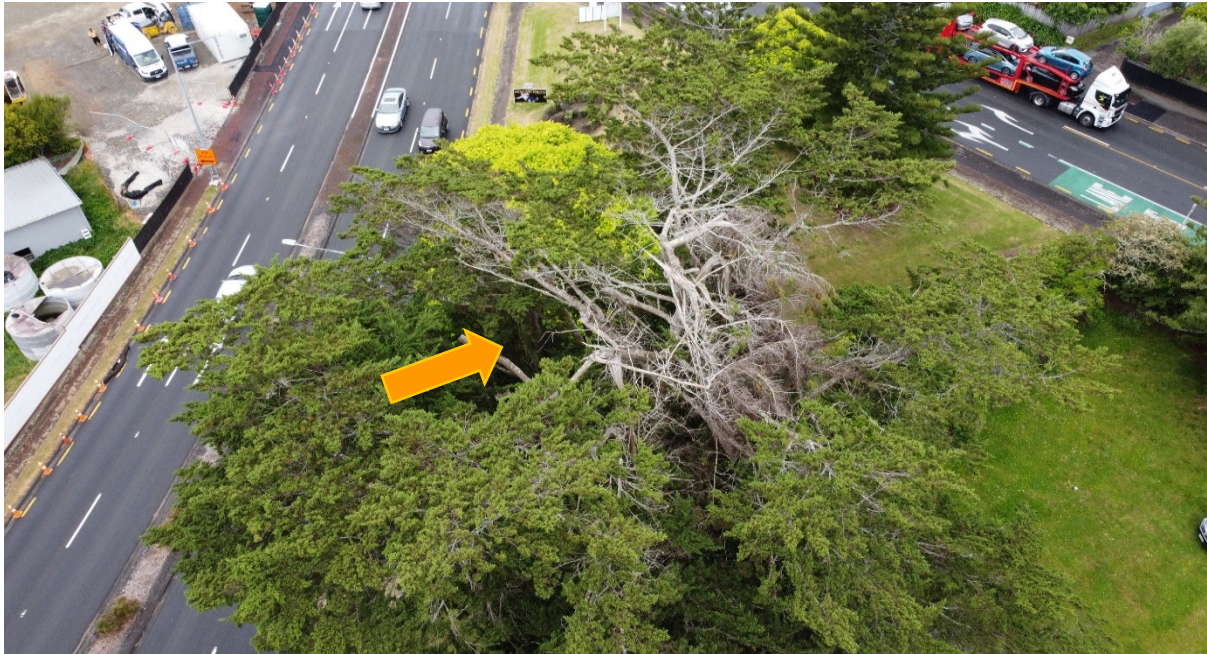
**Photograph 10: Collapsed upper tier of canopy, possibly due to extreme wind loading from a North Westerly direction as indicated by the orange arrow.**

It should be noted that the sudden collapse of the upper tier canopy may not be entirely caused by wind loading, it could also have been made weaker by pests and diseases pre-storm. It would be prudent to sample the live but collapsed branches in the upper canopy to ascertain if there are any significant issues. The lower mid canopy branches have already been sampled and sent to through to MPI for fungal analysis, it is likely to take around three weeks to get the results from this sample (mid December 2020).

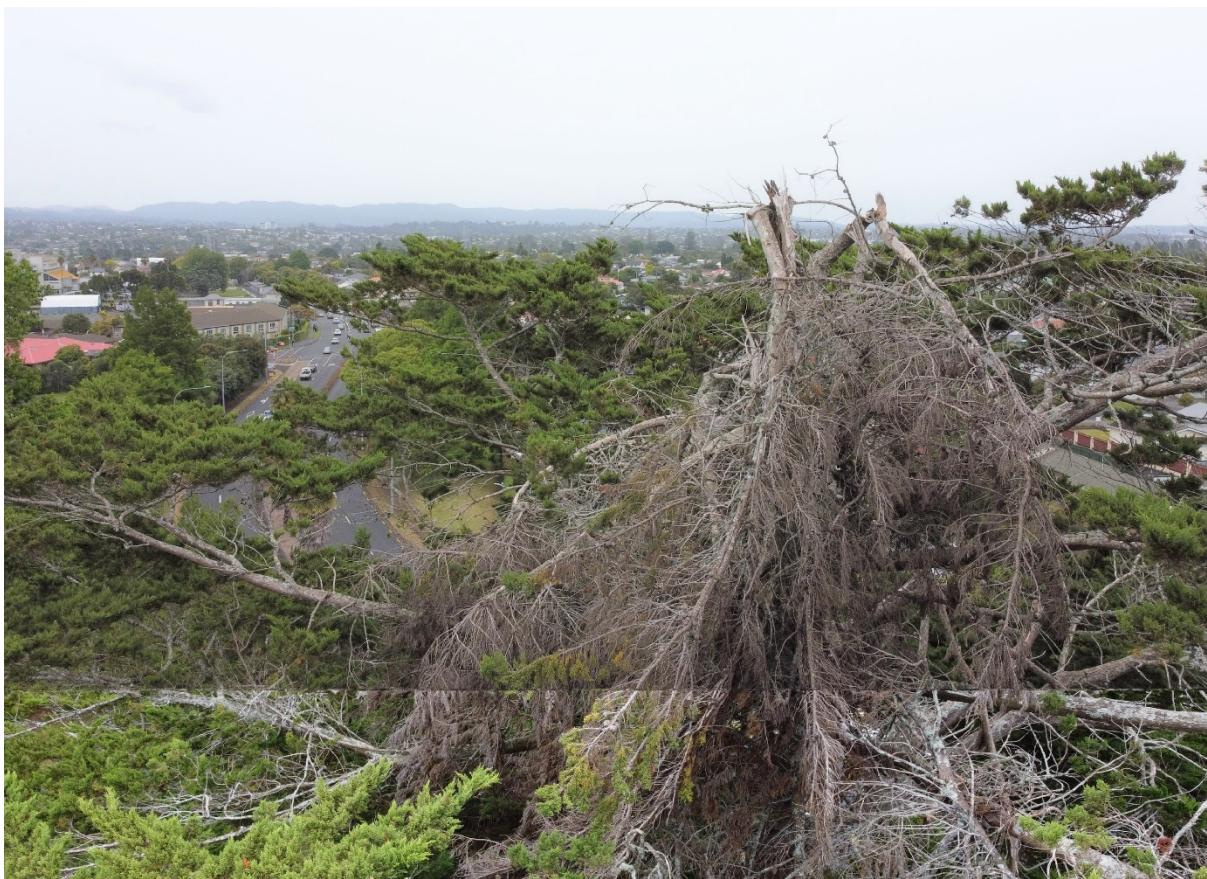
**Photograph 11: Moribund but green branches which have partially ripped out, dead and still attached leaf material indicates that the tree has not retrenched or died back gradually.**

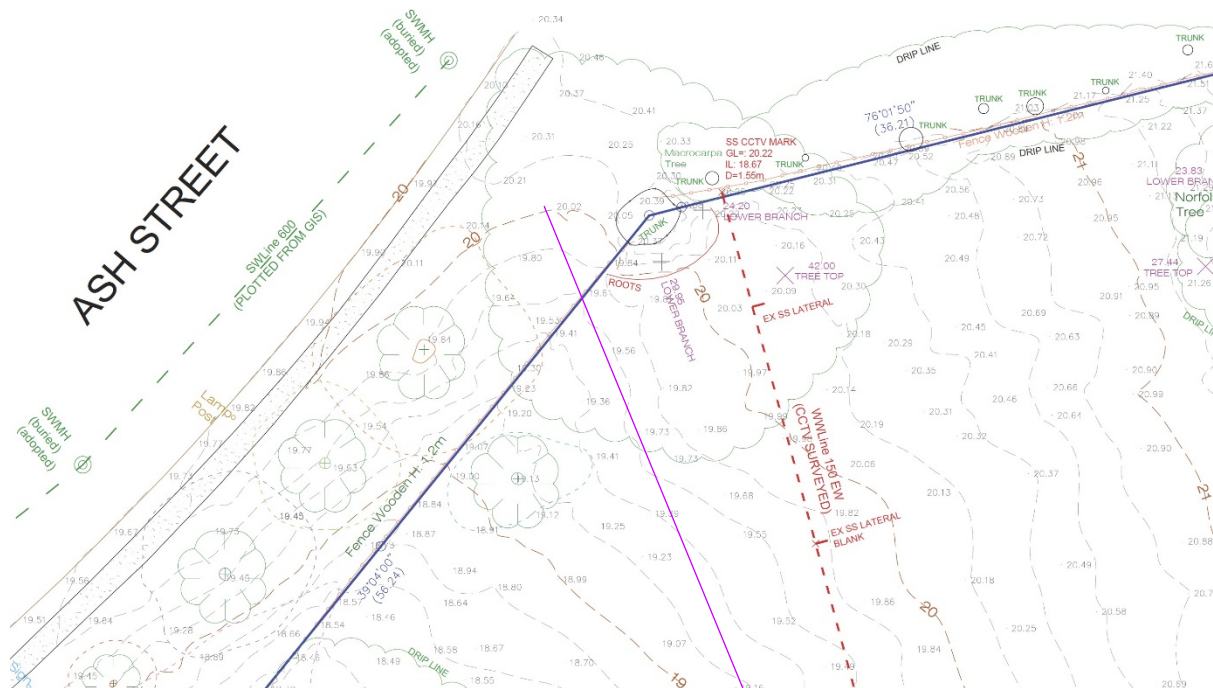
According to the recent topographical plan (Anchor Consulting) completed for LOT 1 DP 514556 a storm water pipe passes through the TPZ and the SRZ to the East of the tree. Identification of the SRZ provides an indicative area within which most structural roots responsible for anchorage and stability are likely to be encountered. It is assumed that this storm water pipe was an open trench excavation which would have impacted the tree at the time and possibly resulted in significant root loss. There is a discrepancy in the location of the storm water pipe as the Auckland GIS plan places the storm water pipe to the West of the macrocarpa while the recent topographical plan locates it to the East, *see figure 8*.

**Figure 8: Stormwater pipe path to the East of the macrocarpa on recent topographical survey (red dashed line), while it is marked on the West of the tree on the Auckland GIS (pink line). (Courtesy of Anchor Consulting)**

The macrocarpa will have little tolerance to construction however it may be possible to construct within the TPZ if exploratory holes were dug and piles were constructed with no root loss over 10mm diameter, however it is important that ground water gradients remain the same and there is no future compaction of the TPZ even by foot traffic. Any construction or changes within the SRZ of the macrocarpa could possibly be catastrophic for the survival of this tree.
