CONSULTANT ARBORIST MEMO

Client: AC Avondale Scheduled Macrocarpa

Location: 1817 Great North Road

Reference: Discovery of substantial crack

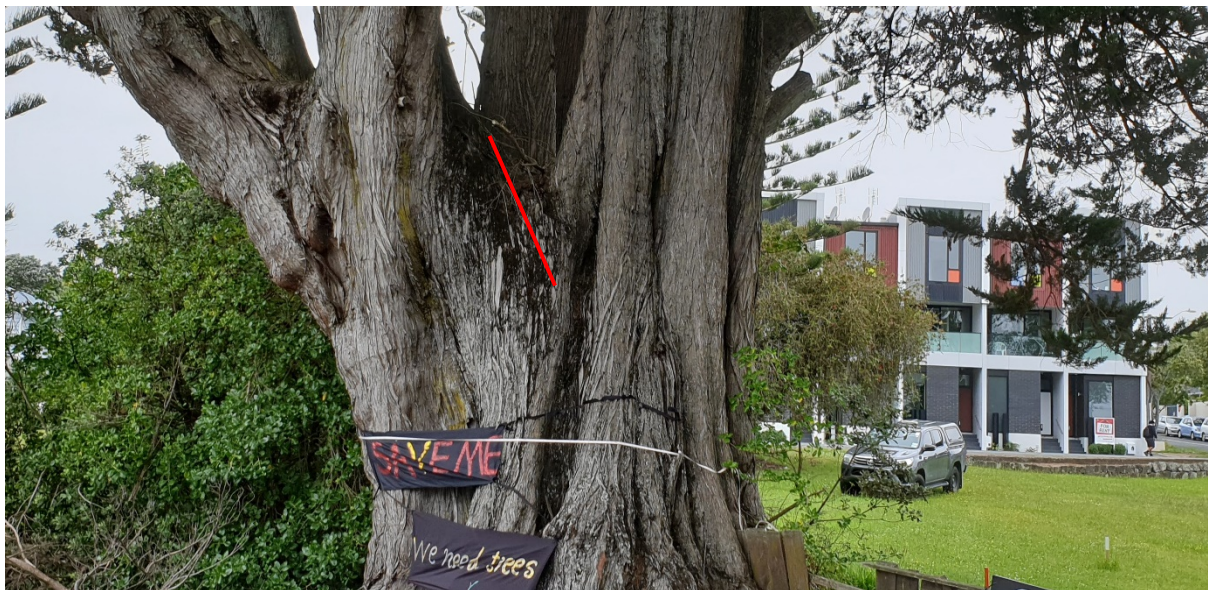
During a post-VTA a resistograph assessment was carried out, during the closer climbing inspection a substantial crack at the main union was discovered which has compromised the long term viability of a stem inclined towards Ash Street (SH9)

Photograph 1: Approximate location and extent of visible crack

Discovery of visible crack approximately 3m long—8mm wide-100mm deep 4th December 2020

Reduce large stem so total failure does not reach State Highway and footpath.

Retain as much as reasonably possible.

Recommend fencing off dripline zone and no mow zone to deter people entering the area.

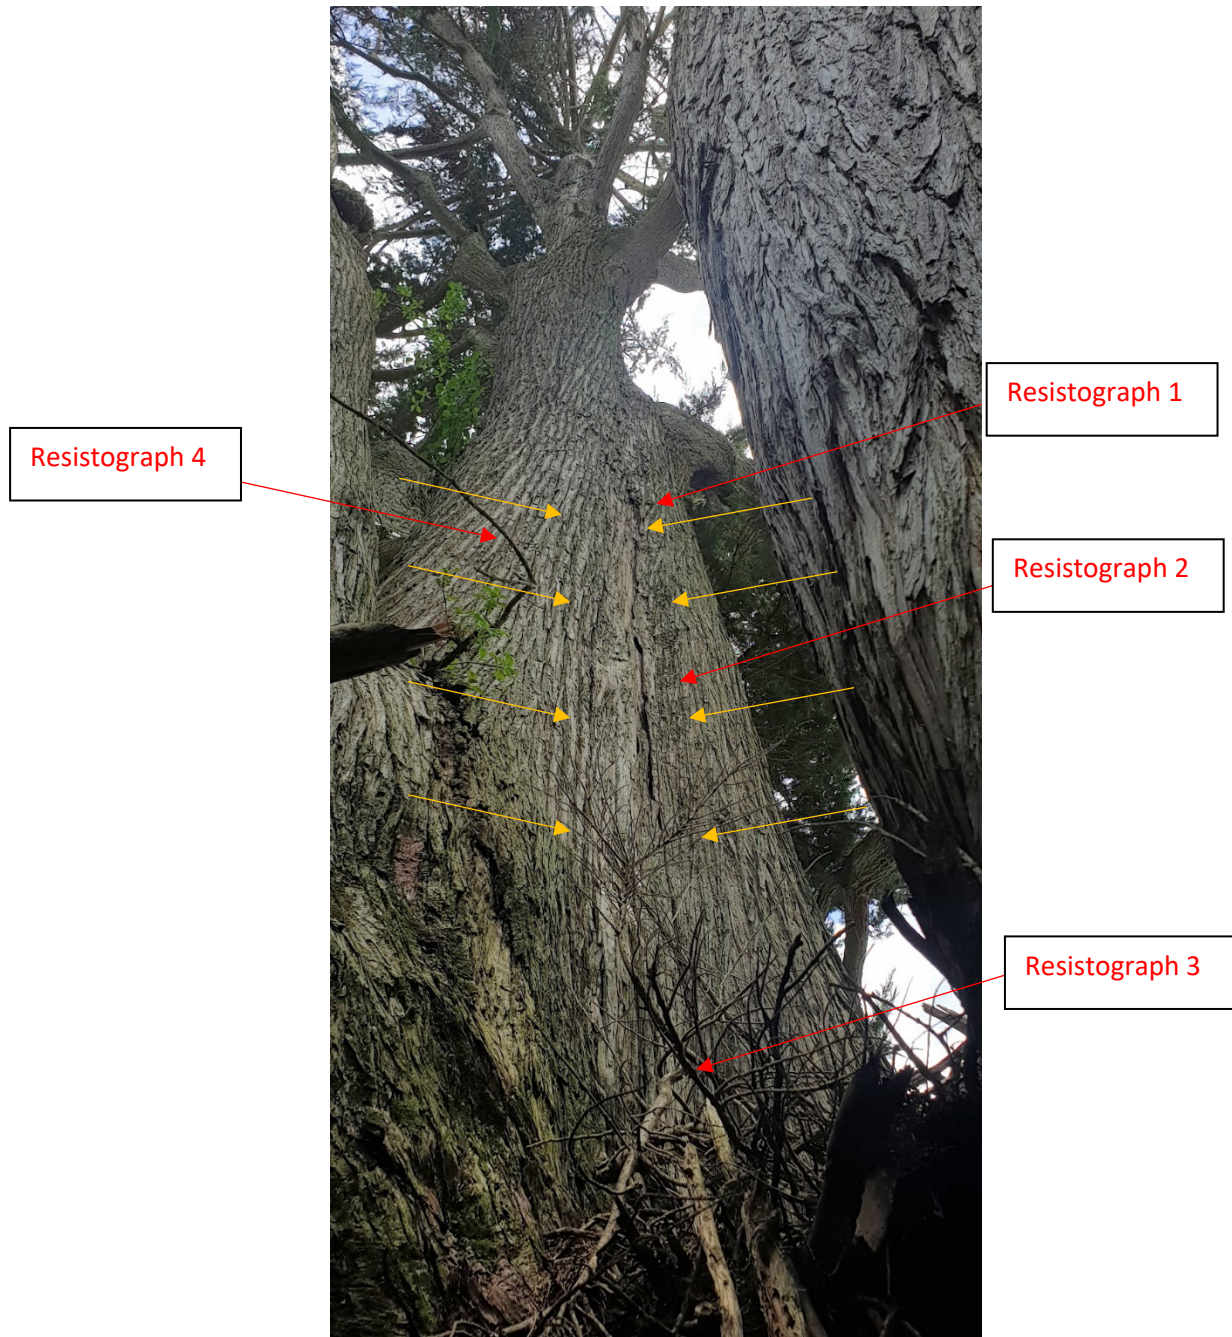
The main dominant stem which has suffered storm damage was resistographed as it was exhibiting a lower stem bark depression stretching from the union approximately 5m to the first branch union.

Photograph 2 Zone of bark dysfunction, area of resistograph investigation.

The total diameter of the stem is an estimated 1100mm the resistograph measures the resistance of the wood up to 500mm depth. Below are the results from four drills with approximate dimensions indicating boundaries bark/sapwood/heartwood.

Resistograph 1: 1.8m from stem union: 40mm decayed bark to cambium, 90mm sapwood, 160mm heartwood, 200mm hollowing.

Resistograph 2: 1.0m from stem union: 25mm decayed bark to cambium, 120mm sapwood, 120mm decaying/poor resistance heartwood, 220mm hollowing.

Resistograph 3: 0m from stem union, 25mm decayed bark to cambium, 270mm sapwood/heartwood, 110mm decay/hollowing, 80mm heartwood.

Resistograph 3: 1.5m height to East rib (reactionary wood?) 30mm bark, 70mm sapwood, 380mm heartwood.

It appears that there is a zone or a pocket of hollowing within the main stem associated with the strip of bark dysfunction which could be described as a canker. Combined with the recent storm damage of the upper canopy it seems more likely that the macrocarpa has been subjected to cankering for some time, leading to branch weaknesses. Although the effects of the Seiridium canker are thought to act slowly on more mature trees, this strip of decay indicates that the canker has been acting for a significant amount of time already. However the species is still to be identified by MPI.
