Mt Richmond Domain Western Playing Field – Underlying Ground Conditions, Construction Photographs

1676 Fraser Geologics Ltd Prepared 30 July 2020

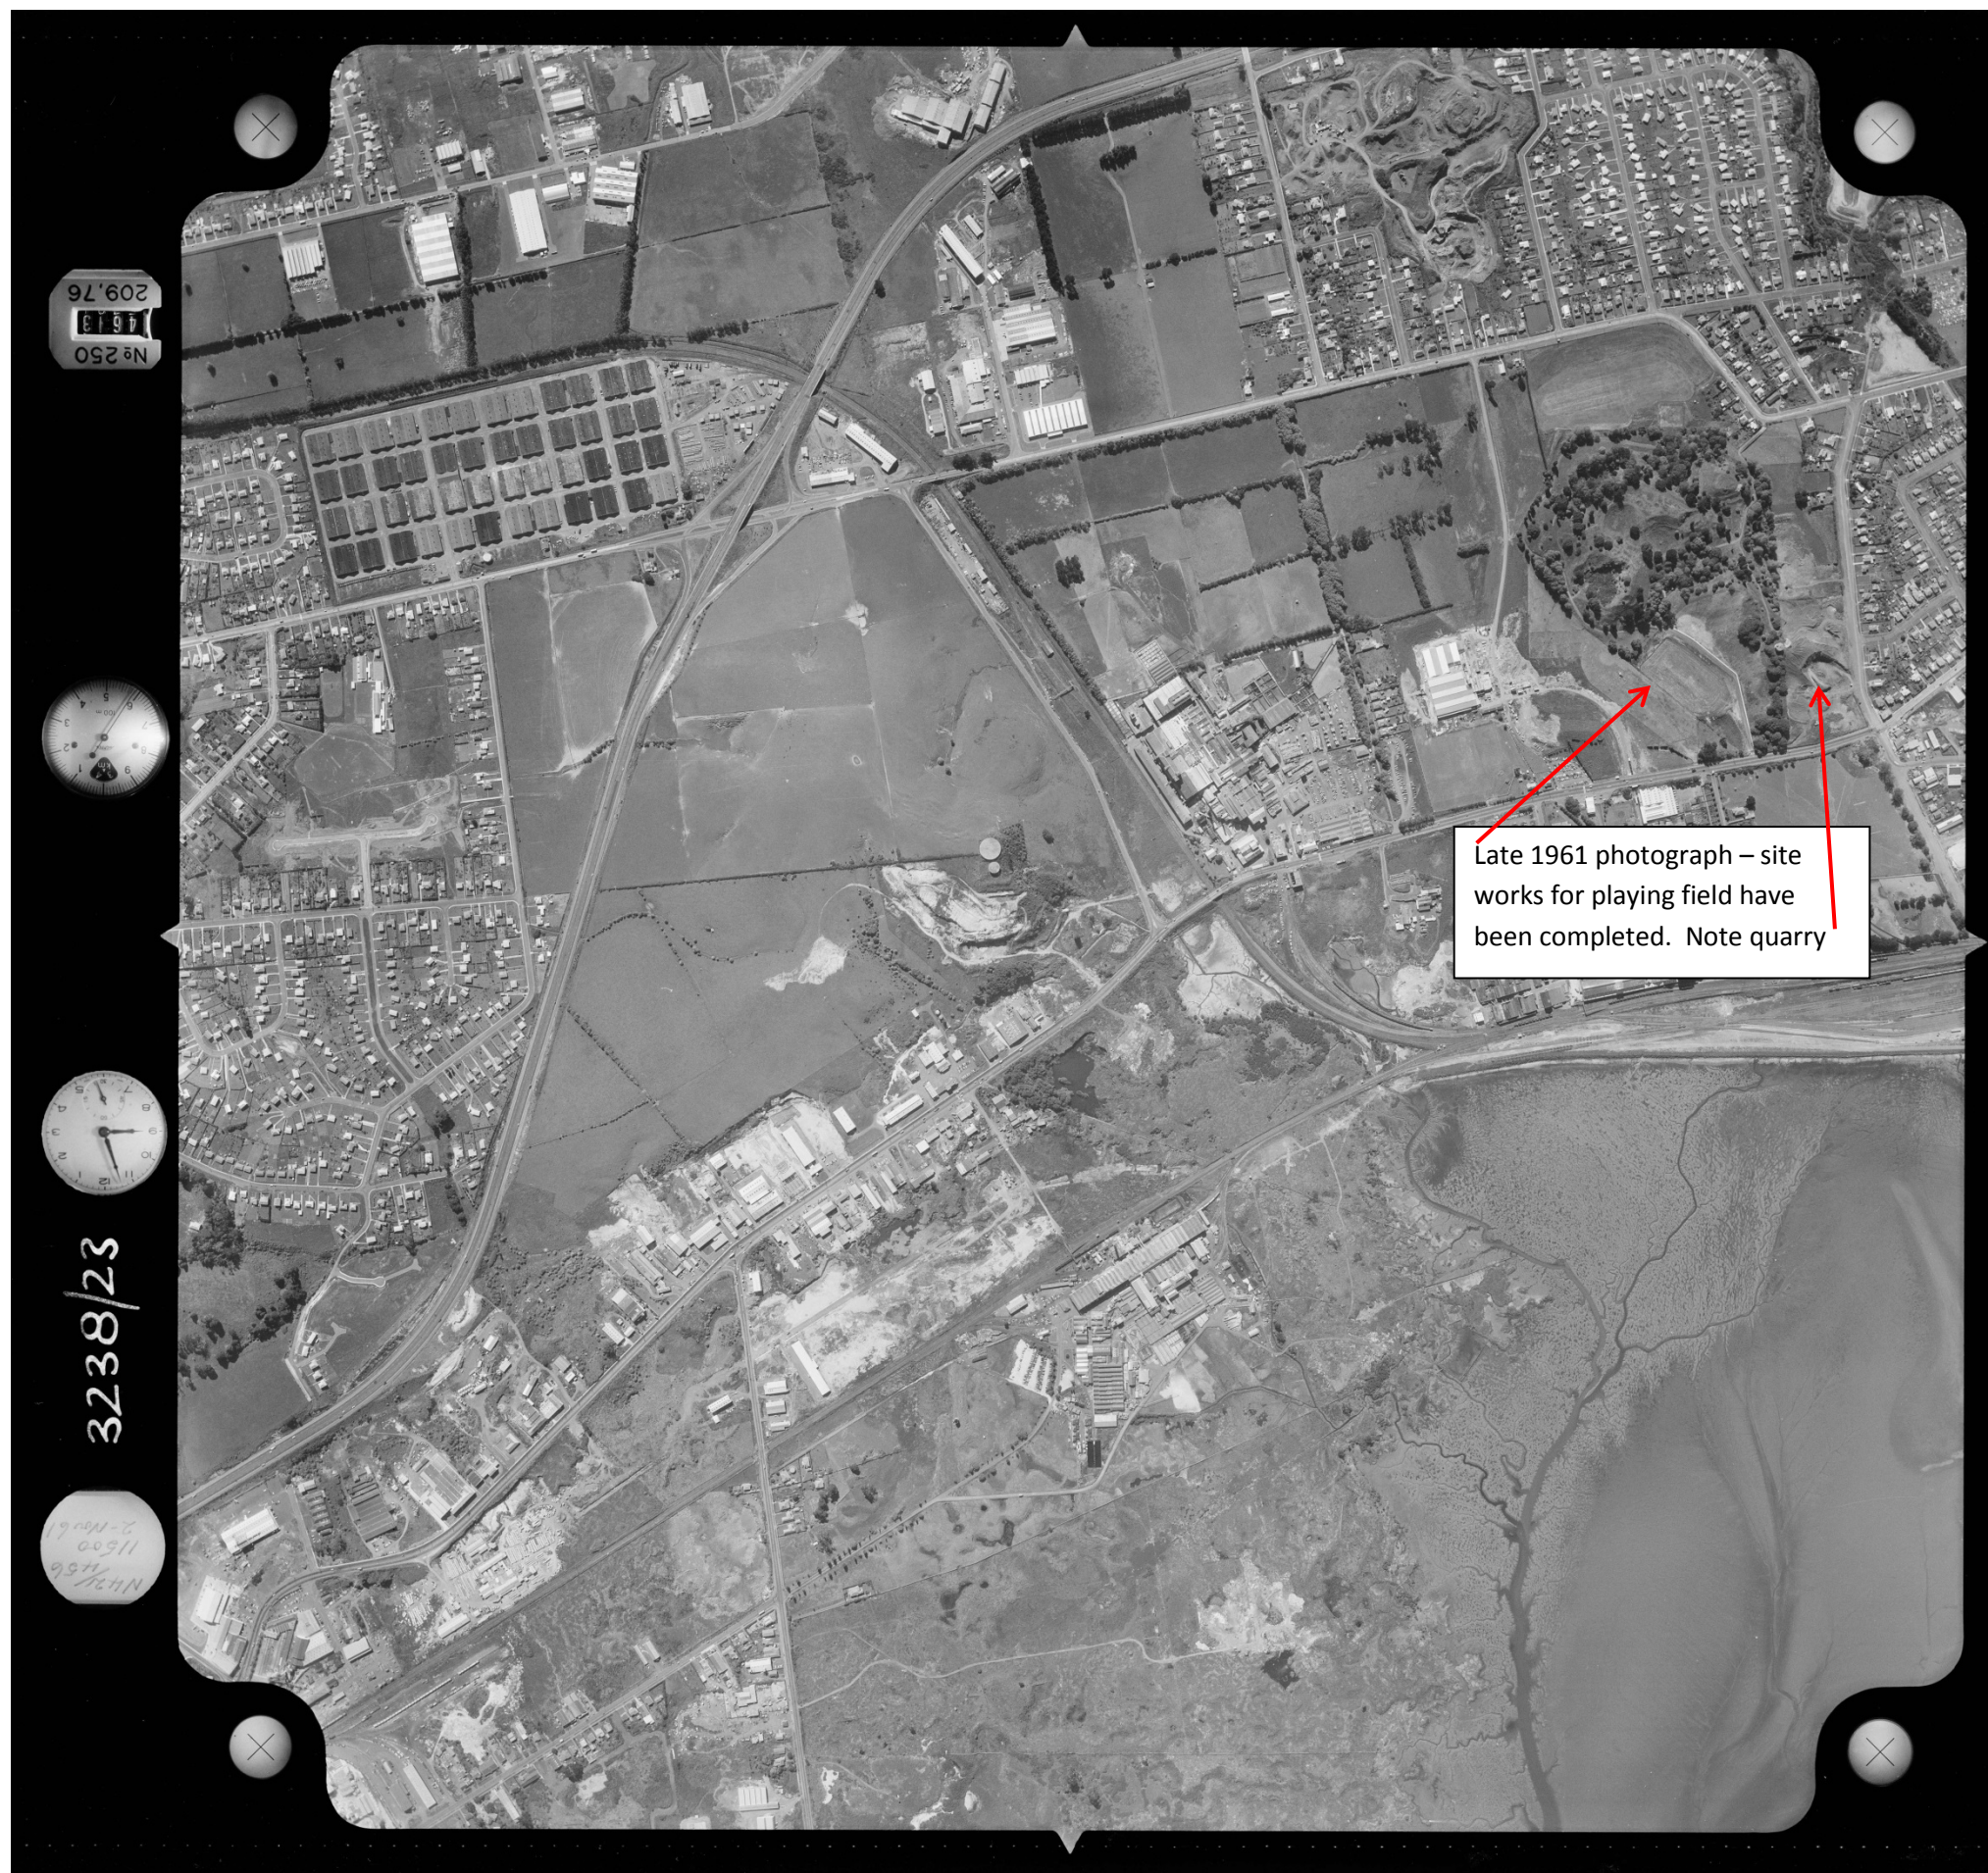
NZAM vertical aerial photograph, SN1392 run 3238 image 23. Flown 02.11.1961

Late 1961 photograph – site
works for playing field have
been completed. Note quarry

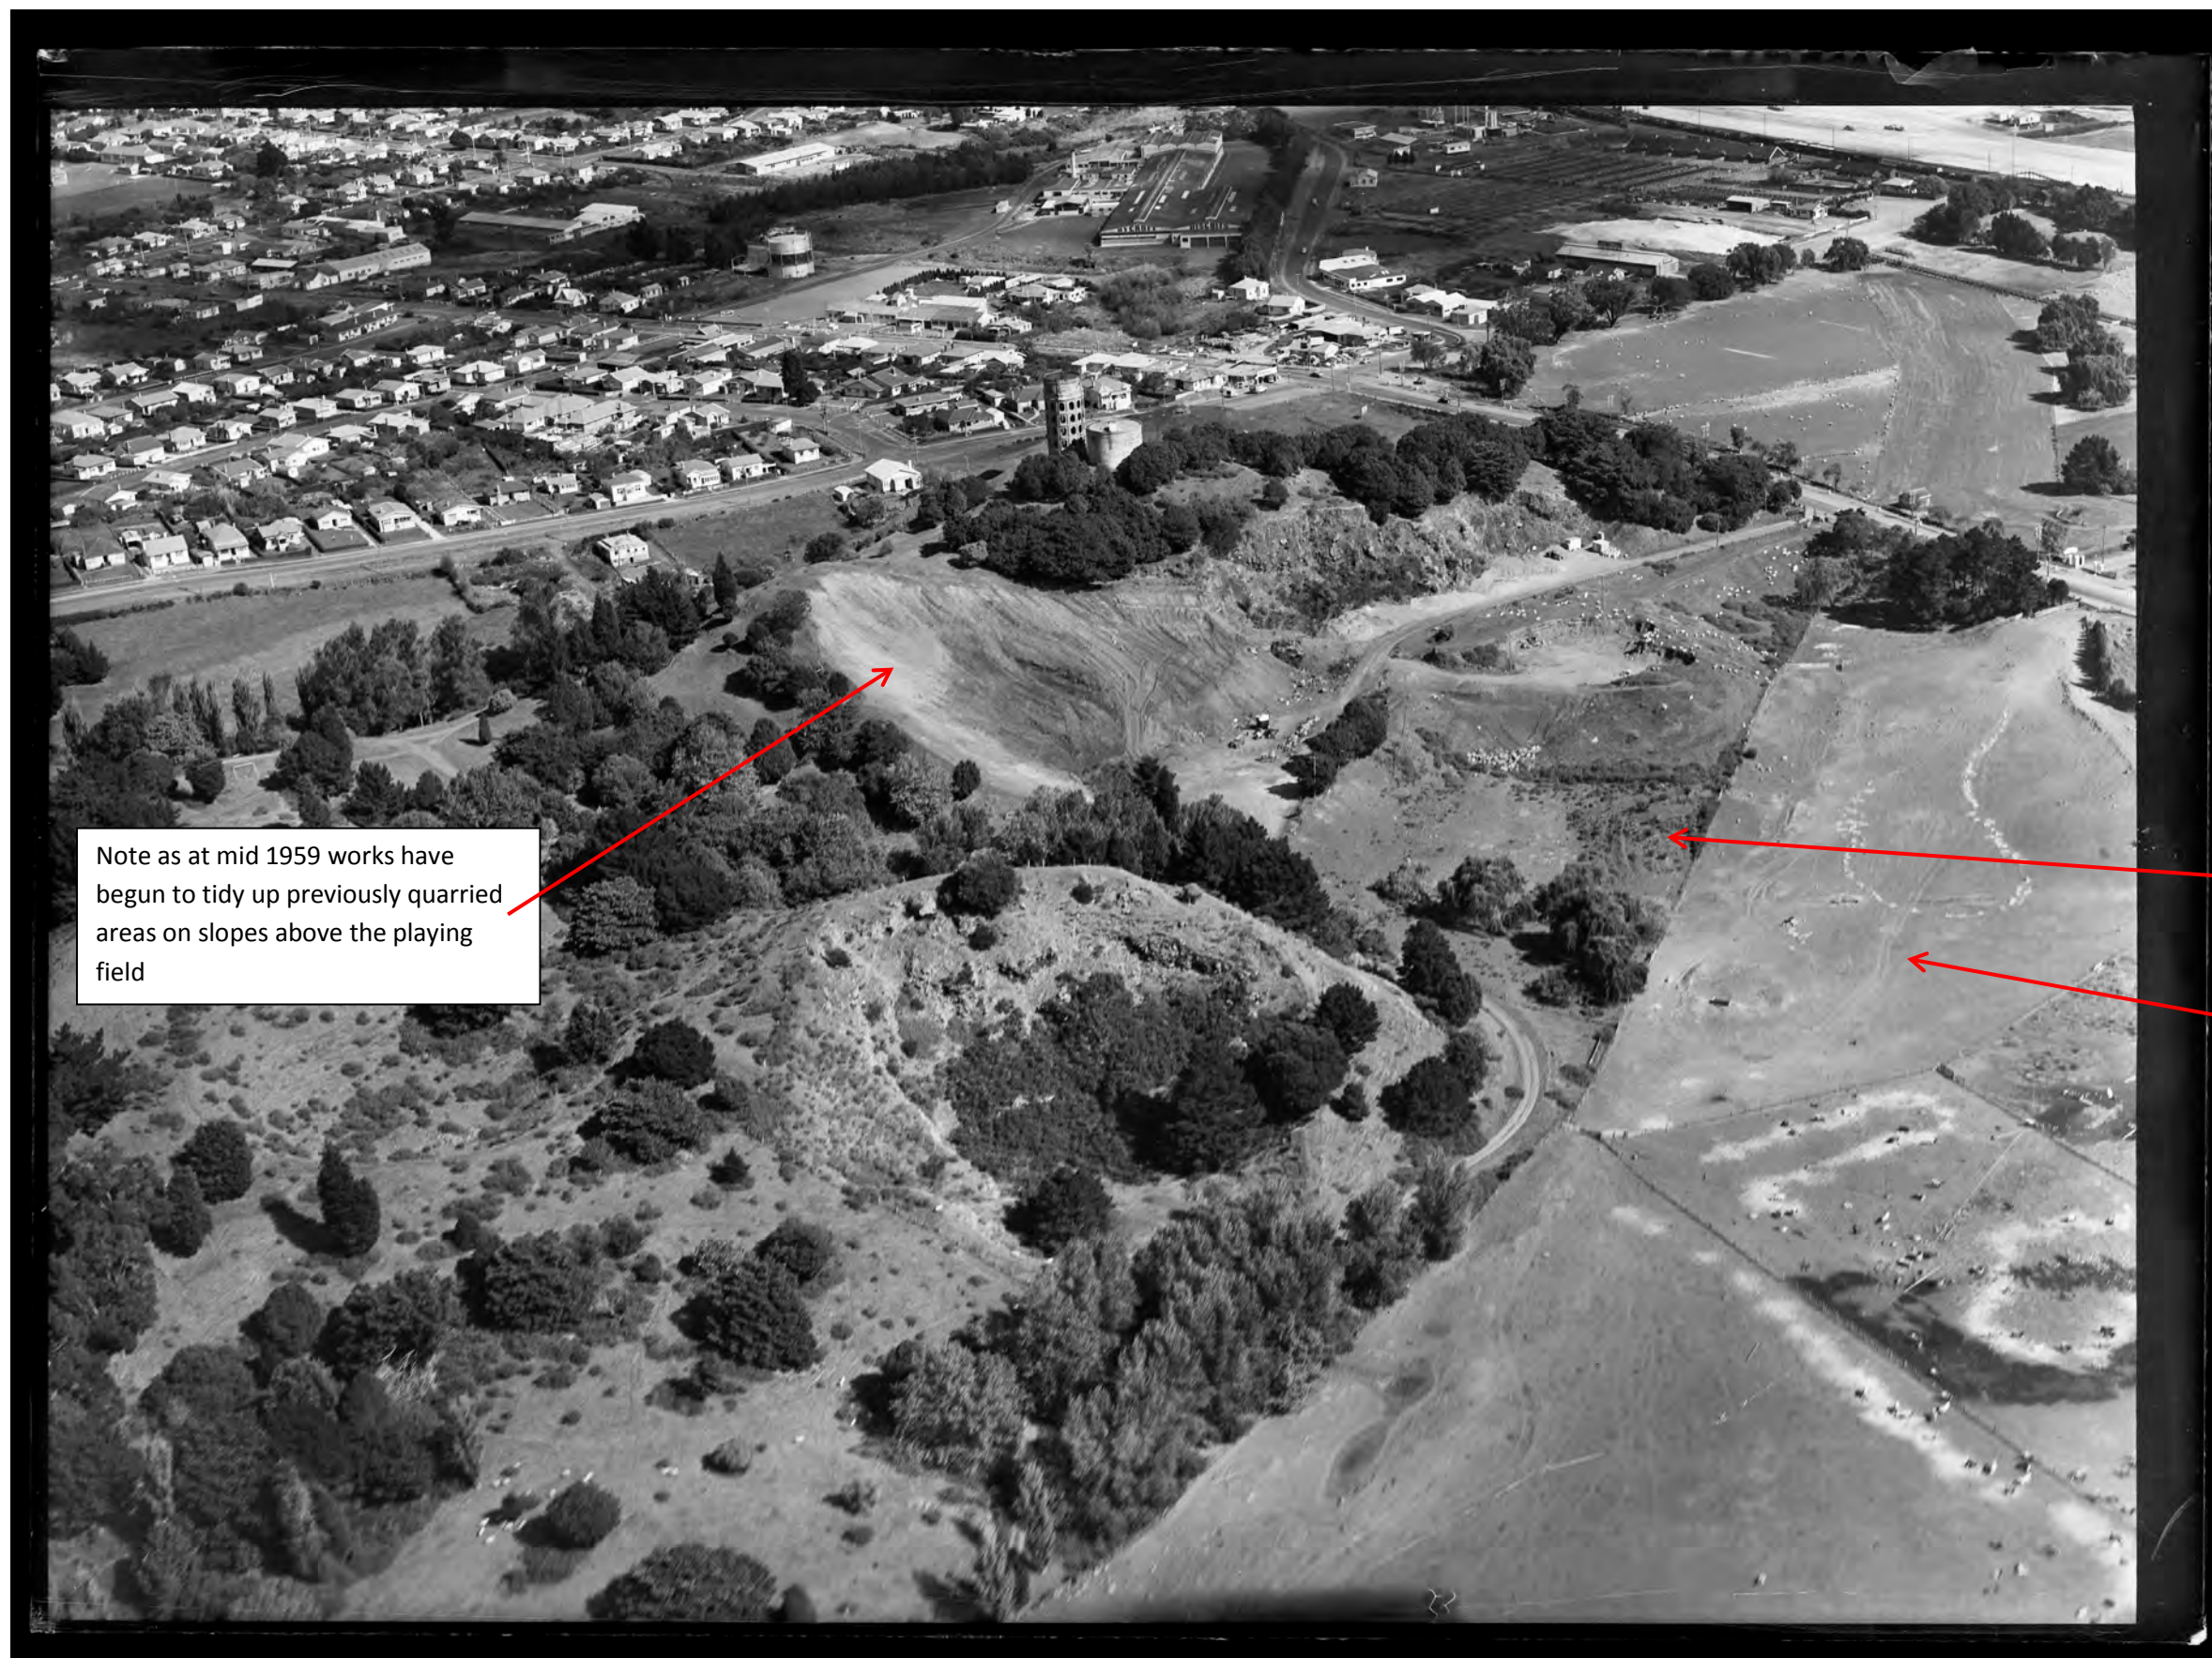
Note as at mid 1959 works have begun to tidy up previously quarried areas on slopes above the playing field

Site Location – note lava flows under playing field area (rubbly upstanding terrain).

Organic soils are over the boundary to the west (more visible in vertical photographs above)

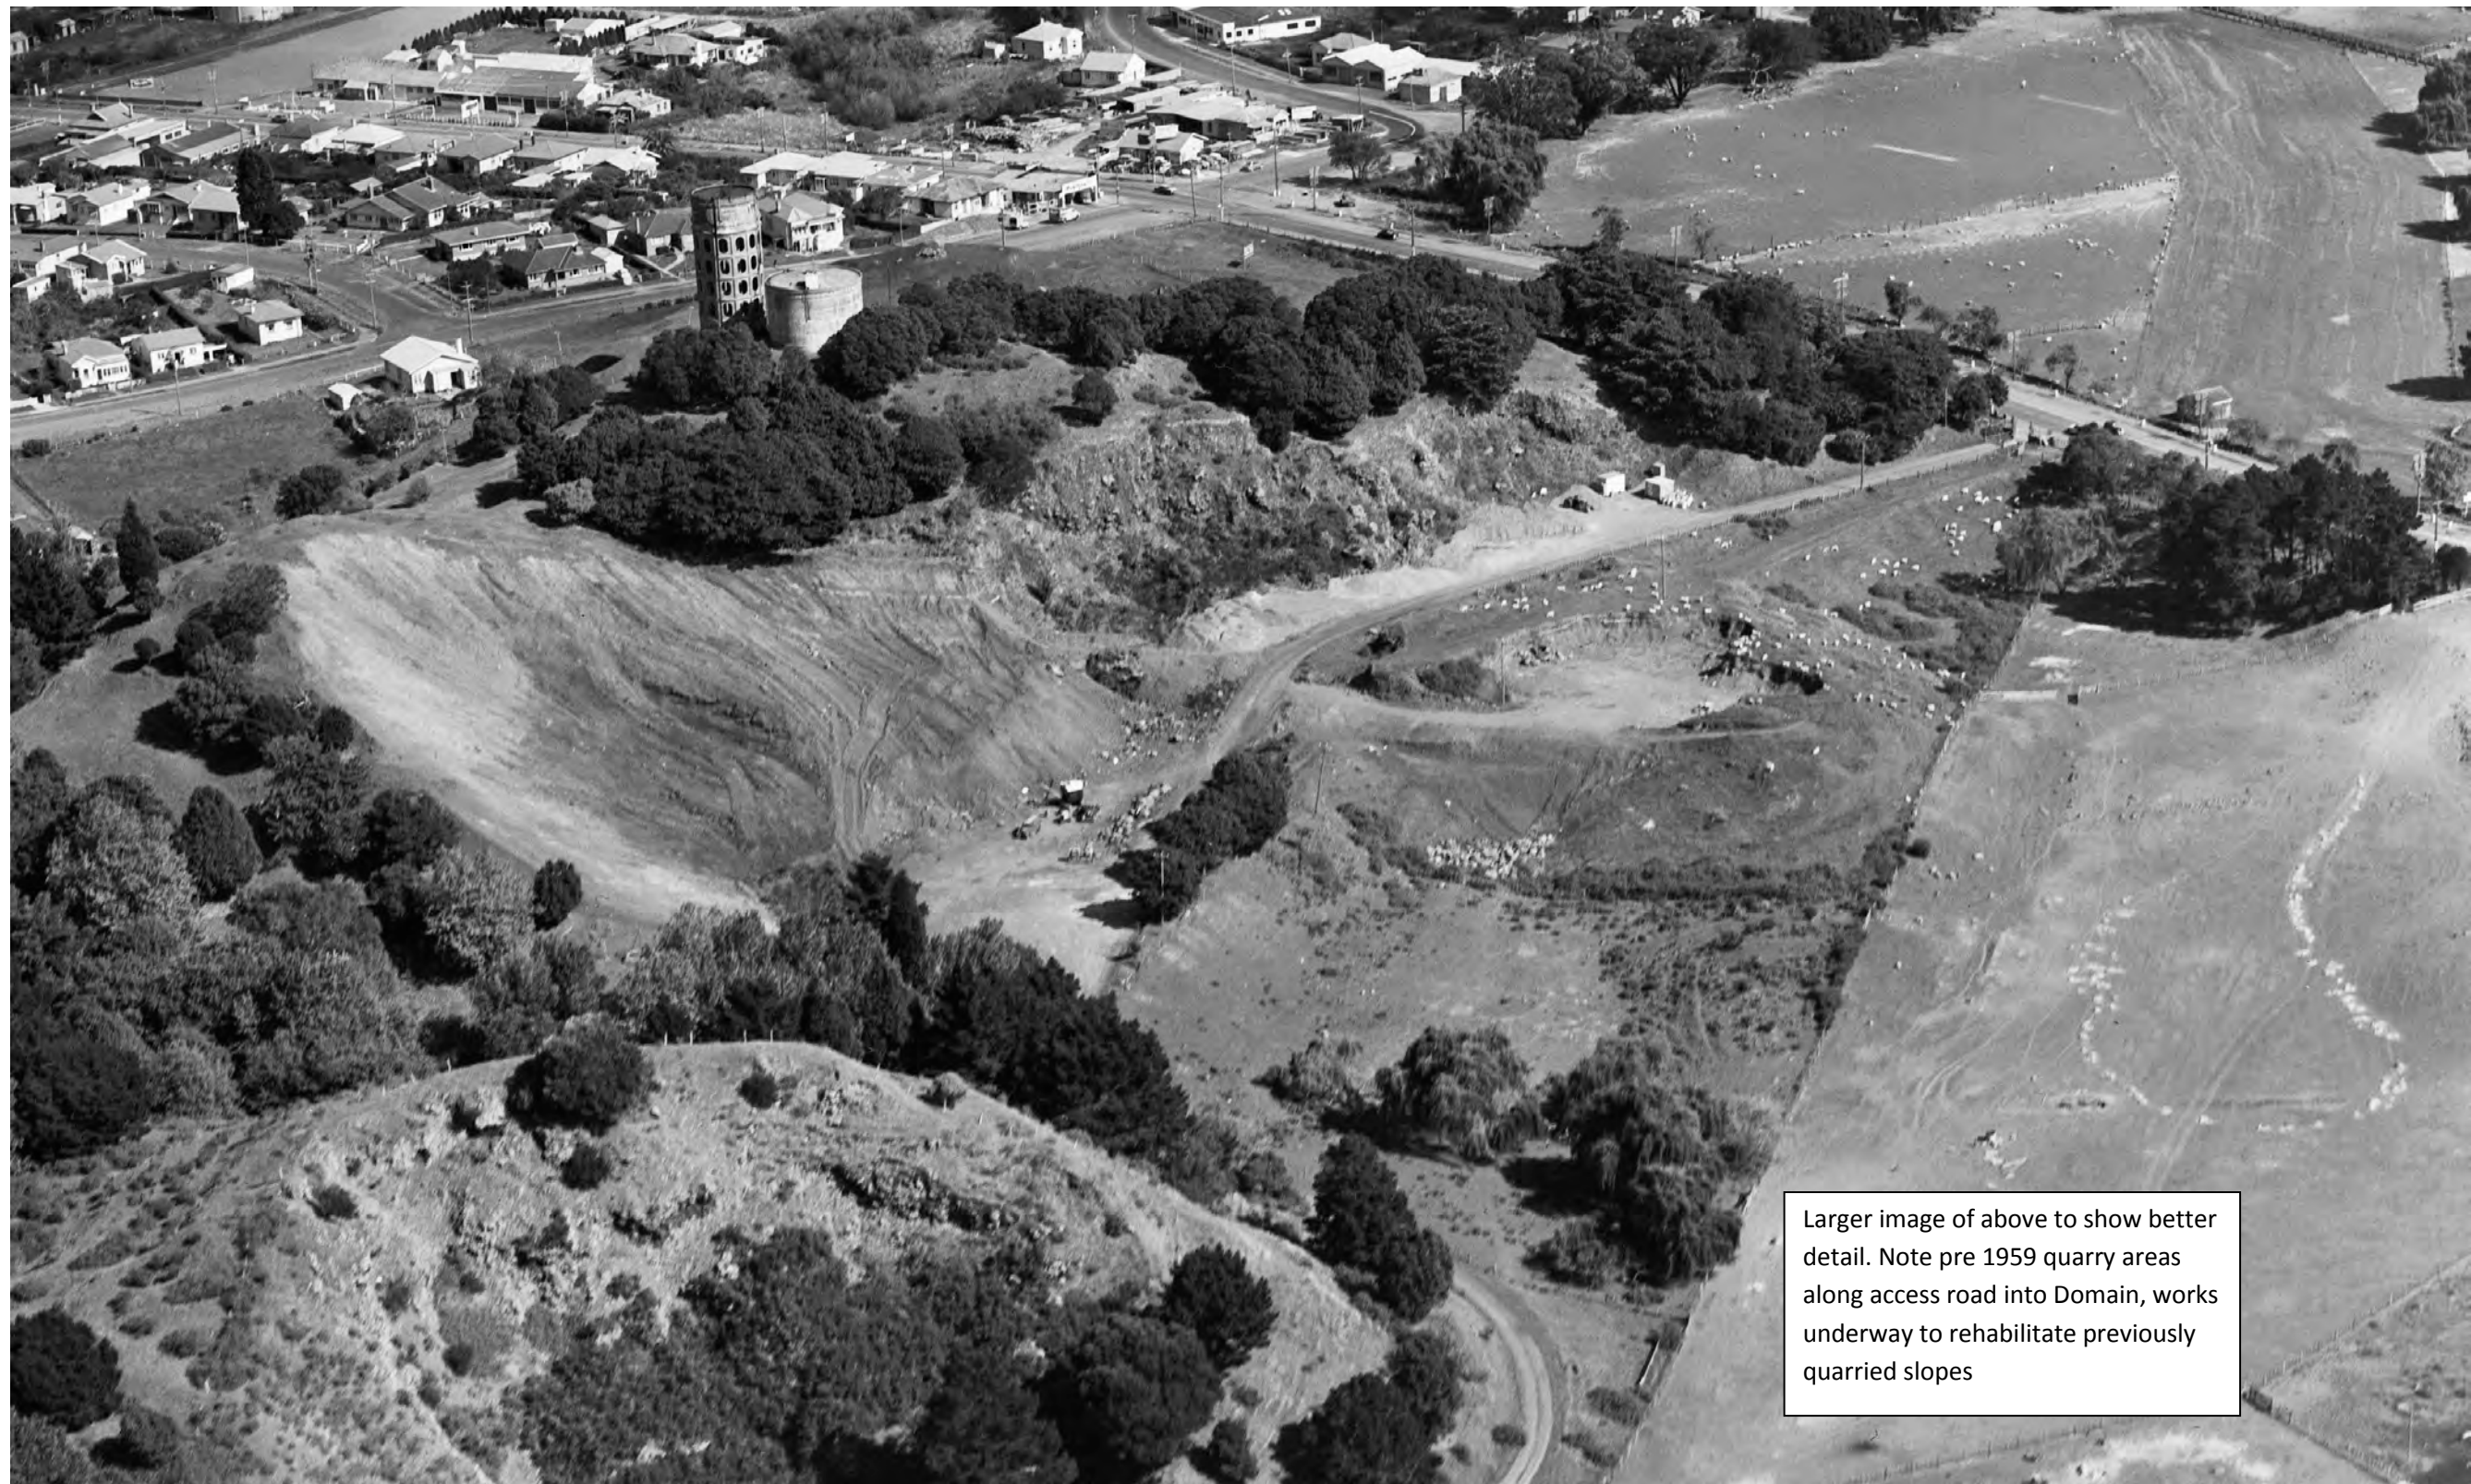
5th April 1959. Mt Richmond & Otahuhu, Auckland. Whites Aviation Ltd, Photographs, Ref WA-50124. Alexander Turnbull Library, Wellington, NZ. Item 32370093 Cropped and enlarged image.

Larger image of above to show better detail. Note pre 1959 quarry areas along access road into Domain, works underway to rehabilitate previously quarried slopes

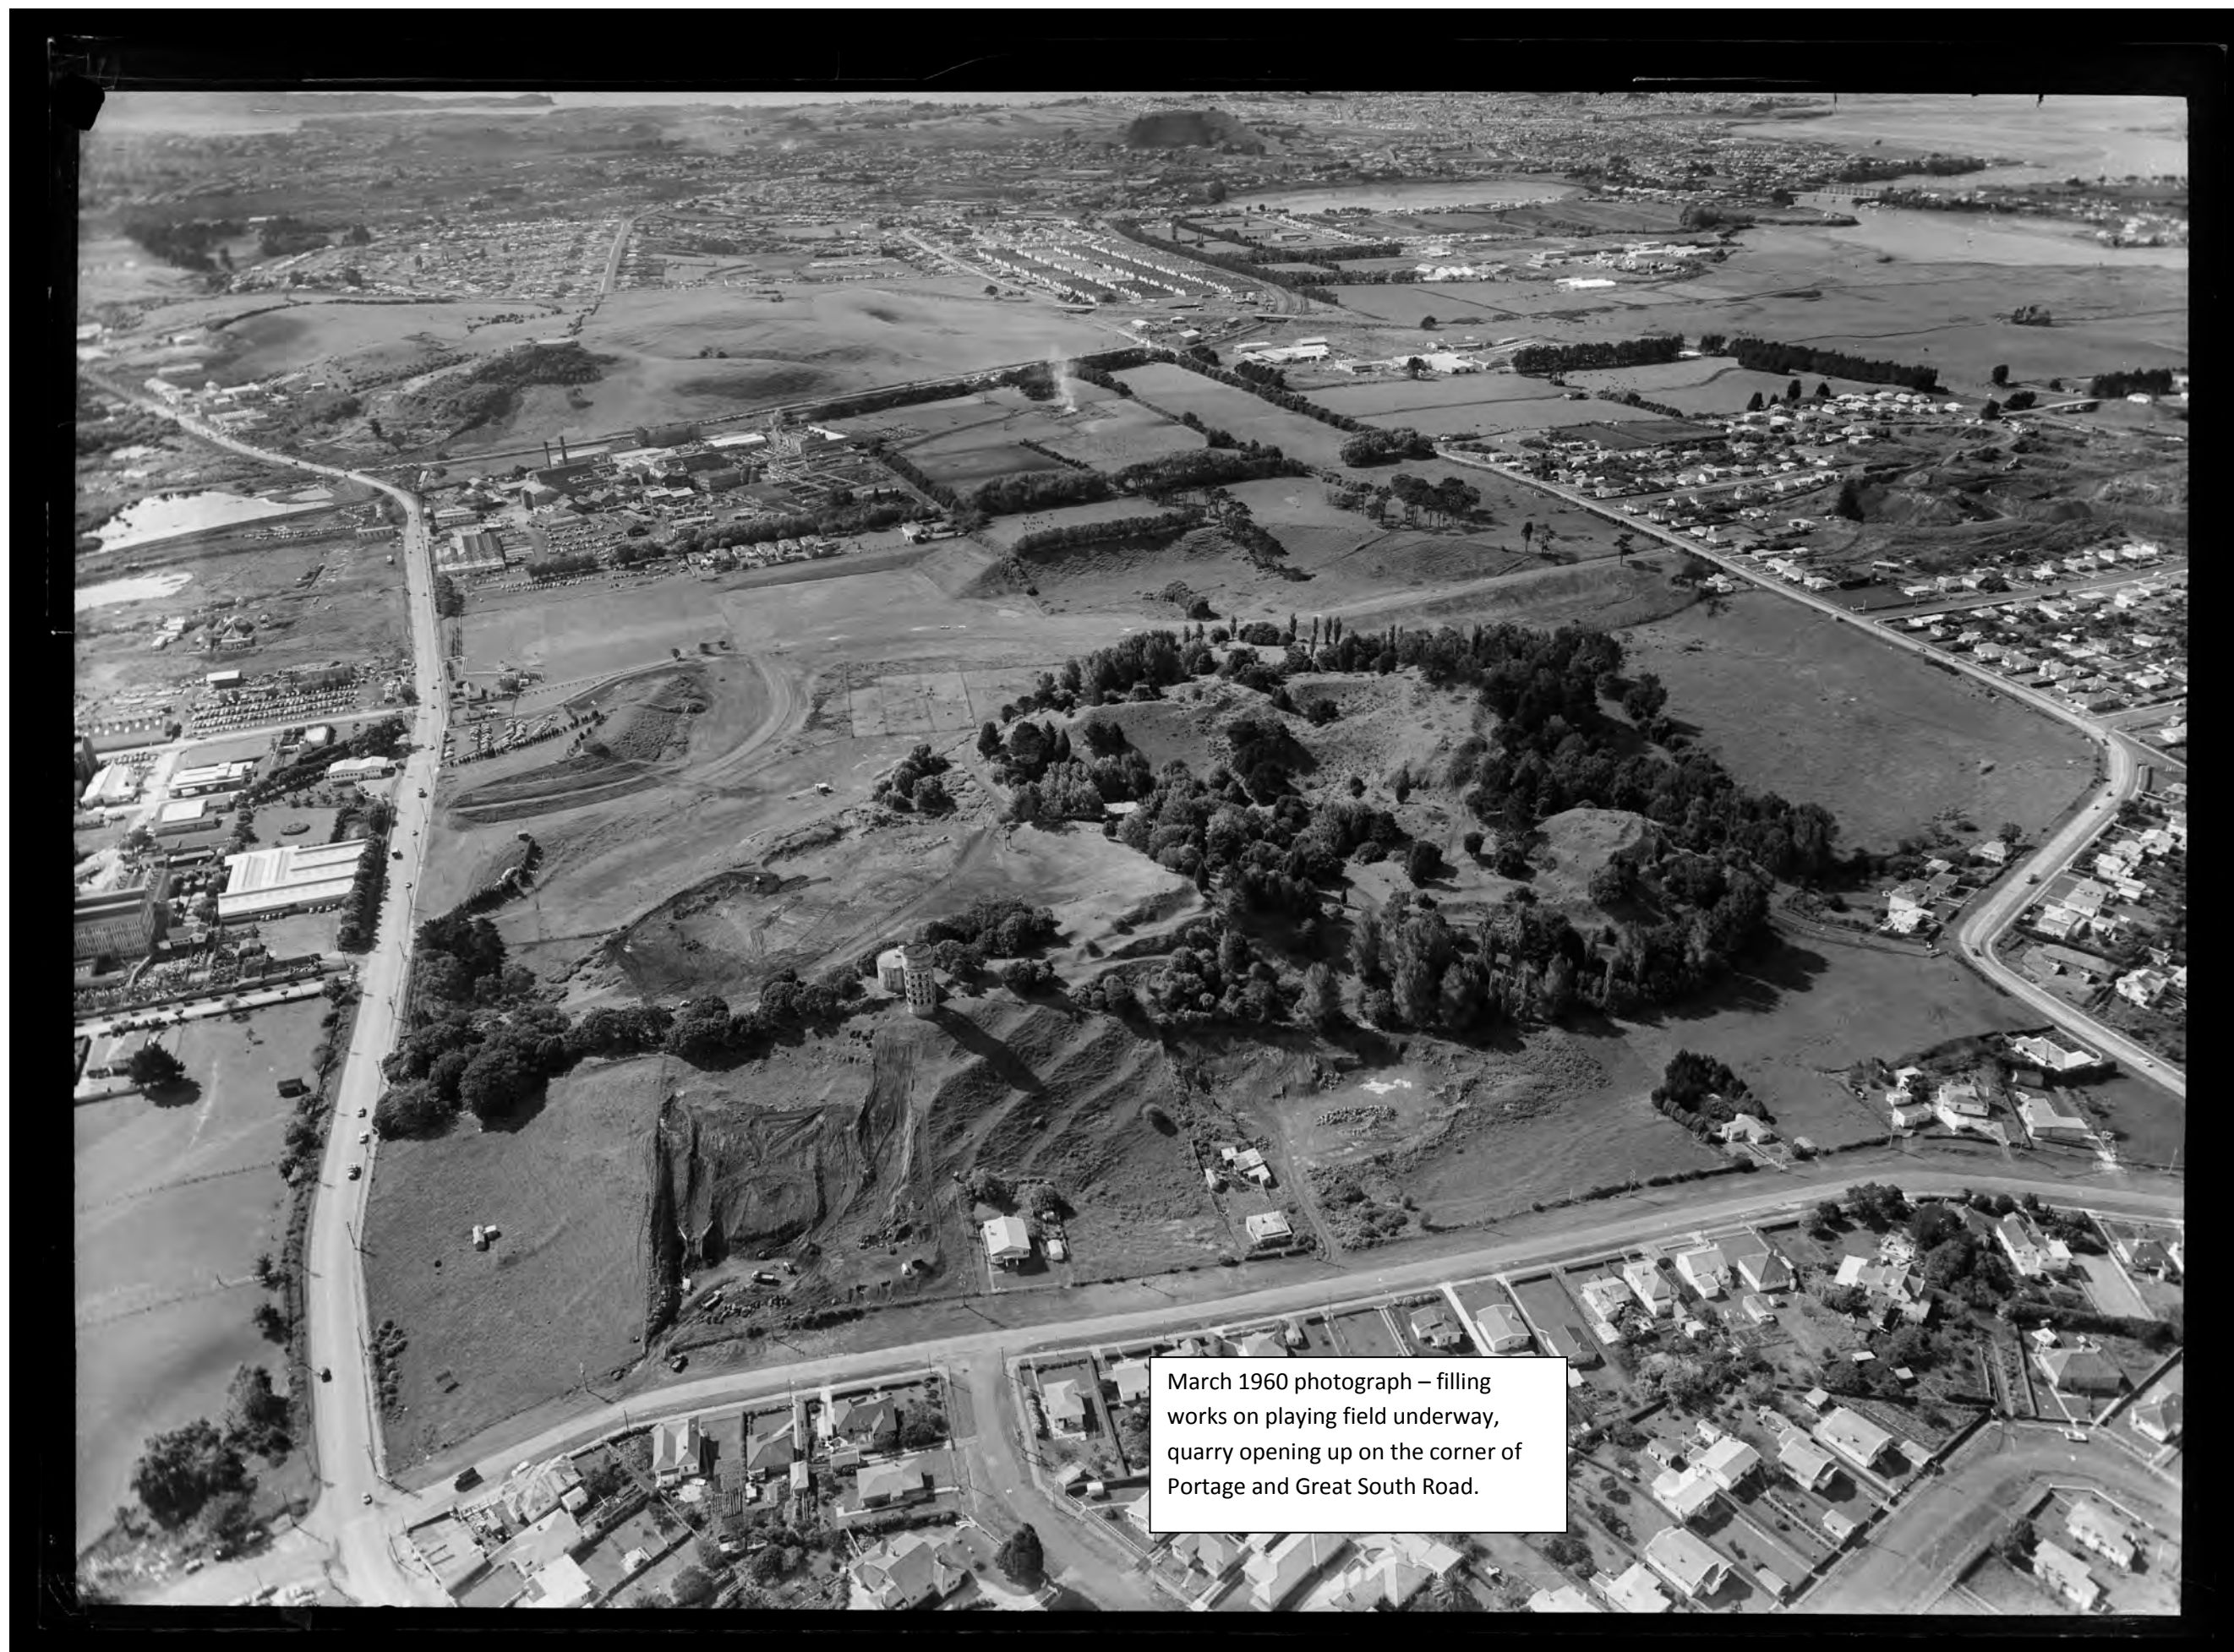
March 1960 photograph – filling works on playing field underway, quarry opening up on the corner of Portage and Great South Road.

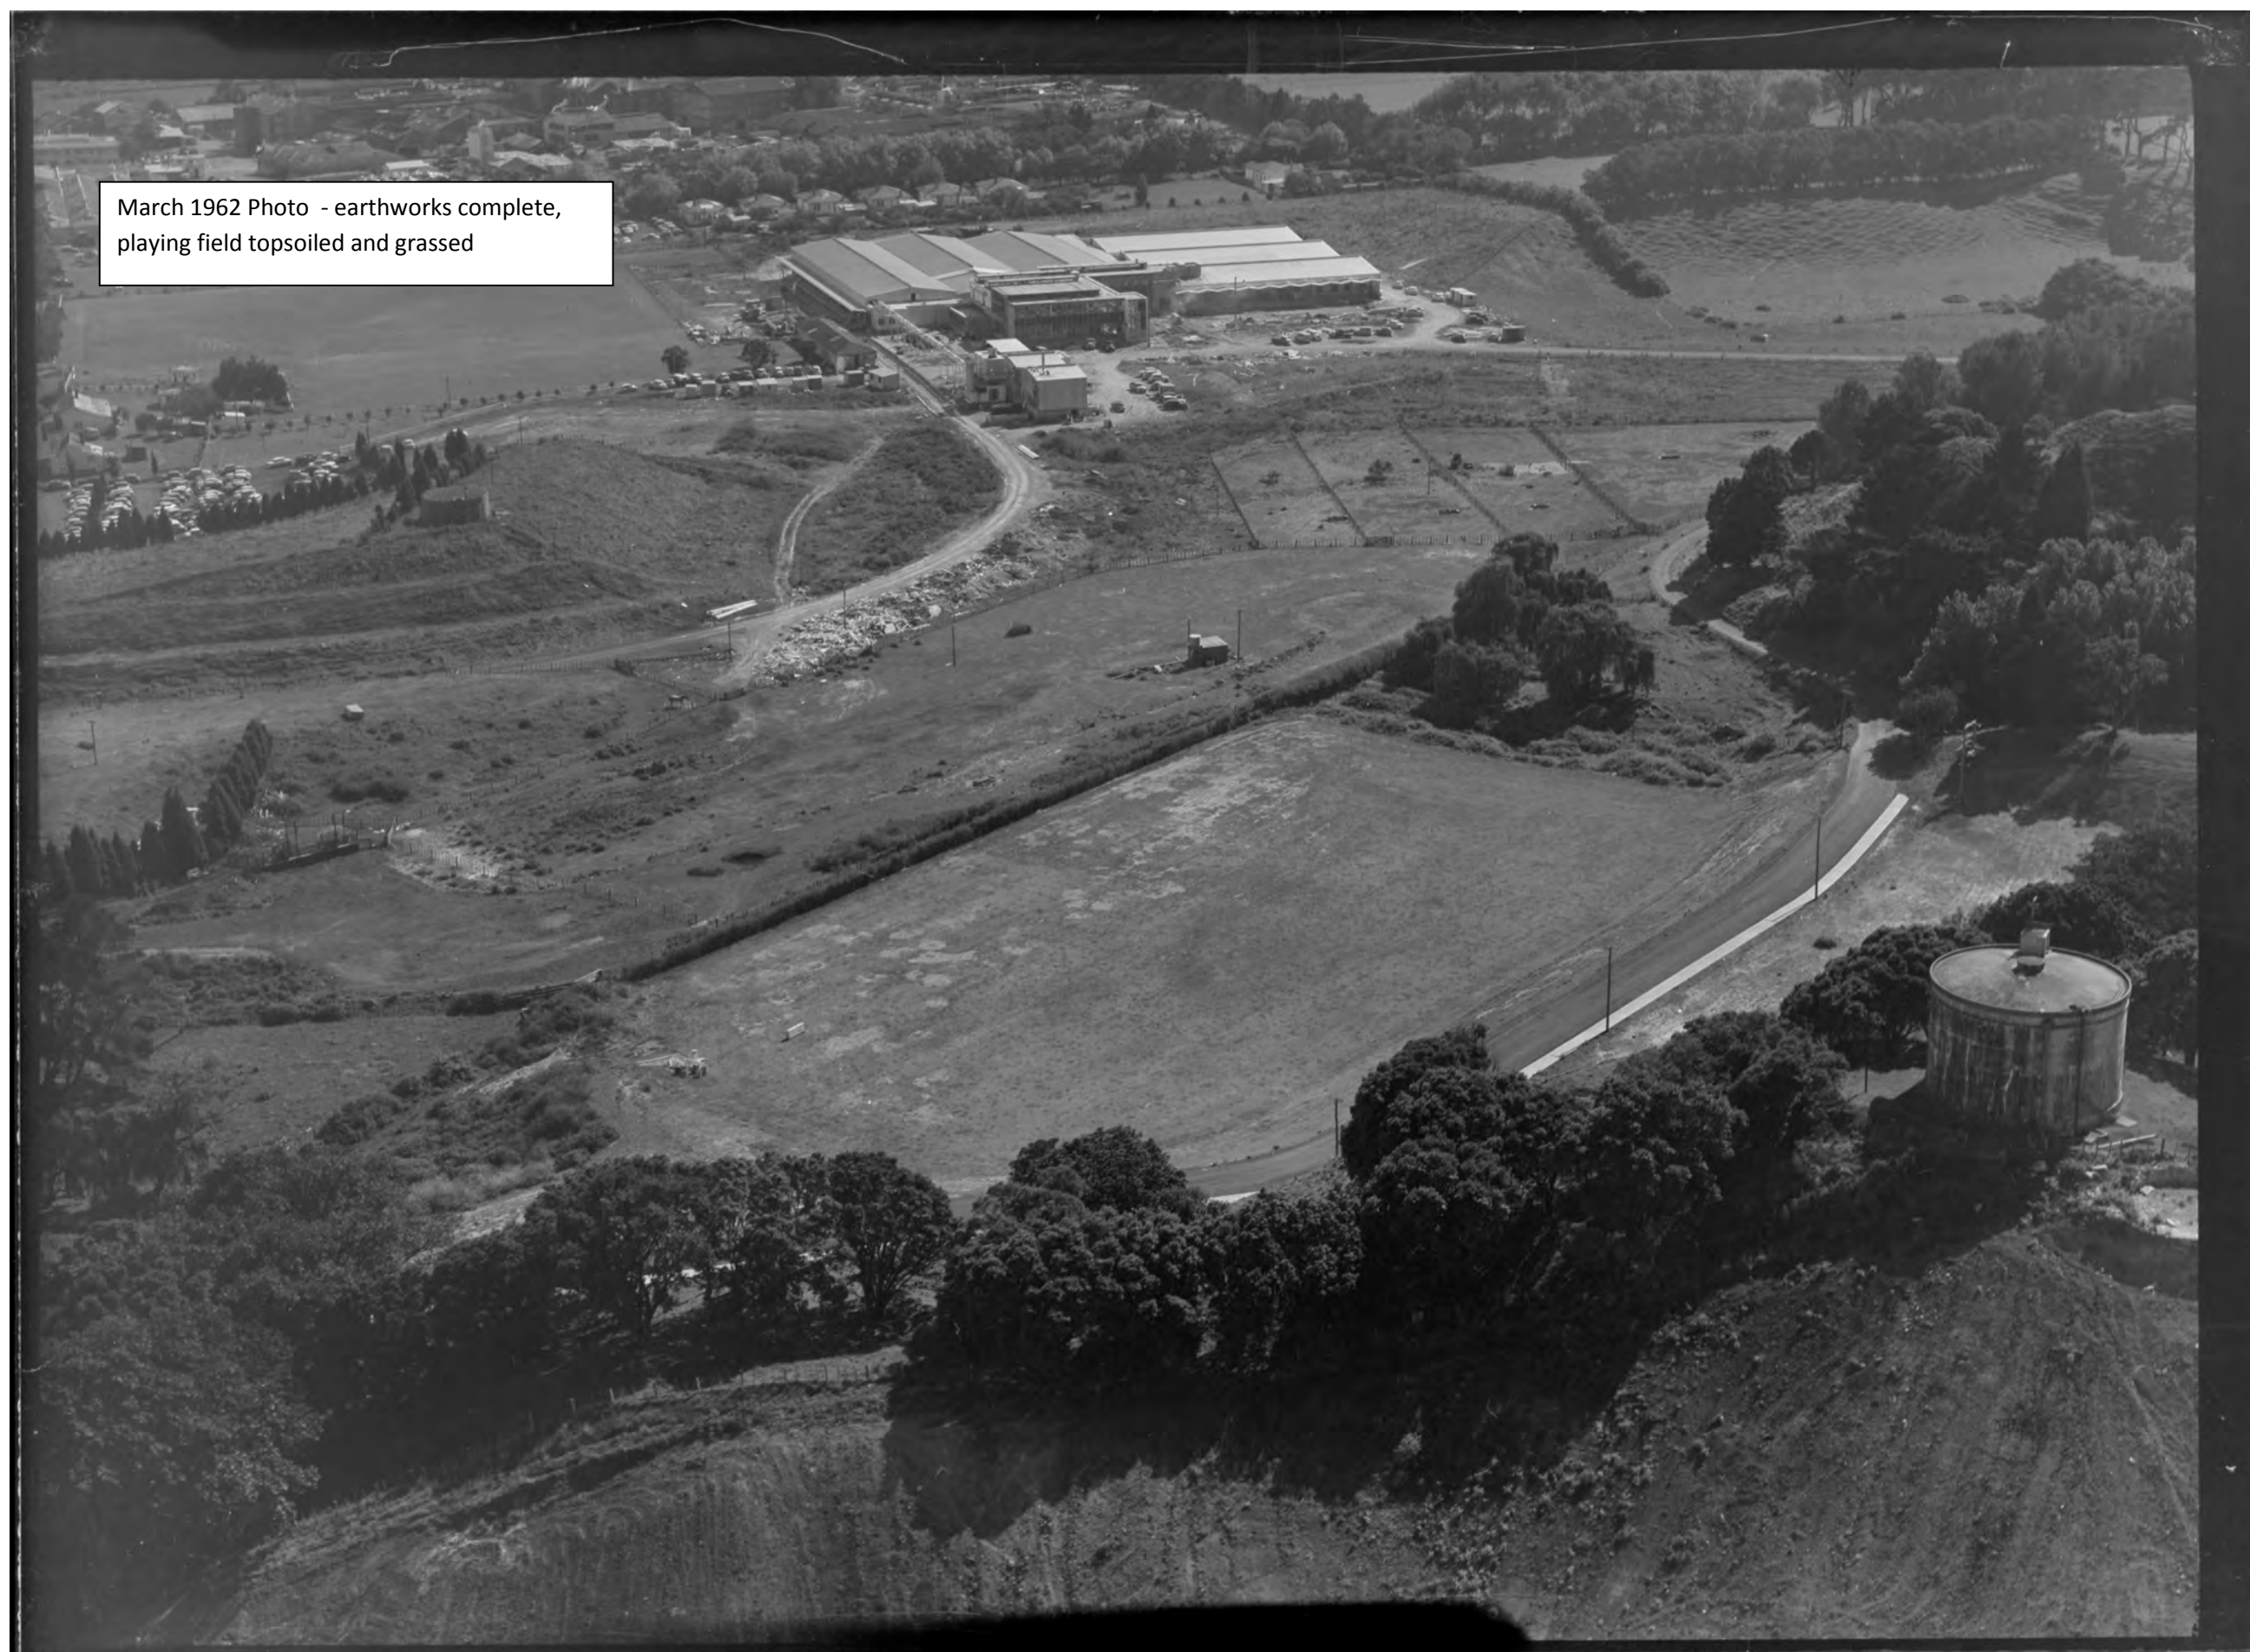
March 1962 Photo - earthworks complete,
playing field topsoiled and grassed
