Tūpuna Maunga Authority

Heritage Impact Assessment of Proposed Tree Removals and Re-vegetation Planting Plan for Ōhuiarangi / Pigeon Mountain

October 2018

FOR : Tūpuna Maunga Authority
BY : Brent Druskovich - MA(Hons), BCom.
Consultant Archaeologist

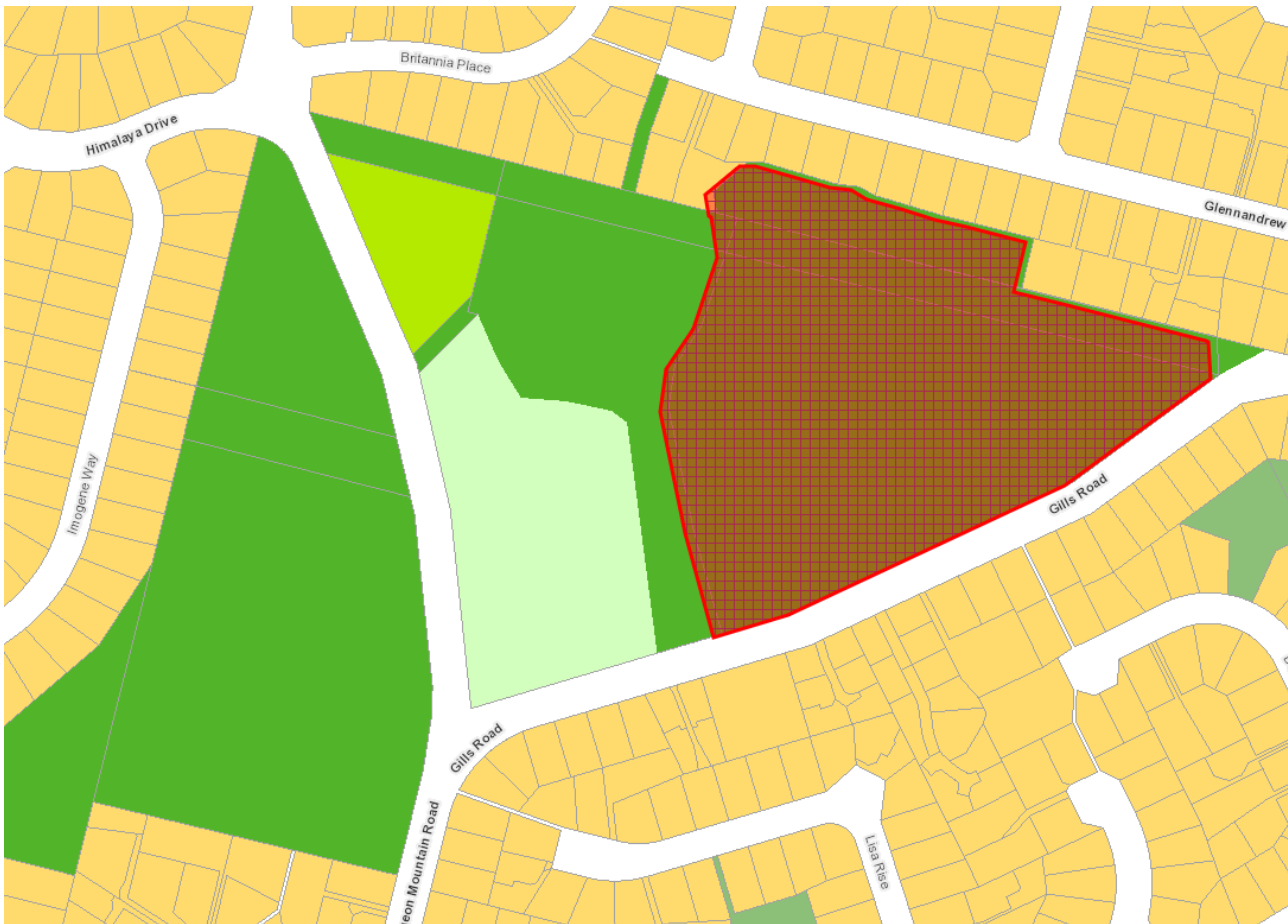
Figure 1. Auckland Council Unitary Plan illustrating the scheduled part of Ōhuiarangi Mountain outlined in red.

Part of Ōhūiarangi is scheduled on the Auckland Council Unitary Plan as ID 1289 (Figure 1) as a Significant Historic Heritage Place. Ōhūiarangi is recorded on the Auckland Council Cultural Heritage Inventory (CHI) with the record number 11733 and recorded with the New Zealand Archaeological Association (NZAA) as site R11/38. A midden site is recorded across Pigeon Mountain Road near the Himalaya Drive intersection with the NZAA as R11/2825, this is outside the scheduled area of the site, but within the larger reserve area.

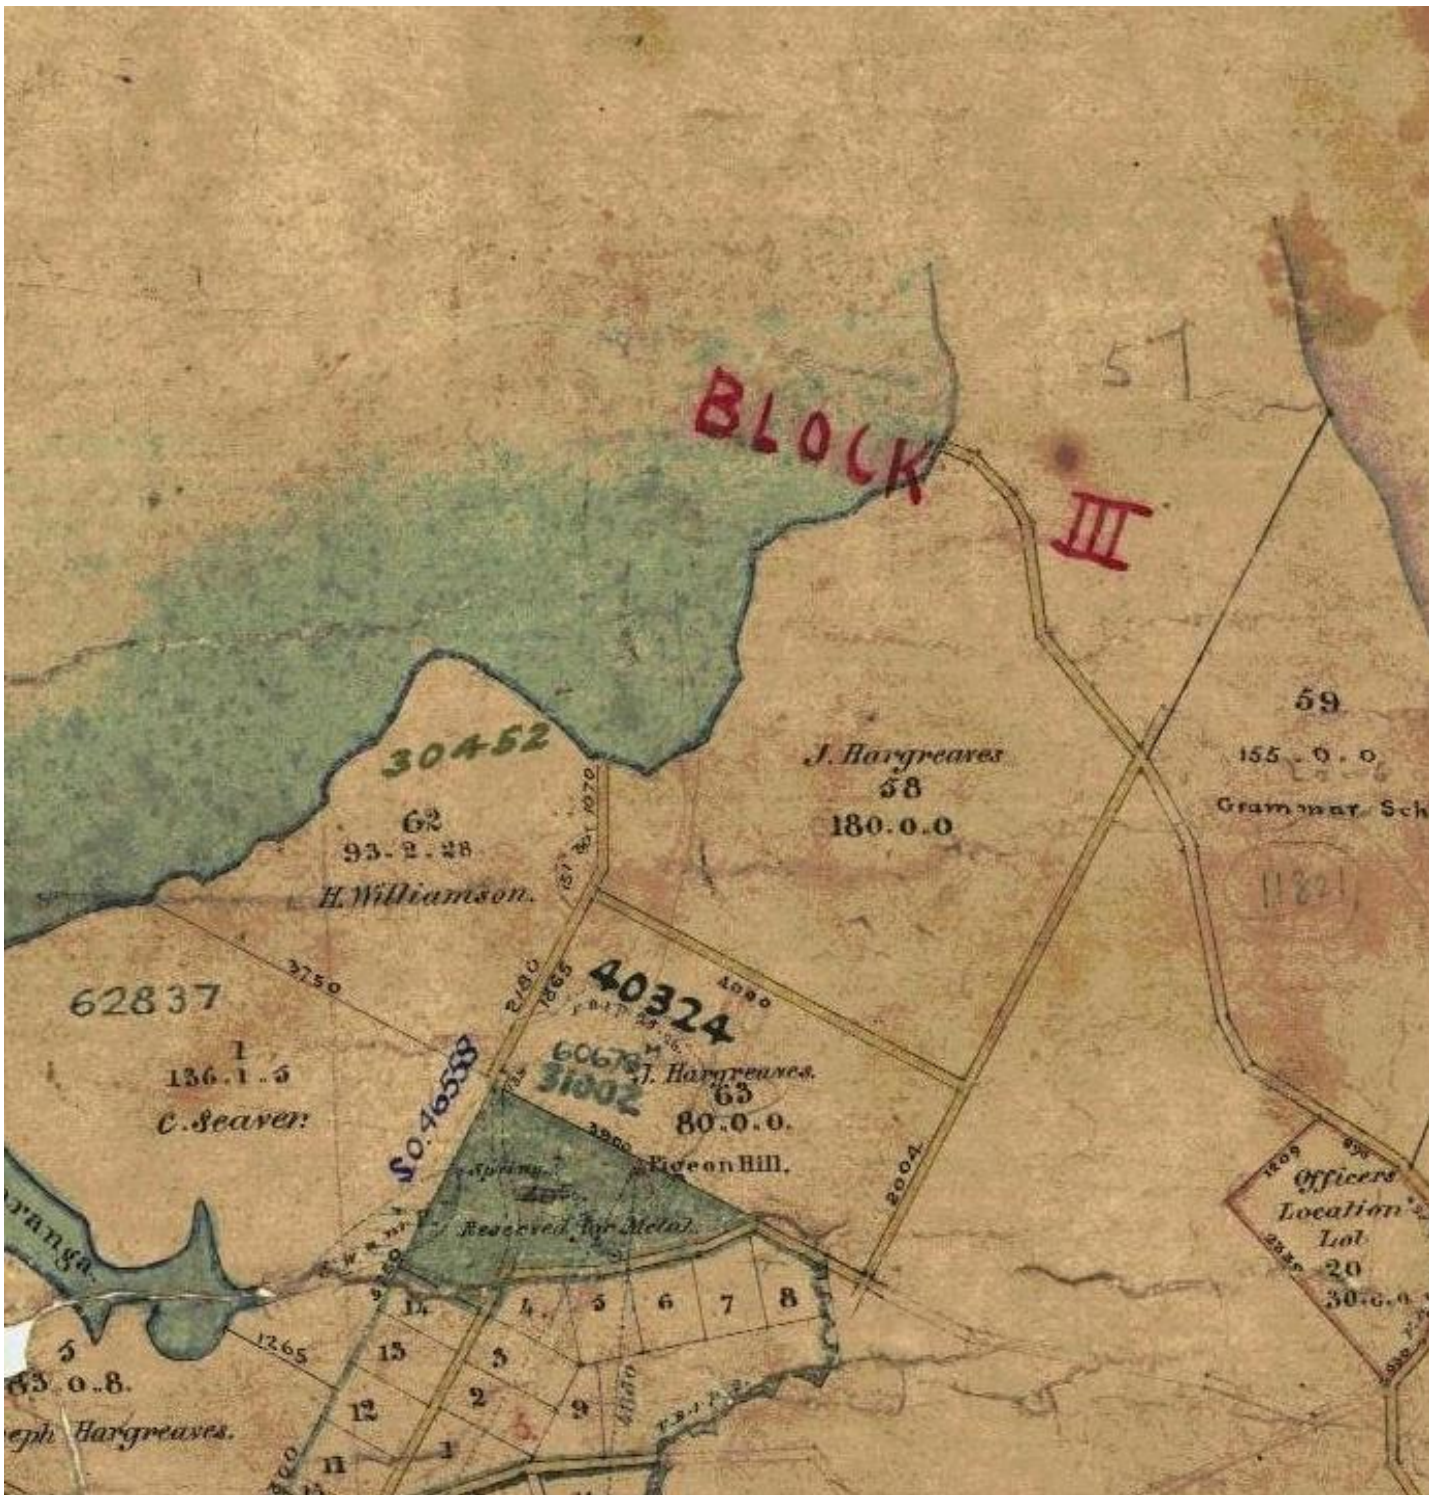
Figure 3. Part Plan SO 931, circa 1860s. Note the Mountain is referred to as “Pigeon Hill.” The spring and swamp are illustrated in that part of the Reserve currently across the road from the Scheduled area. The Scheduled area has written upon it “Reserved for Metal.” The former extent of the tuff associated with the mountain is illustrated.

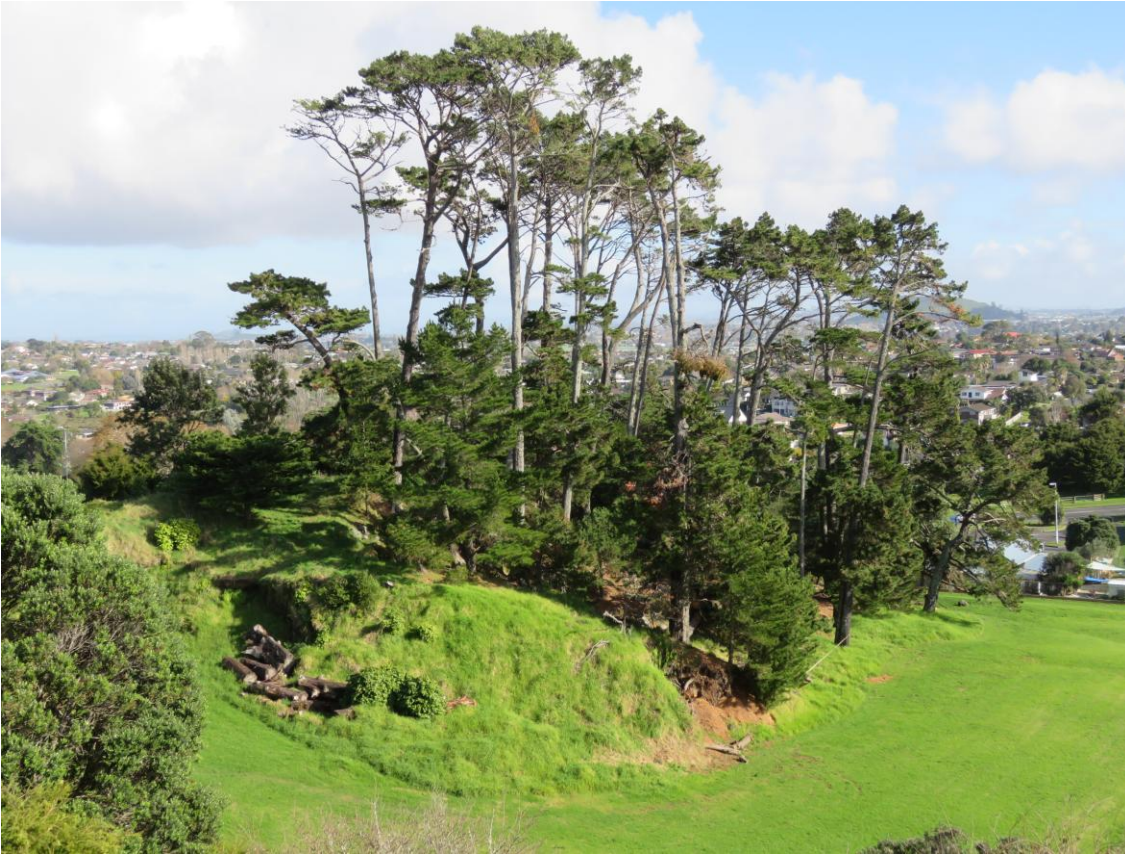
The former quarry area is immediately adjacent to the north and a hard stand has been formed behind the sports buildings at the western end. The earthworked and cut down sports field is adjacent to the south. All of these areas have no archaeological value and are suitable locations to set the crane up on to remove the trees.

Plate 1. Area A illustrating the former rehabilitated quarry immediately adjacent to the trees where a crane could be set up on.

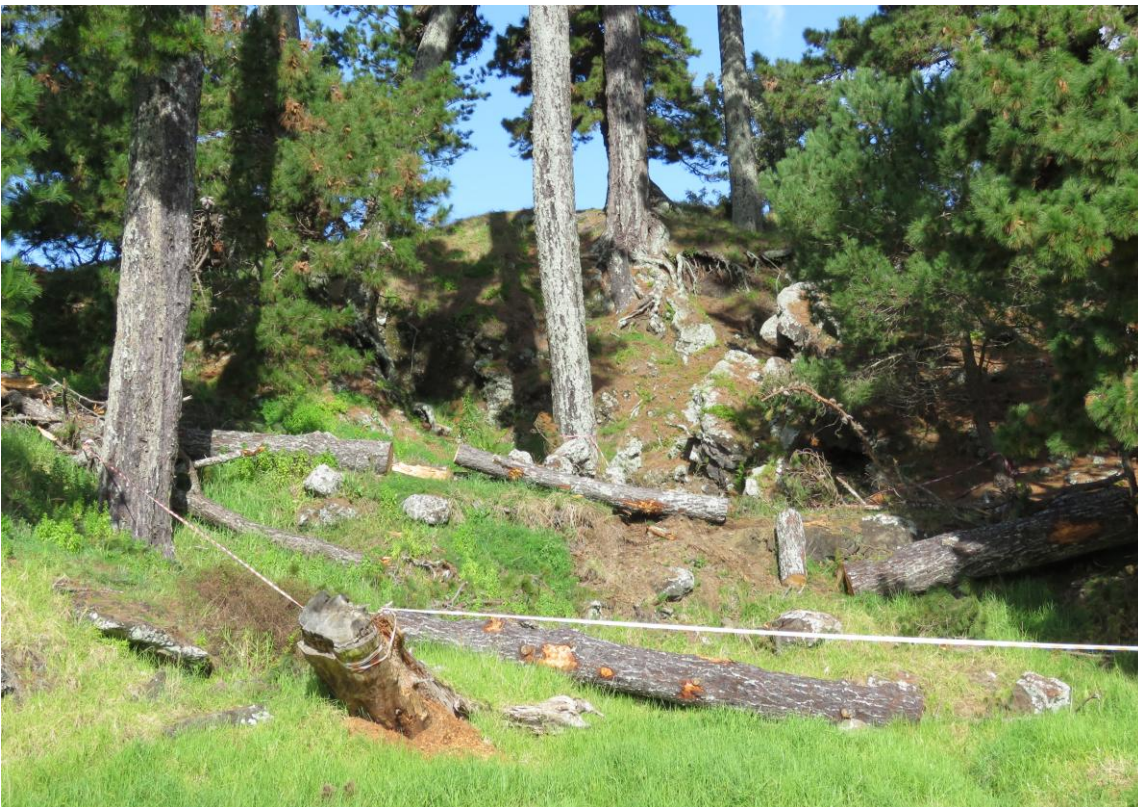
This area consists of a rocky outcrop that leads down from the main pa site, a remnant of a defensive ditch is found at the eastern end. Vegetation is generally dense and it is difficult to be certain what archaeological features are present beneath the vegetation, however there are parts of this area that are definitely terraced, it is possible that a storage pit or two are present and midden deposits are readily visible. The lower slopes have a number of quarry drives that reach into the old lava flows, particularly on the north and western ends. Parts of this area are highly disturbed and archaeological evidence will have been destroyed, whereas immediately adjacent are areas of apparent no more than minor disturbances having occurred.

Plate 2. An illustration of the lava flow around which archaeological evidence is found, a small quarry drive is present to the left of the pine in the centre of the plate.

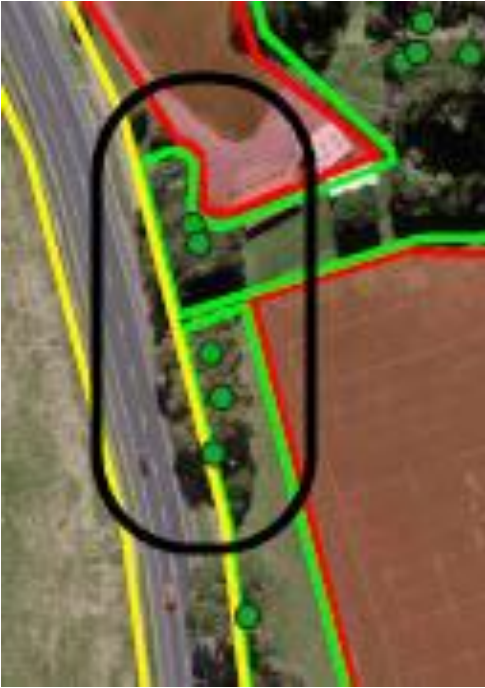
Treescape (2018:12) propose to use the already formed roading to bring a crane on site and lift sections of the trees onto the roading or directly onto the processing sites. The majority of these trees are in areas where there is no obvious surface archaeological evidence and in many cases there is evidence of earthworks, both cut and fill having occurred. Some loose shells have been noted near the cricket pavilion as well as what appears to be insitu midden in the vicinity of a large *Macrocarpa* just outside Area C. Should it be necessary to lower any limbs or other matter to the ground in this area, other than directly to the processing area crash mats should be used in the area pictured in Figure 7 below. Elsewhere it would appear that there are no risks to archaeological evidence.

Figure 7. Part Figure 6 illustrating area in which trees should have crash mats beneath if limbs and other material isn't to be lifted directly to the processing area.

- b) For the area identified as Boundary Road, crash mats to be used in the area depicted in Figure 7 should it be necessary to lower limbs or other matter to the ground in this area, other than directly to the processing area.

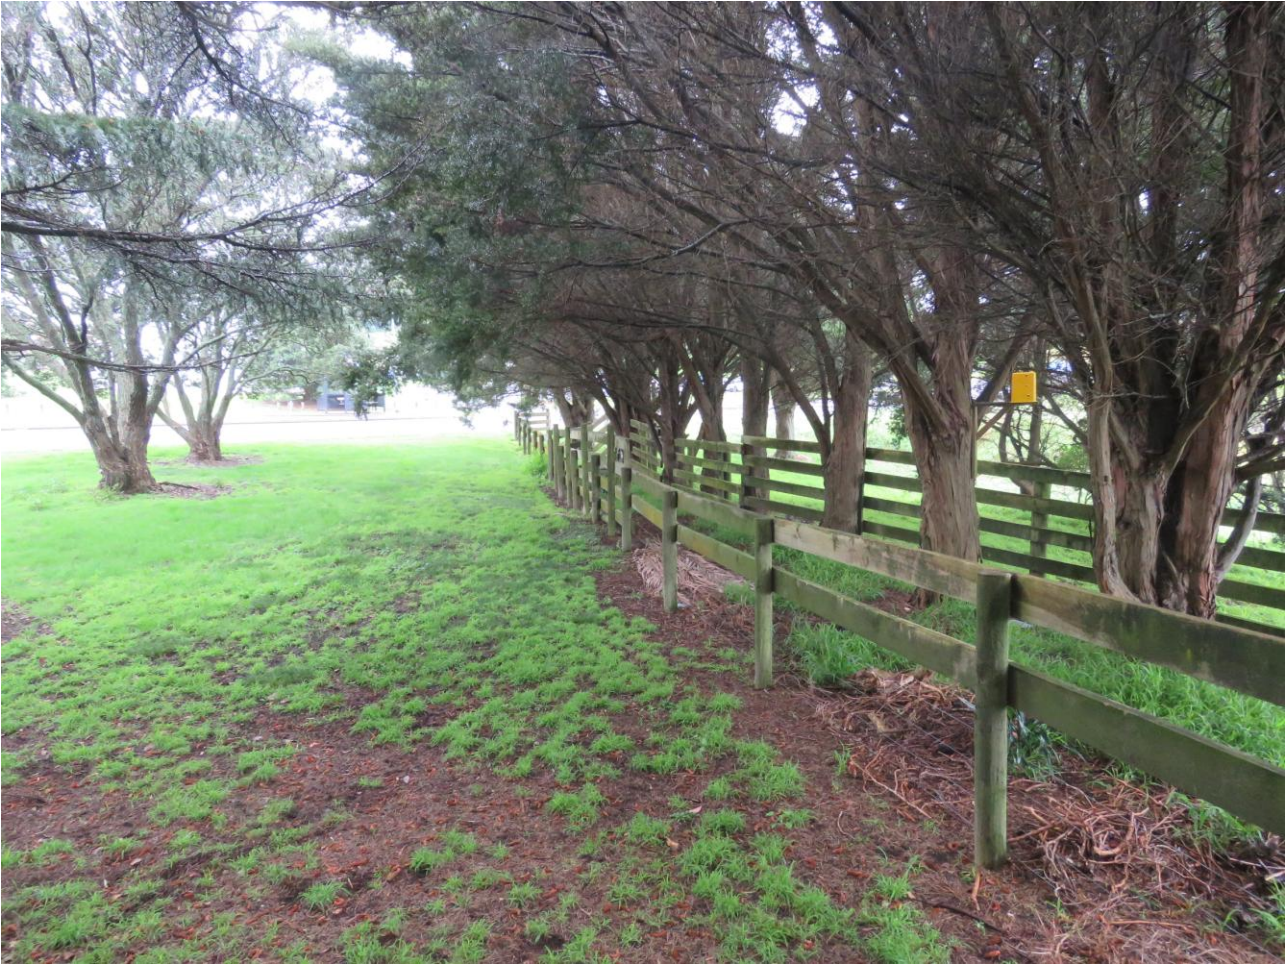
It is in this corner of the reserve that midden site R11/2825 has been recorded. Shell is occasionally visible on the surface adjacent to the trees and fence pictured in Plate 3, as well as detectable subsurface with a probe. No surface features are visible, however it is almost certain that further subsurface evidence will be present here. Although earthworks have occurred in the immediate vicinity to create the housing and roading it would appear that this area has been relatively untouched by them, though invasive investigations would be required to confirm this. Treescape propose to manually fell the trees in this area. This should only be done when the earth is hard and with the extensive use of crash mats to prevent impact and gouging damage to any subsurface archaeology. Vehicles could be brought onto the Reserve to facilitate the felling, but should not be allowed to park or traverse where the surface evidence is present or in the immediate vicinity of that evidence. The exclusion zone for vehicles, plant and equipment should be defined by the project archaeologist as part of the set up for this area.

Plate 3. Shell midden is visible occasionally on the surface in the vicinity of the pictured trees and fencing. This area should be avoided for parking any vehicles or other plant and equipment.

- c) All tree felling in the area identified as North Corner must be onto crash mats.
- d) The project archaeologist should be onsite when tree felling is to occur in North Corner to define an area as an exclusion zone for vehicles, plant and equipment.

- e) Should it be necessary to drag any trees or limbs across the exclusion area as defined in d) above crash mats should be laid across the surface to protect it from dragging damage.

- f) The project archaeologist should define areas where onsite residue can be left within the North Corner area. Should the allowed area not allow for all of the residue, any excess residue should be removed.

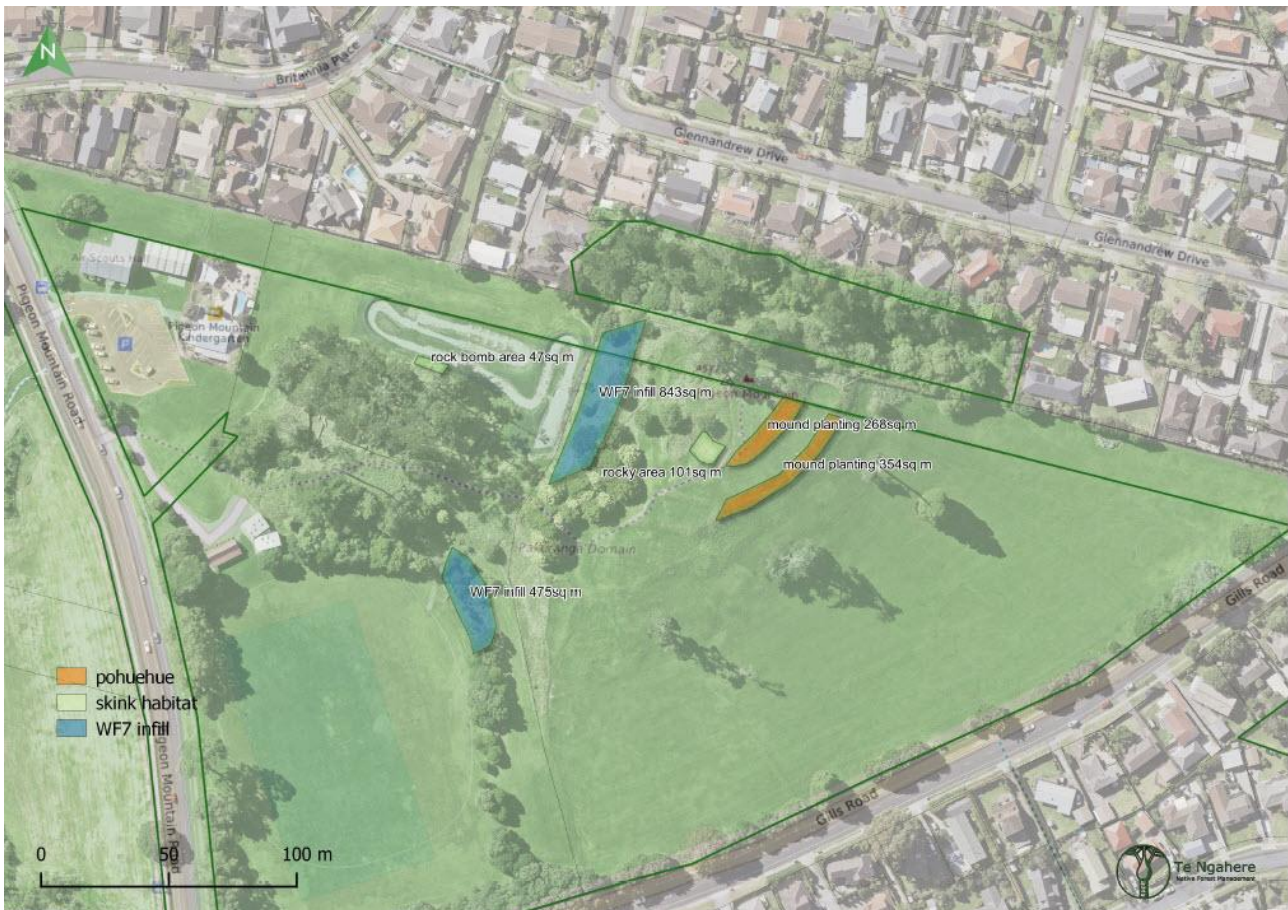
The following sections are based on the report by Te Ngahere (2019) and their proposed methods and locations for conservation plantings, including the desire to provide habitat for native skinks. Conditions vary across the locations, as a consequence this section is divided into the areas as proposed by Te Ngahere (Figure 8).

Figure 8. Proposed planting locations from Te Ngahere (2018)

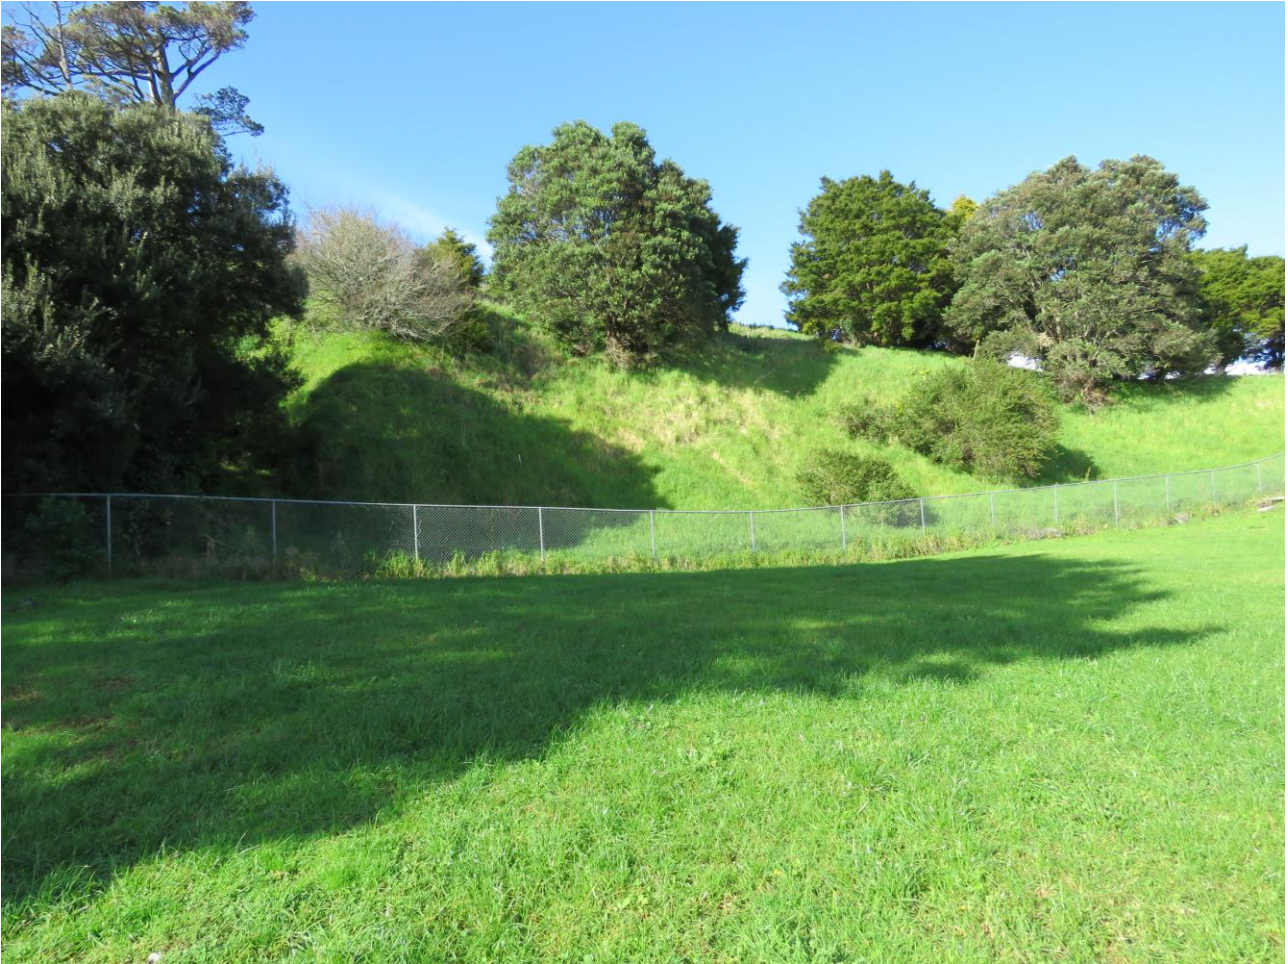
Two areas are identified for these planting works. The northern most one is on steep banks that have been quarried from Ōhuiarangi (Plate 4). It is not clear from the Te Ngahere Figure if the edges of the area touch the edge of terracing found there or not. As some of the species of tree within the list have large root systems it is recommended that plantings within 5m of archaeological features are confined to those listed in Jones (2007) as being suitable for plantings on archaeological sites. To ensure that this happens planting layout should be supervised by the project archaeologist.

Plate 4. Part of the former quarry wall where the northern infill planting is planned.

- a) For the northern WF7 Infill planting only species that are defined as suitable for planting on archaeological sites, as per the Department of Conservation (Jones 2007) publication or any updated list that is subsequently released by the Department of Conservation, should be planted within 5m of archaeological features.
- b) The project archaeologist should be on site for the set out for the northern WF7 Infill plantings to define the limits of the adjacent archaeological evidence to facilitate recommendation a) above.
