# **Tūpuna Maunga Authority**

## **Heritage Impact Assessment of Proposed Tree Removals and Re-vegetation Planting Plan for Ōtahuhu/ Mt Richmond**

**January 2019**

FOR : Tūpuna Maunga Authority  
BY : Brent Druskovich - MA(Hons), BCom.  
Consultant Archaeologist

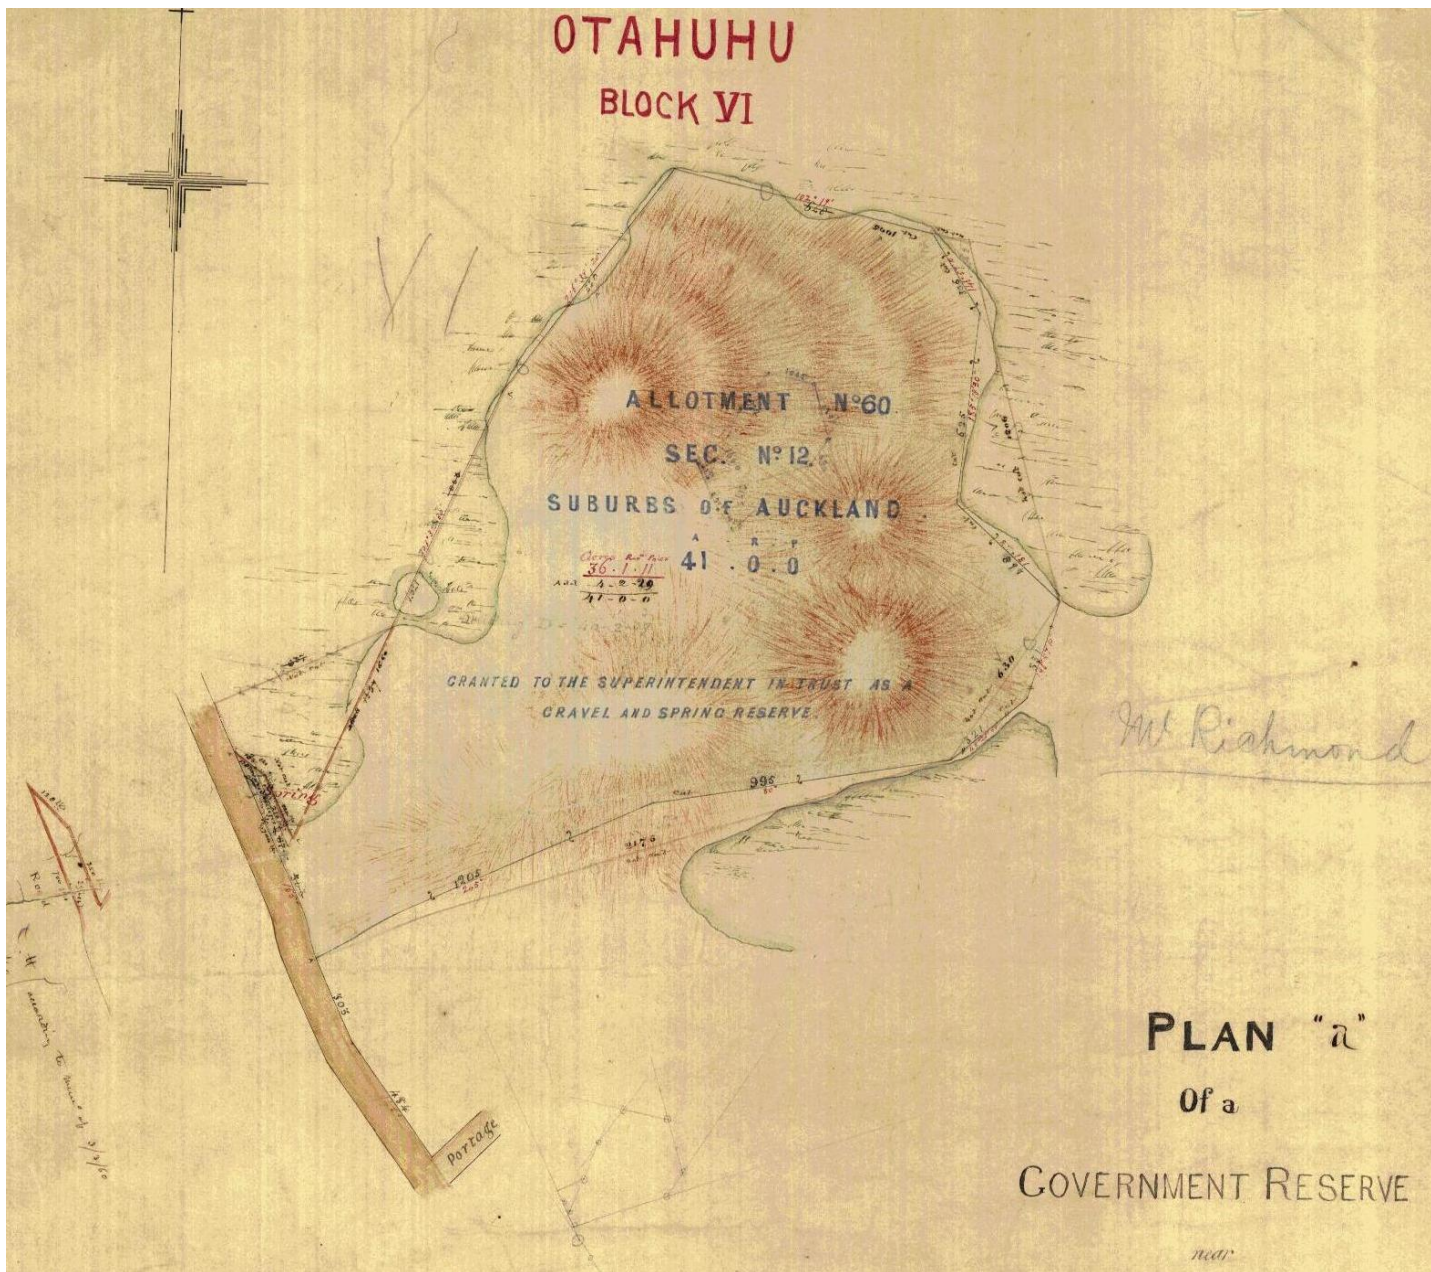
**Figure 5. Part SO 706 of 1860 refers to the mountain as a “GRAVEL and SPRING RESERVE”. The swamp is illustrated around much of the mountain and the word “spring” appears in red next to Great South Road.**

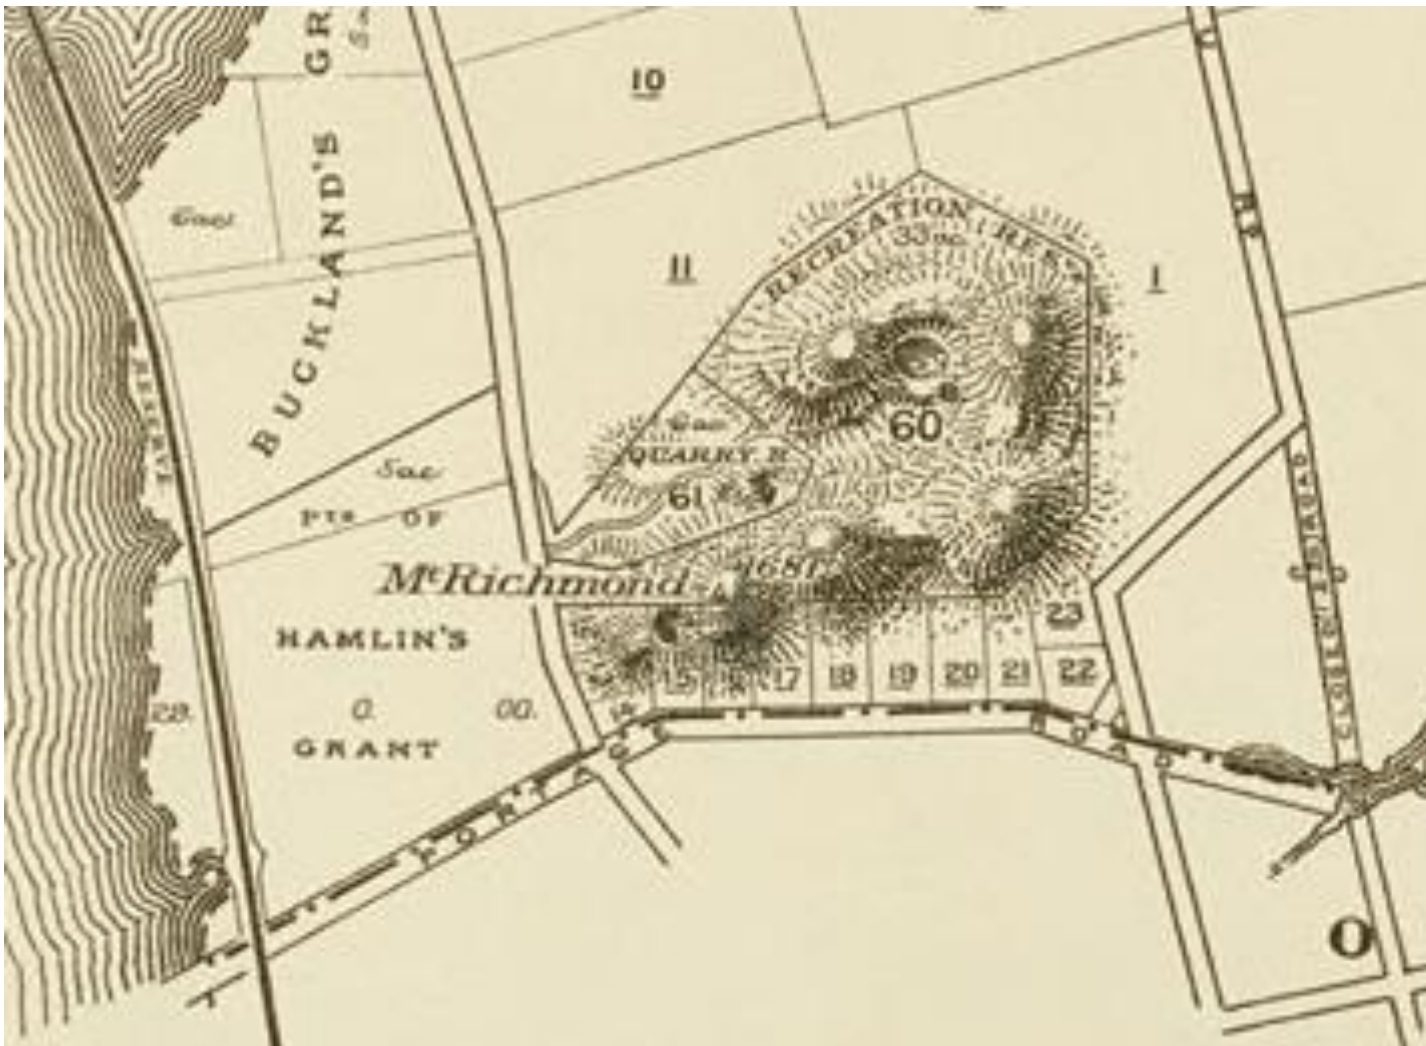
**Figure 7. Plan from Grenfell 2015. Grenfell states “Map of the Mt Richmond area in 1890 (part of a map of “Eden County”). Not particularly accurate but does show the cluster of scoria cones and that quarrying activity was already underway.” The two separate areas (Quarry and Recreation Reserve) and their boundaries are clearly illustrated.**

Another plan (illustrated in Grenfell 2015) cited as dating from 1890 shows the extent of quarrying in the quarry Reserve but not elsewhere on the maunga. The quarries illustrated in the series of plans illustrate the point that Howard (1997:164) makes where it is stated that Mount Richmond “...has been quarried for scoria at various times and from several locations. The last being from the Great South Road/Portage Road corner to provide for the Mechanics Bay Container Terminal.”

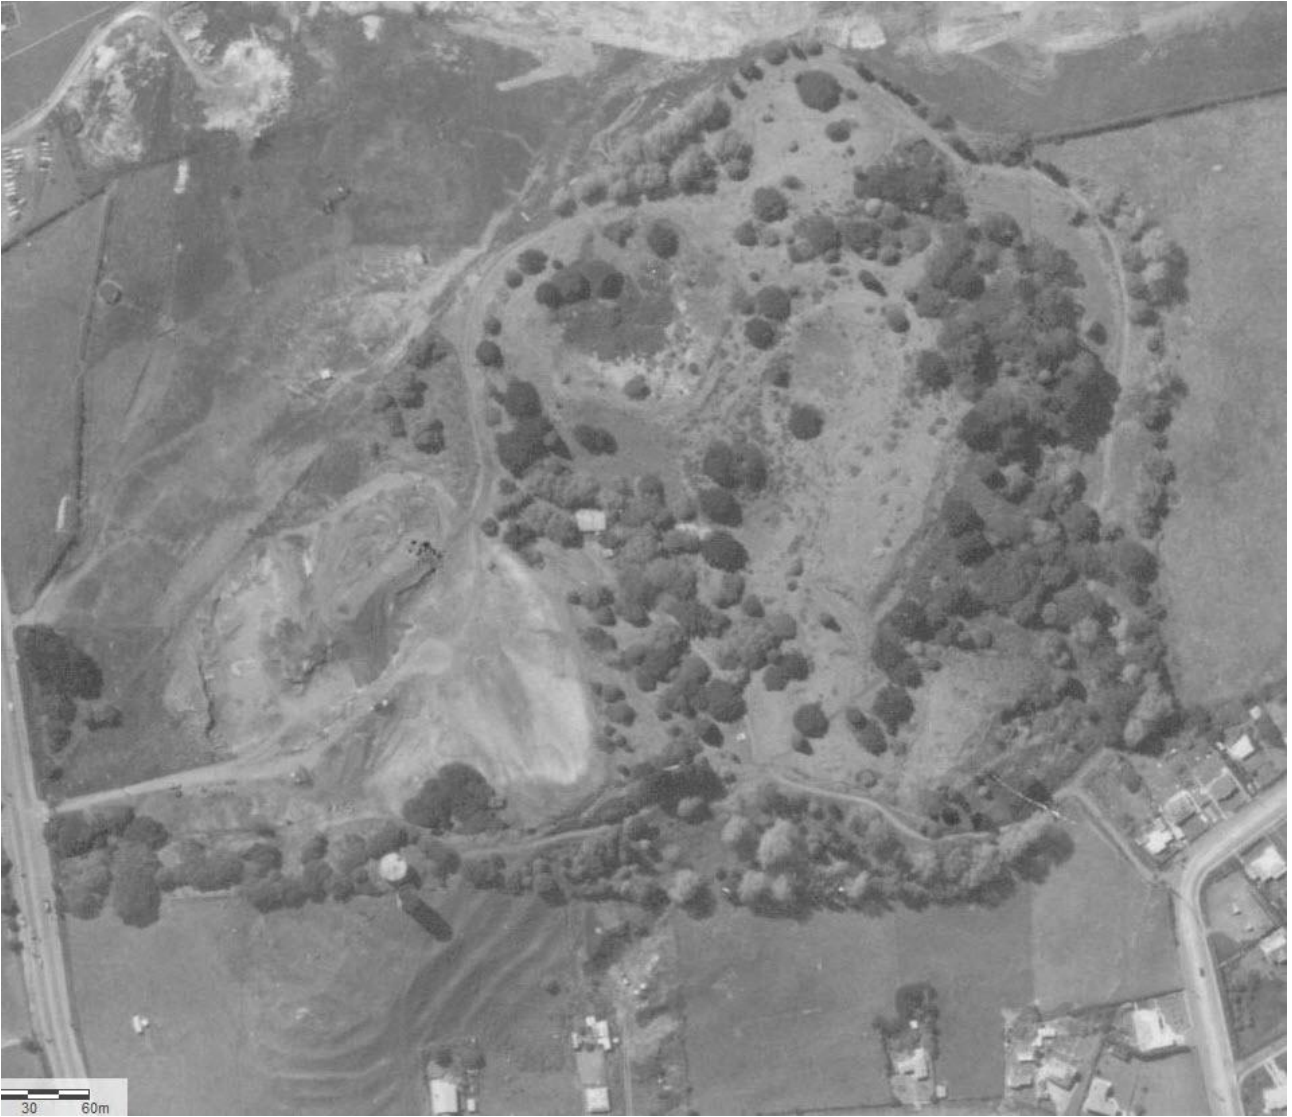
**Figure 9. 1959 aerial photograph, this shows that most of the quarry off Great South Road is still in operation and has been extended somewhat, the slopes upto the tihi have been rehabilitated and sloped prior to becoming part of the Reserve.**

The 1959 aerial photograph illustrates that many of these quarries have mature vegetation growing in them, thus illustrating that they are not currently in use, the northern slopes near Great South Road slopes appear to be in a state of being rehabilitated and works appear that they maybe ongoing on the adjacent lower ground.

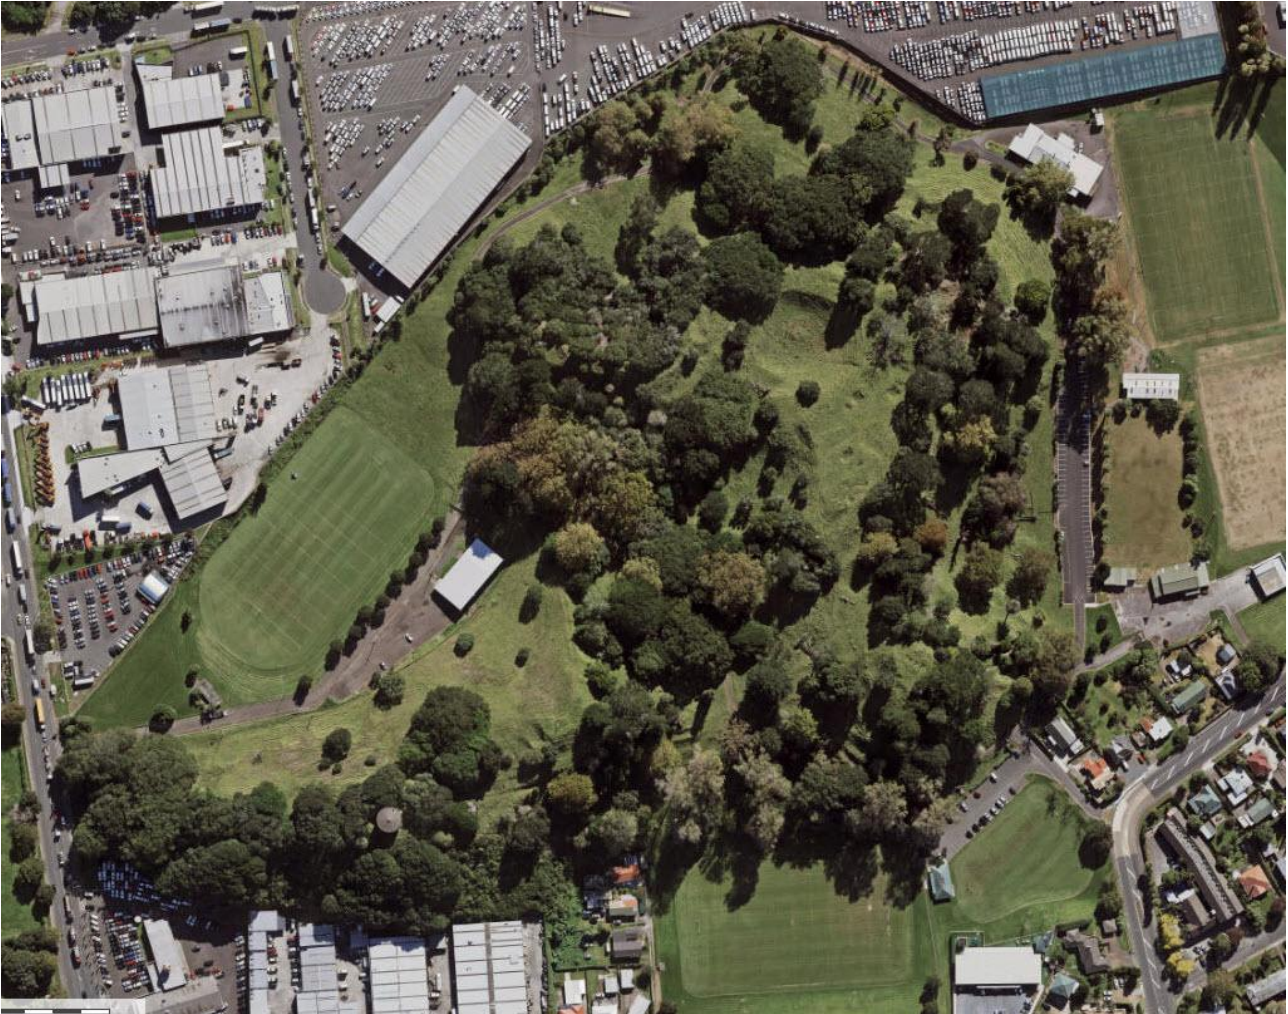
**Figure 10. 2017 aerial photograph, this shows that most of the quarry off Great South Road is still in operation and has been extended somewhat, the slopes upto the tihi have been rehabilitated and sloped prior to becoming part of the Reserve. Features between the Domain and Portage Road have been removed (compare to Figures 8 and 9).**

In the most recent aerial photograph (Figure 10) it can be seen that the growth of the trees within the Domain is such that it is not possible to positively identify the former quarry locations without prior knowledge, the large area quarried near Great South Road could be mistaken as a natural slope. It also illustrates that those parts of the maunga outside the Reserve have since been totally removed and replaced by commercial and residential properties.

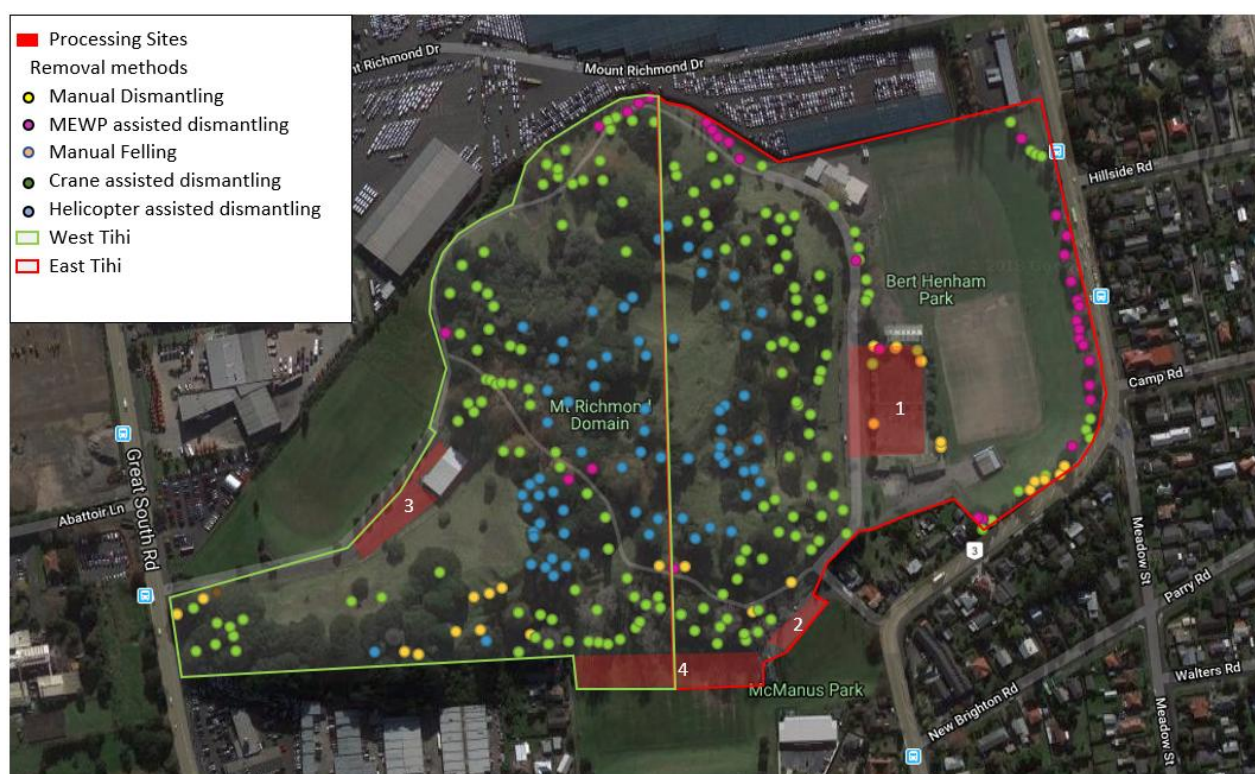
**Figure 12. Tree Removal and Processing site locations as per Treescape Report**

The following is based on the report by Treescape Ltd (2018) and their proposed tree removal methodologies, their proposed worksites and access to Ōtahuhu/ Mt Richmond. Conditions vary across the mountain as a consequence this section is divided into the areas as proposed by Treescape (Figure 12 – Note Figure 12 has been superseded in a later Treescape report where the work zones have been split into 4. My recommendations and conclusions do not change).

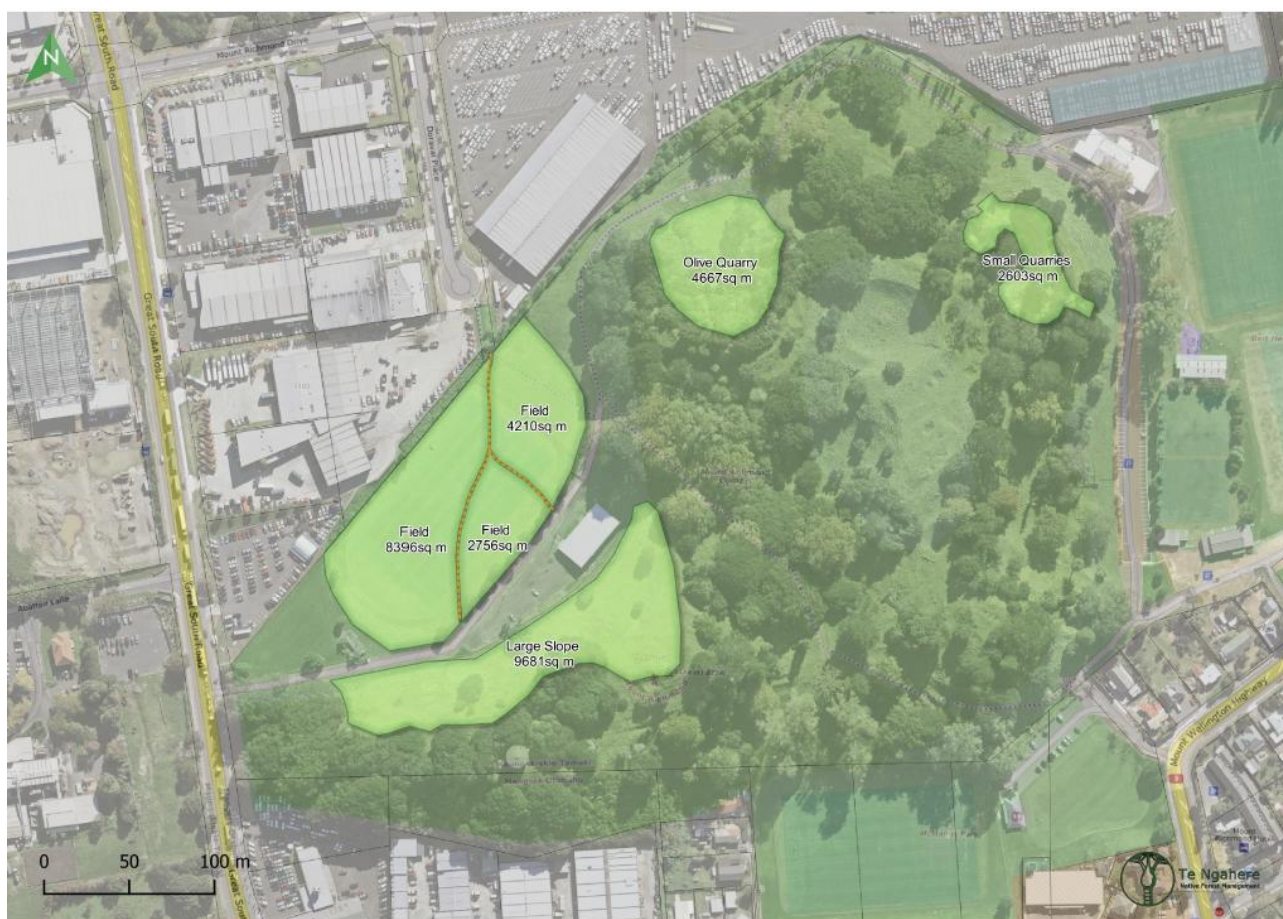
**Figure 13. Proposed planting locations at Ōtahuhu/ Mt Richmond from Te Ngahere (2018)**

The following sections are based on the report by Te Ngahere (2018) and their proposed methods and locations for conservation plantings, including the desire to provide habitat for native skinks. Conditions vary across the locations, as a consequence this section is divided into the areas as proposed by Te Ngahere (Figure 13).
