Tūpuna Maunga Authority

Heritage Impact Assessment of Proposed Tree Removals and Re-vegetation Planting Plan for Puketāpapa / Pukewīwī / Mount Roskill

October 2019

FOR : Tūpuna Maunga Authority
BY : Brent Druskovich - MA(Hons), BCom.
Consultant Archaeologist

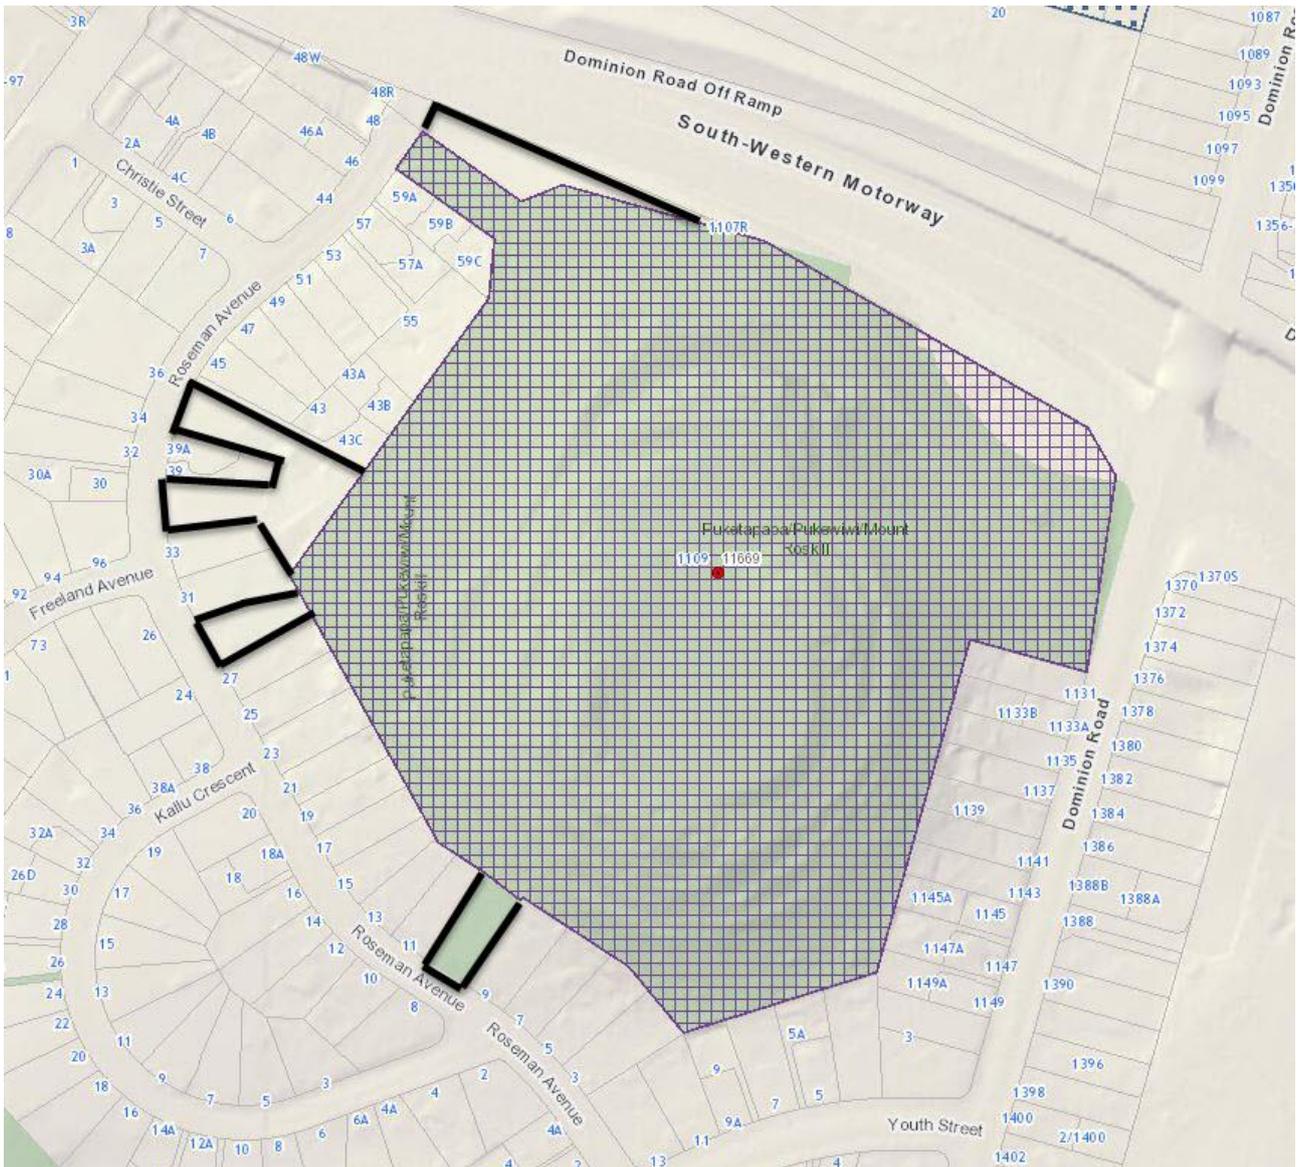
Figure 1. Area of Puketāpapa that is scheduled in the Auckland Council Unitary Plan as a Category A* historic heritage place, as well as areas marked by the black borders that are within the land administered by the Tūpuna Maunga Authority but outside the Historic Heritage Overlay.

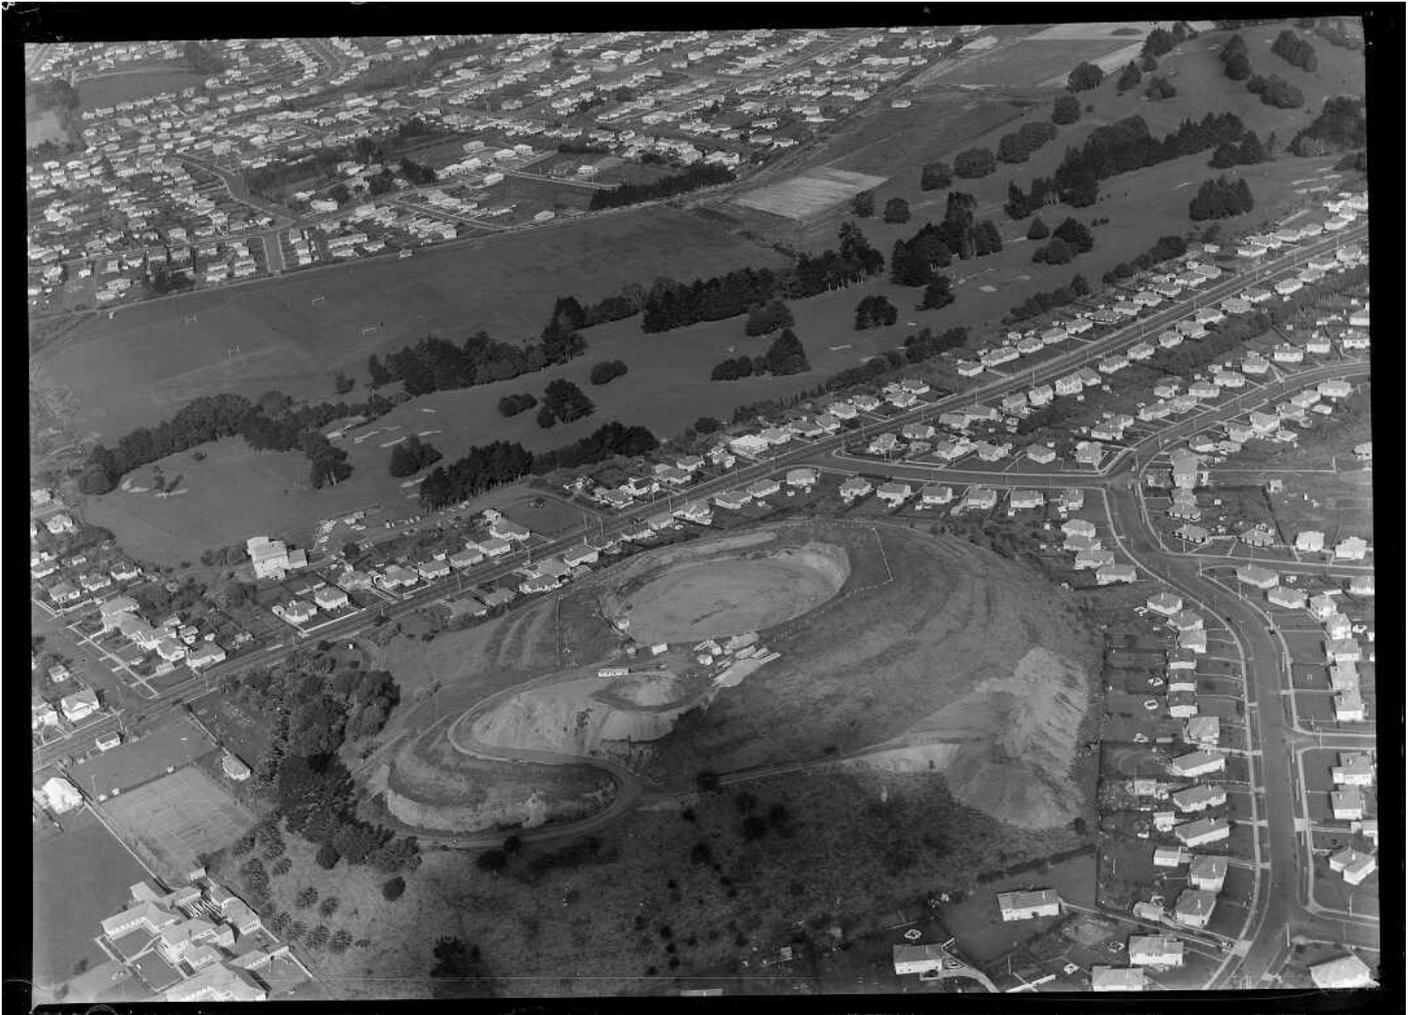
Figure 2. Aerial photograph by Whites Aviation illustrating the area used for works and construction of the reservoir in 1962. From the Alexander Turnbull Library WA-57328-G

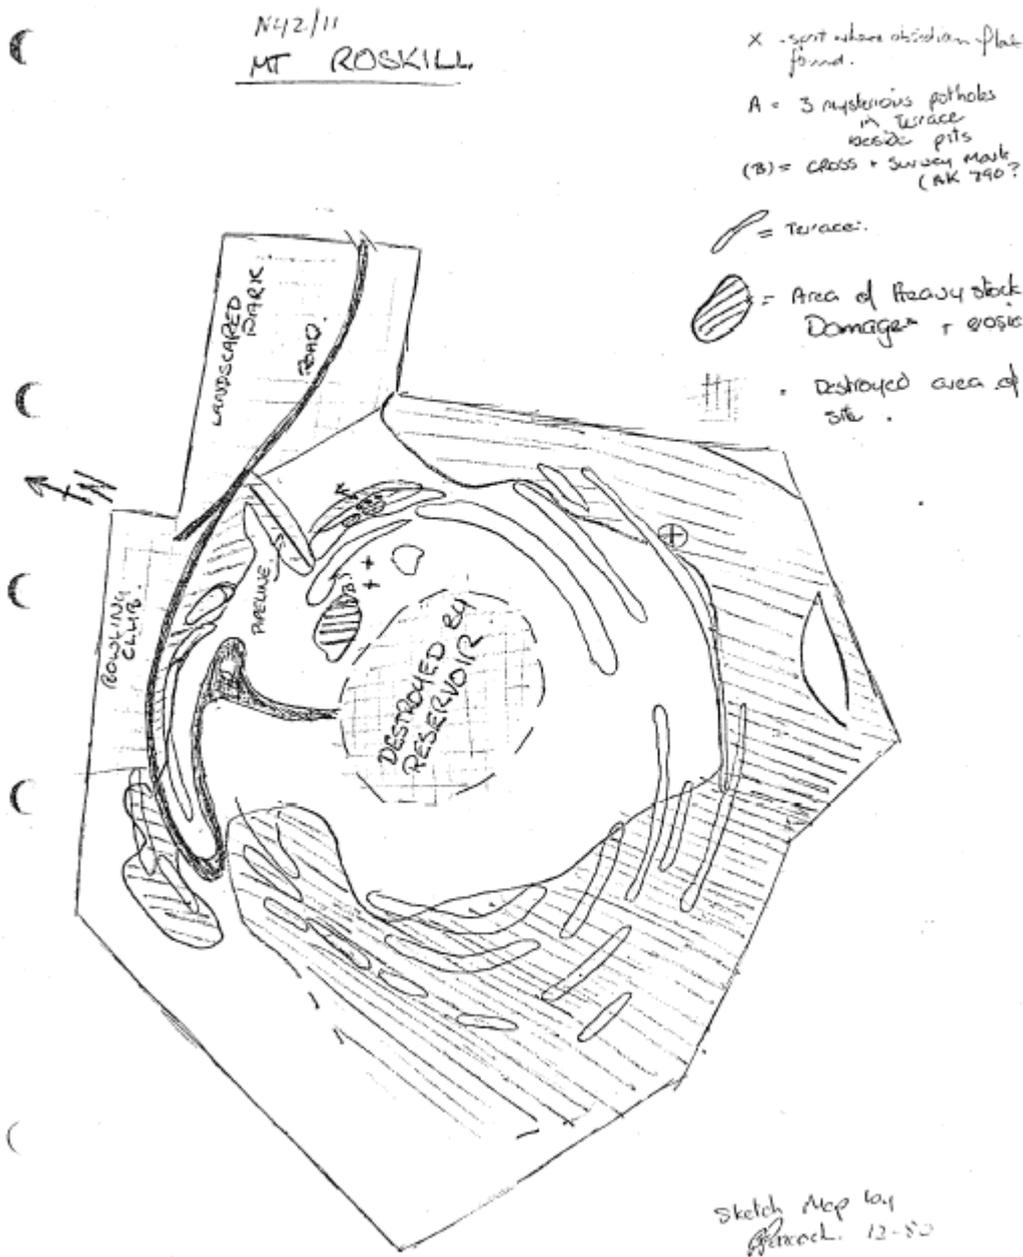
Figure 4. Archaeological plan by Brett Peacock 1980, from the NZAA Site Record Forms

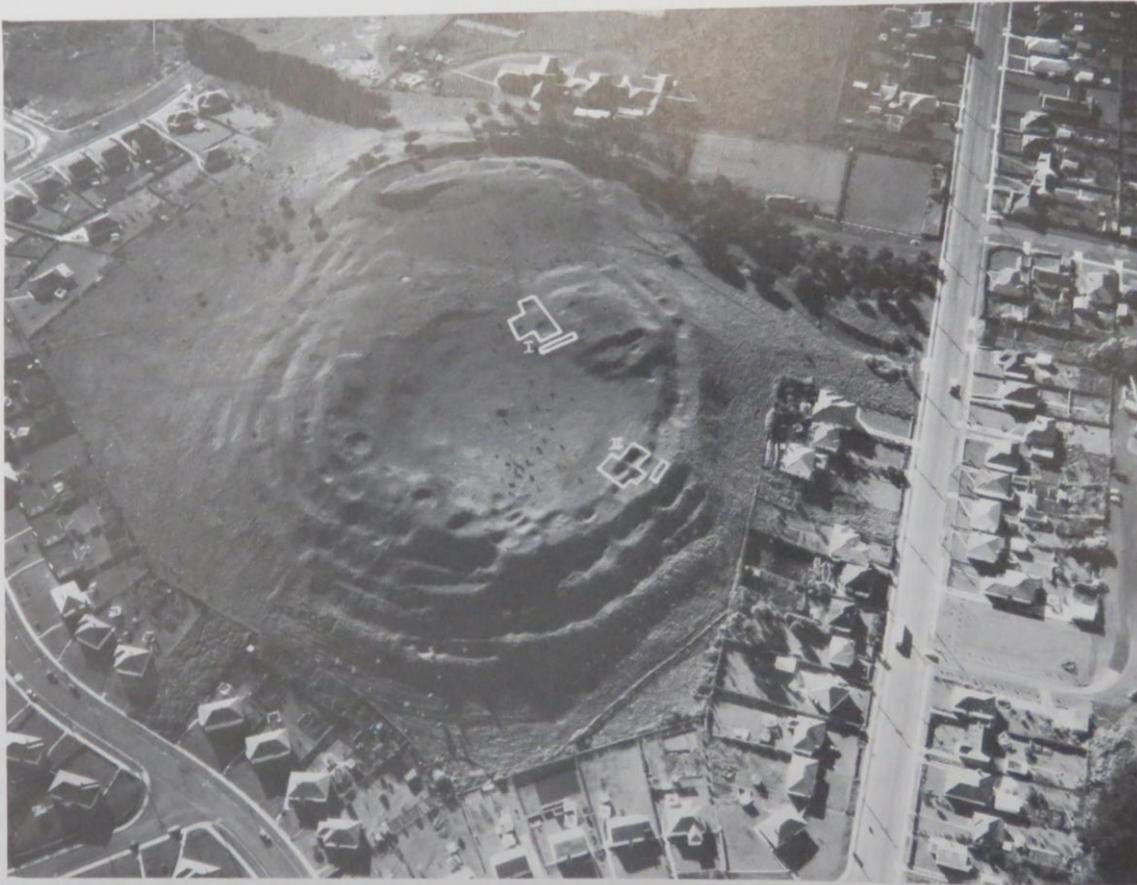
Fig. 1. Air photo of Mount Roskill before the construction of the reservoir and access road. The sites of the 1961 excavations are marked in white. (Photo: Whites Aviation.)

Figure 5. The location of the 1961 archaeological excavations (from Fox:1980)

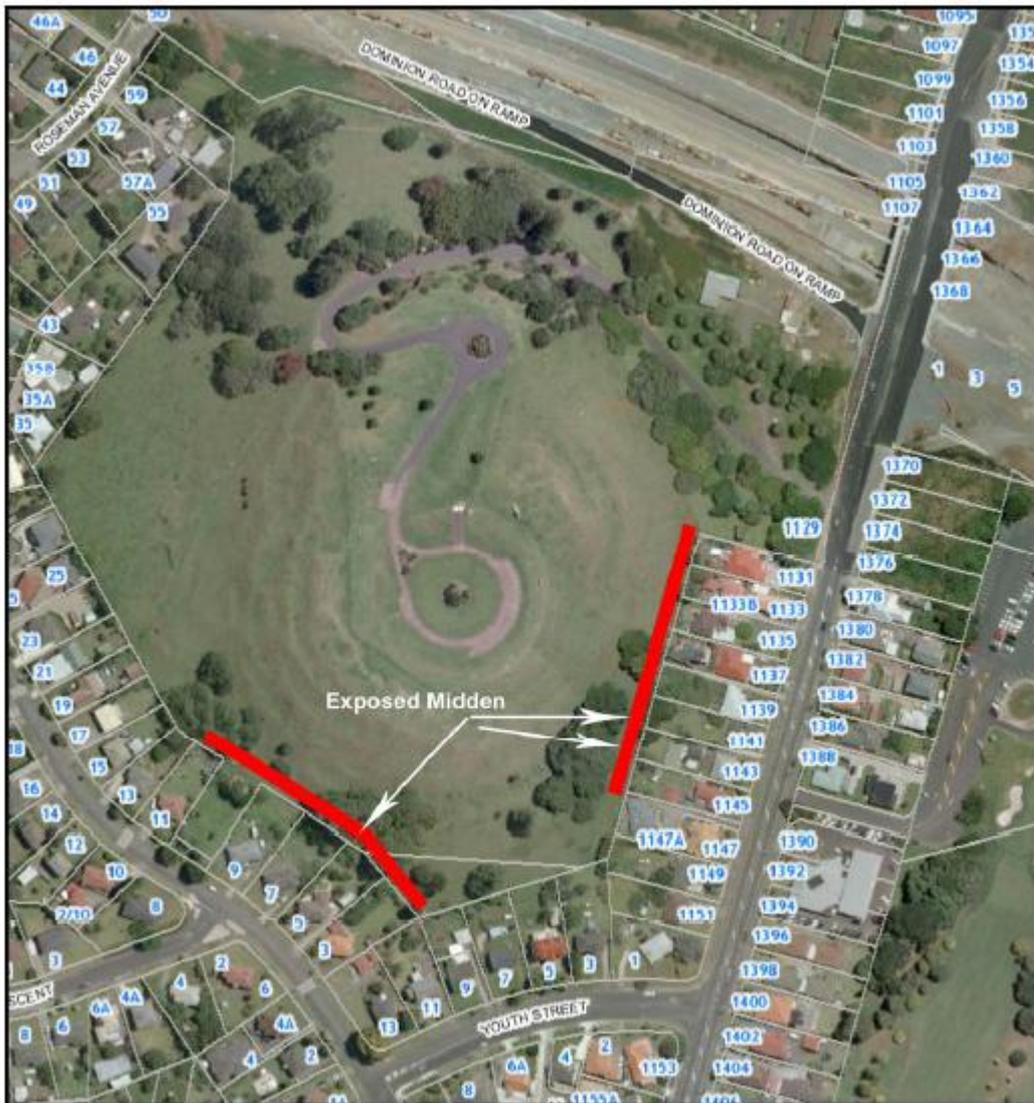
Figure 7. Areas where remedial works had taken place and midden was exposed (Pick and Clough 2010:3).

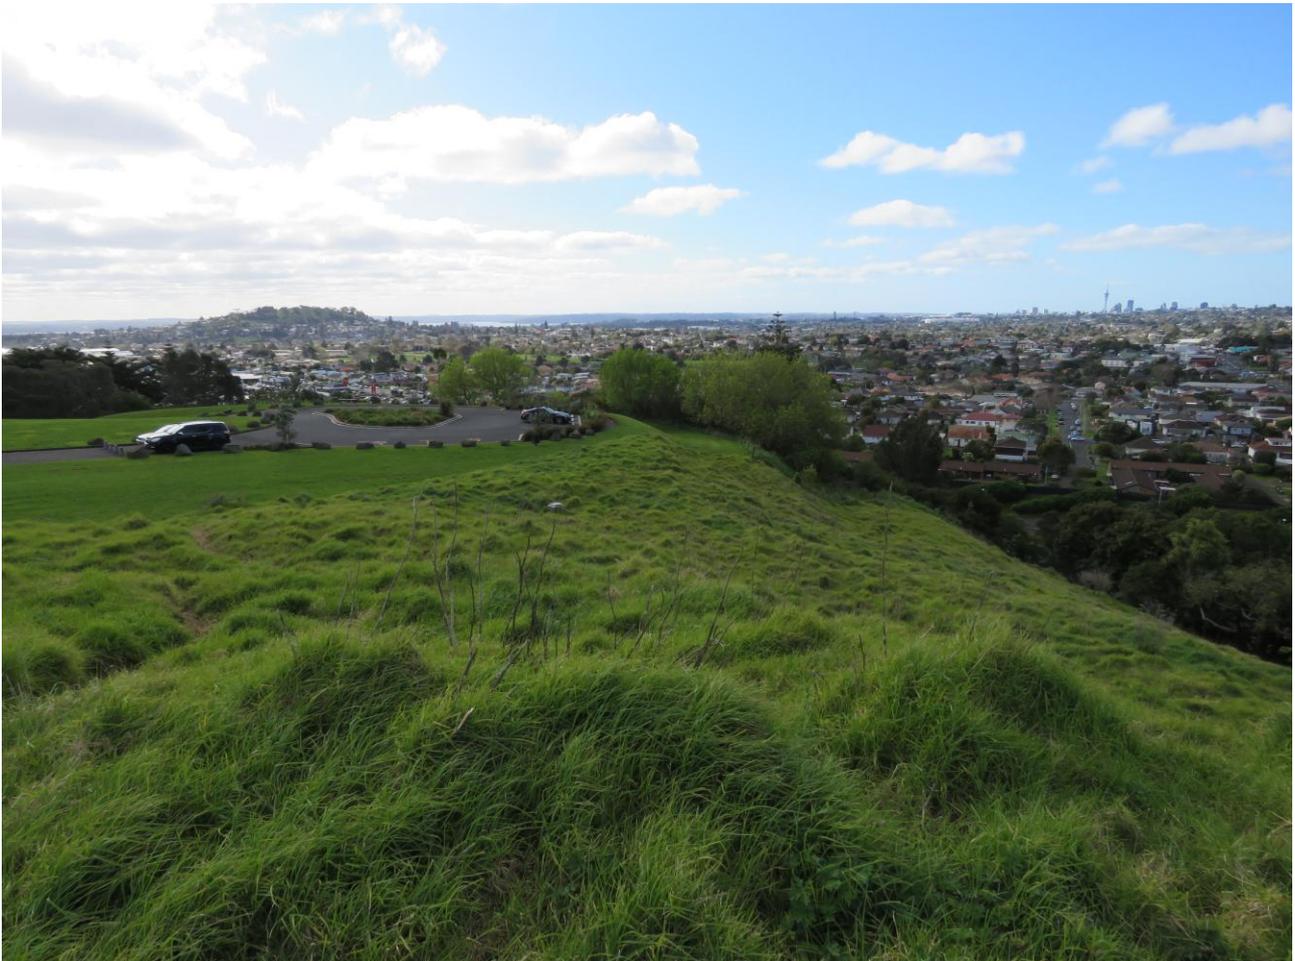
Plate 1. The midden site R11/3182 is recorded in the vicinity of the car parked at the right of the lower summit area, terracing relating to the Maori occupation of the site can be seen on the slopes to the right of this area.

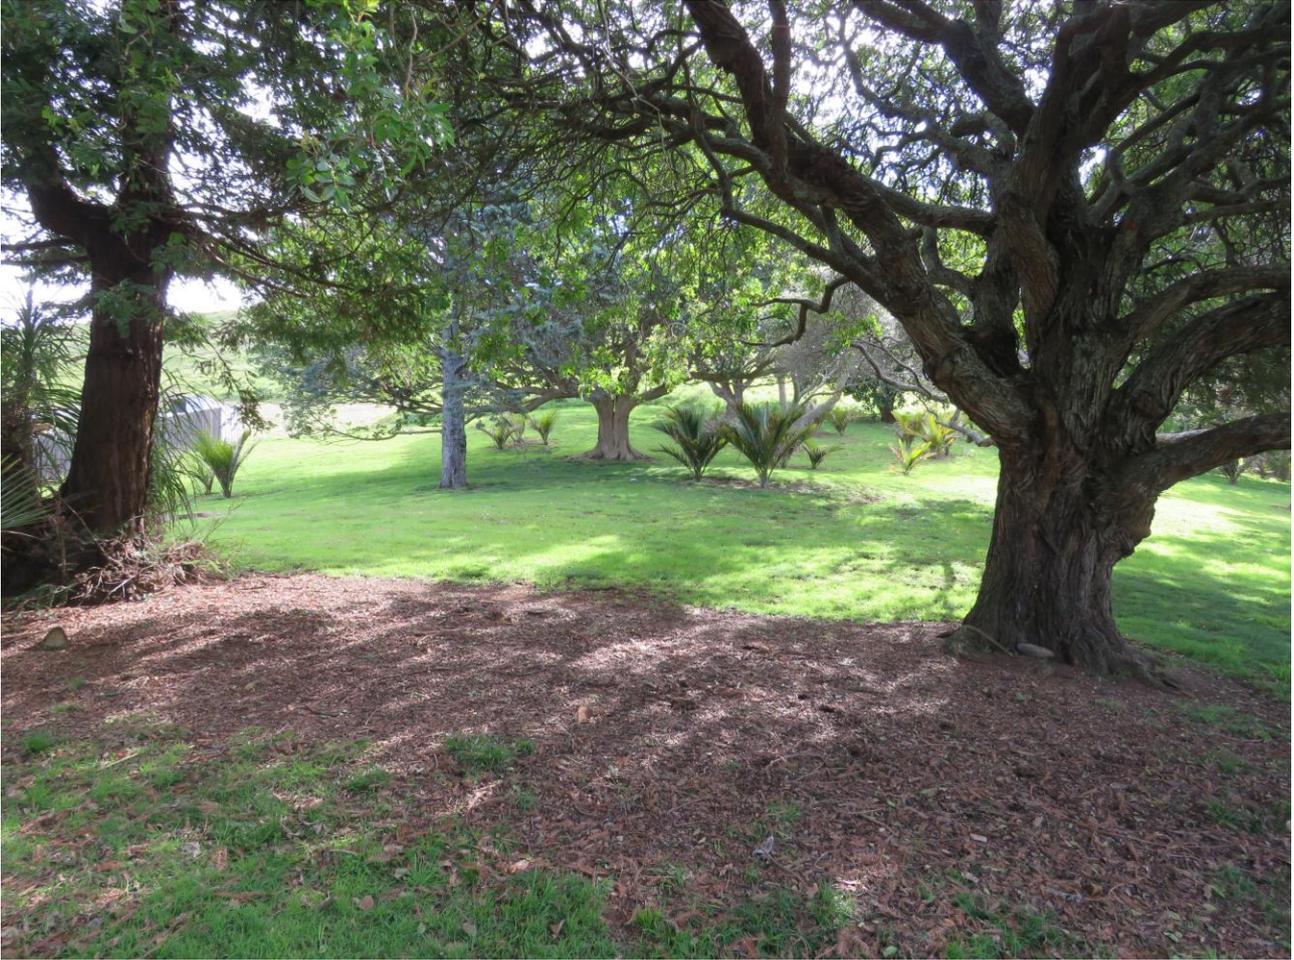
Plate 2. This is the area to the south of the access route, here the slopes are relatively shallow and form a gentle rise until the steep slopes of the volcanic cone are reached. There are some subtle indications of what may be terracing, however years of lawn mowing has founded off any definite indications of whether they are terracing, slumps or just natural variations in the slope. No definitive surface features are found.

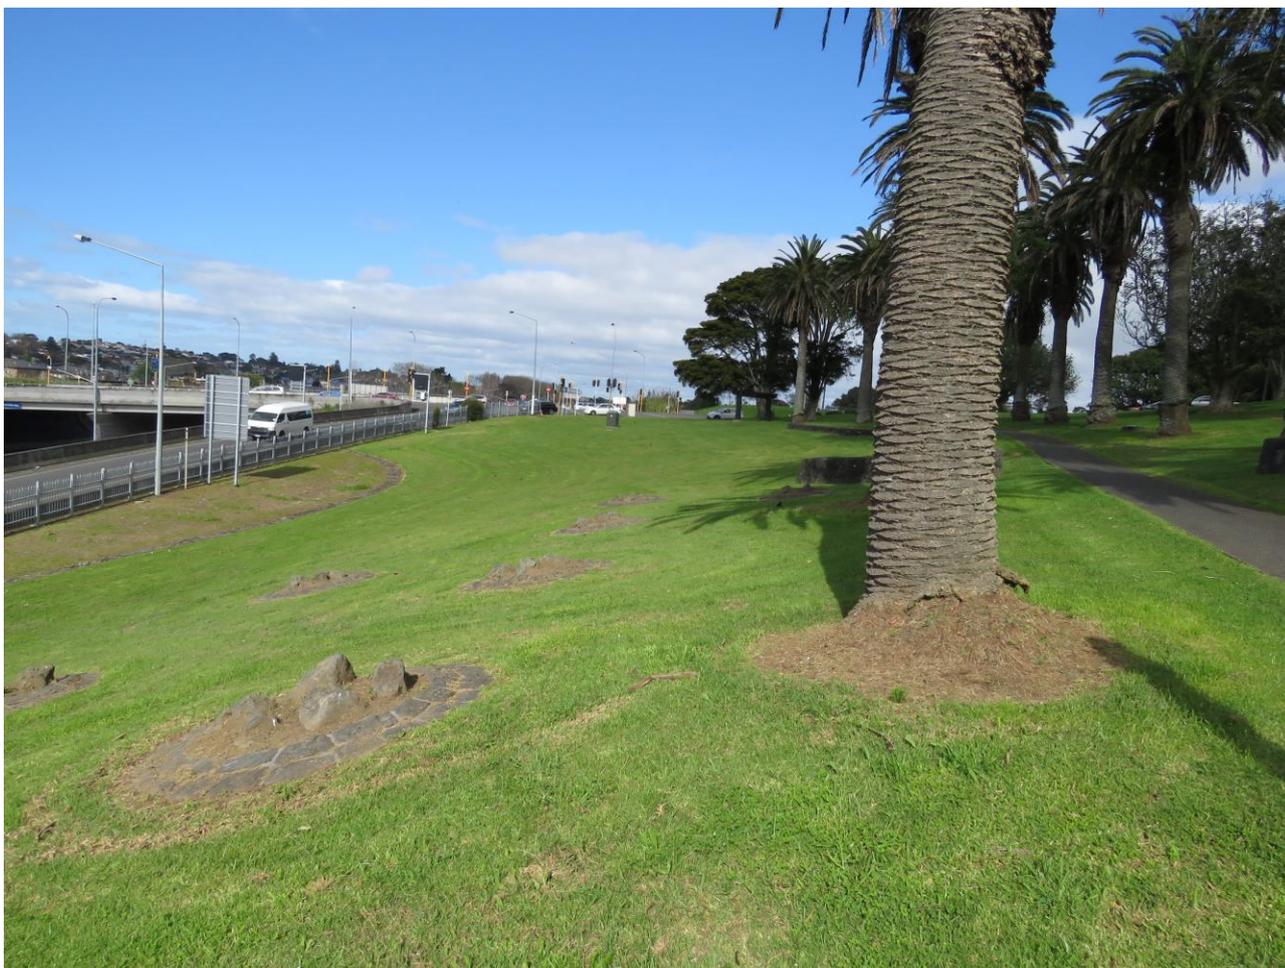
Plate 3. The slope between the path and SH20 has been modified, though at least in the immediate vicinity of the mature trees this may have been either minimal or in the distant past.

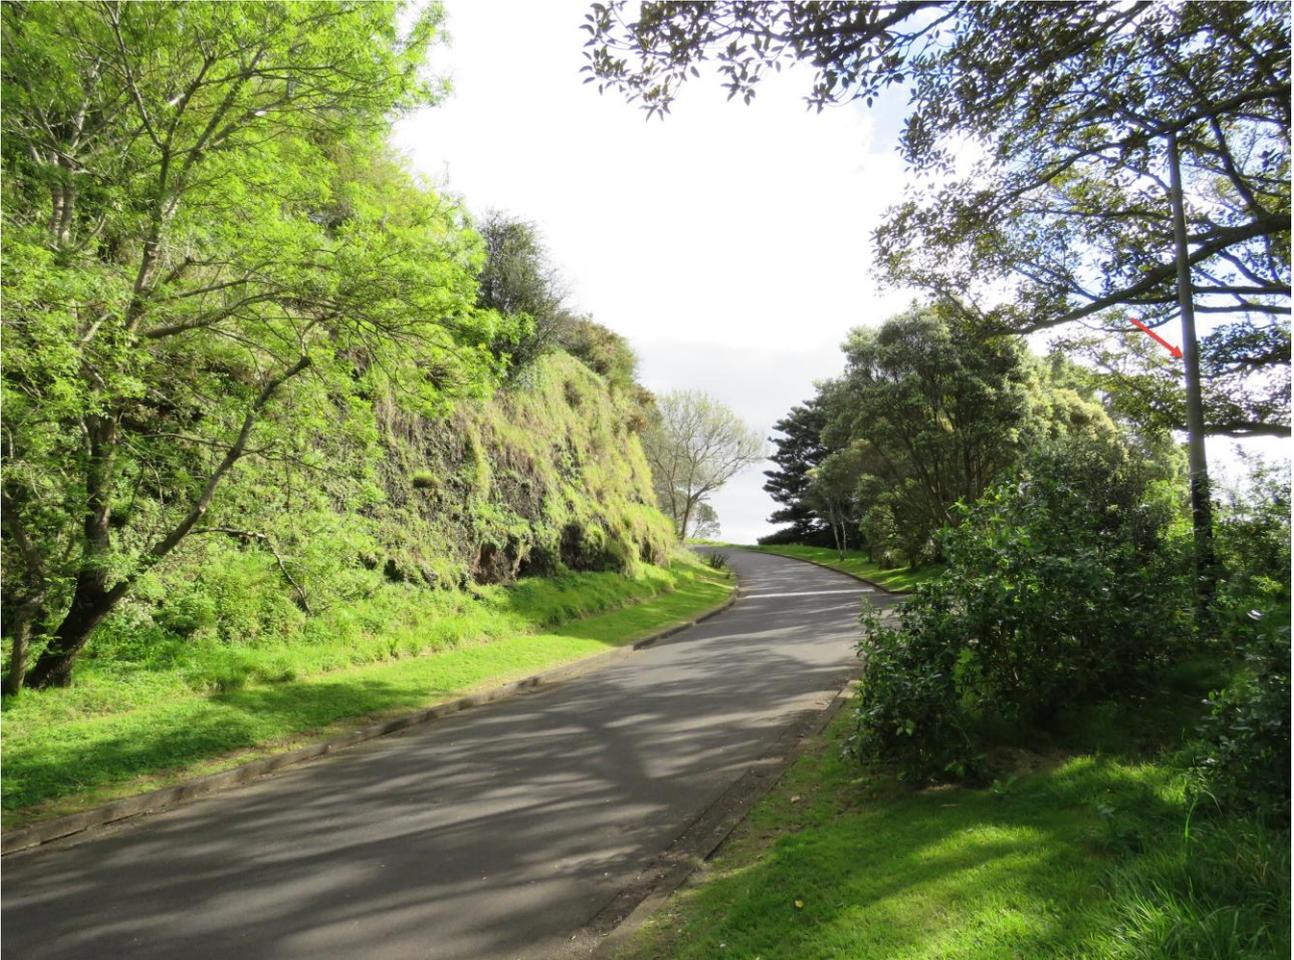
Plate 4. The access road to the summit, this has been bulldozed and formed, a former quarry face is visible on the left of the plate, the flat grassed areas adjacent to the road have also been bulldozed and will not contain in-situ archaeological evidence. Electricity has been installed along the length of this access as evidenced by the light pole (arrowed in red on right of frame).

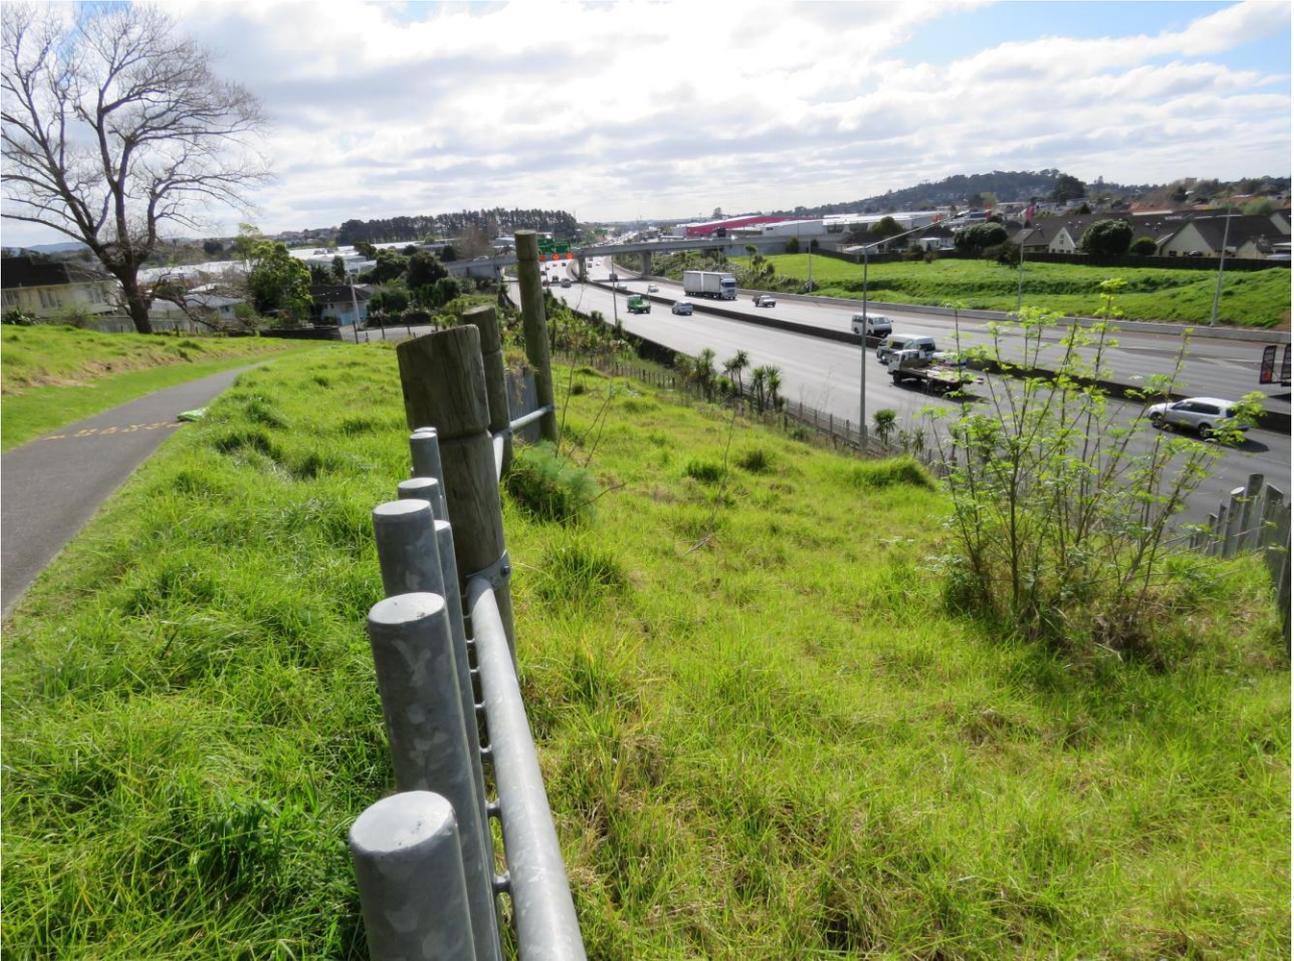
Plate 5. The western end of the flanking cycleway that passes through the reserve, a cut is clearly visible on the southern edge of the cycleway and the slope to the motorway below has all been earthworked.

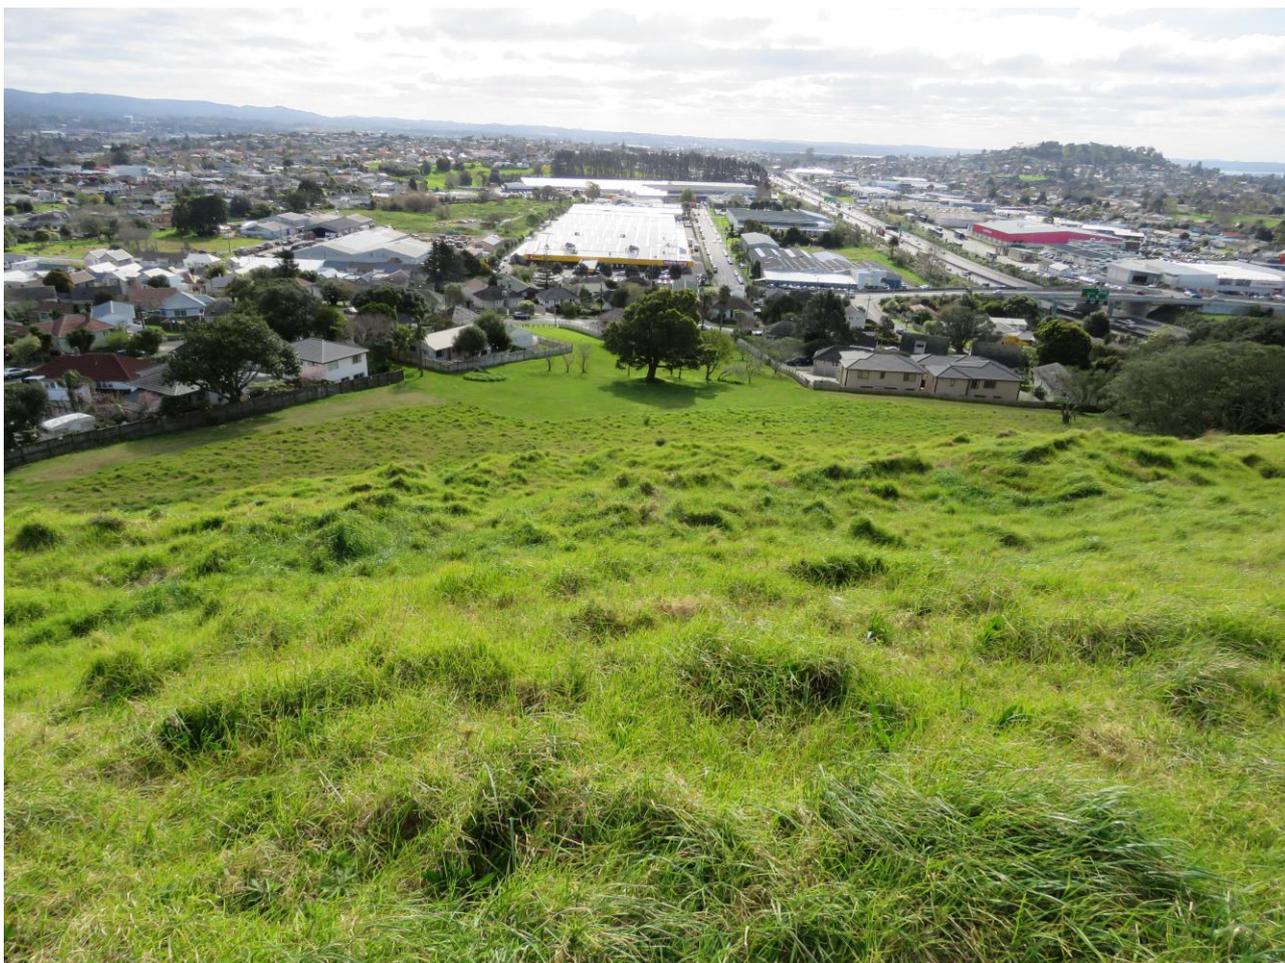
Plate 6. The western side of the Reserve with residential properties bordering along Roseman Ave, including some entrances where housing has been recently removed and incorporated into the Reserve. The view is from the summit of Puketapapa looking down the terraced slope (not easily defined from this angle with the grass length) to what is a relatively featureless flat below. Within this flat, especially, but not exclusively, on the edges with the residential properties there are occasional features that are indicative of 20th and 21st century cuts for either Reserve management purposes but often with the building of fences, some of which are cuts into the Reserve edge assuming that the fencing is actually on the legal property boundary. In the 1962 aerial (refer Figure 2) a large stockpile of spoil is evident over much of this area, some of the features, especially cuts at the base of the maunga are likely caused by the subsequent removal of this stockpile and some may have been made originally as preparation for its' placement.

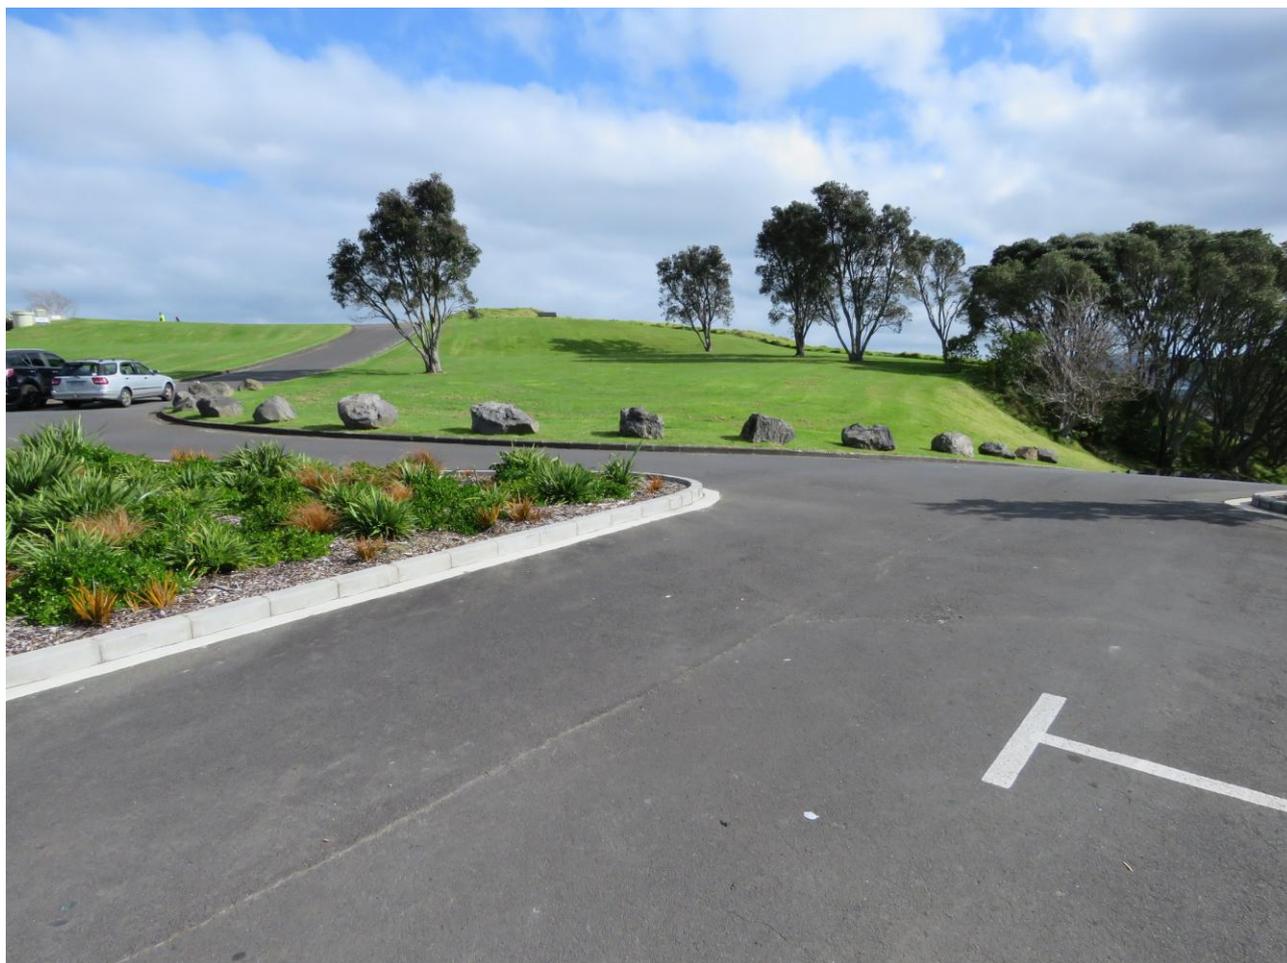
Plate 7. The view across the “lower” tihi or summit area, the manicured grass to the right of the plate is an area that shows clearly as being earthworked in historic photographs and a significant cut has occurred to allow the road to reach the summit. The road to the background rises up a slope created as part of the works associated with the reservoir, if was not apparent on the aerial photographs how much earthworking may have occurred on the manicured grass to the left behind the pictured vehicles. It is unknown if any intact subsurface archaeological deposits might exist in this area and it has been made an exclusion zone for these purposes (refer Figure 8). Note in Figure 5 this area appears relatively flat and featureless in the pre-reservoir aerial, and in Figure 2 during the works a few small buildings associated with the works are set up in this area which may indicate that it wasn’t extensively earthworked.

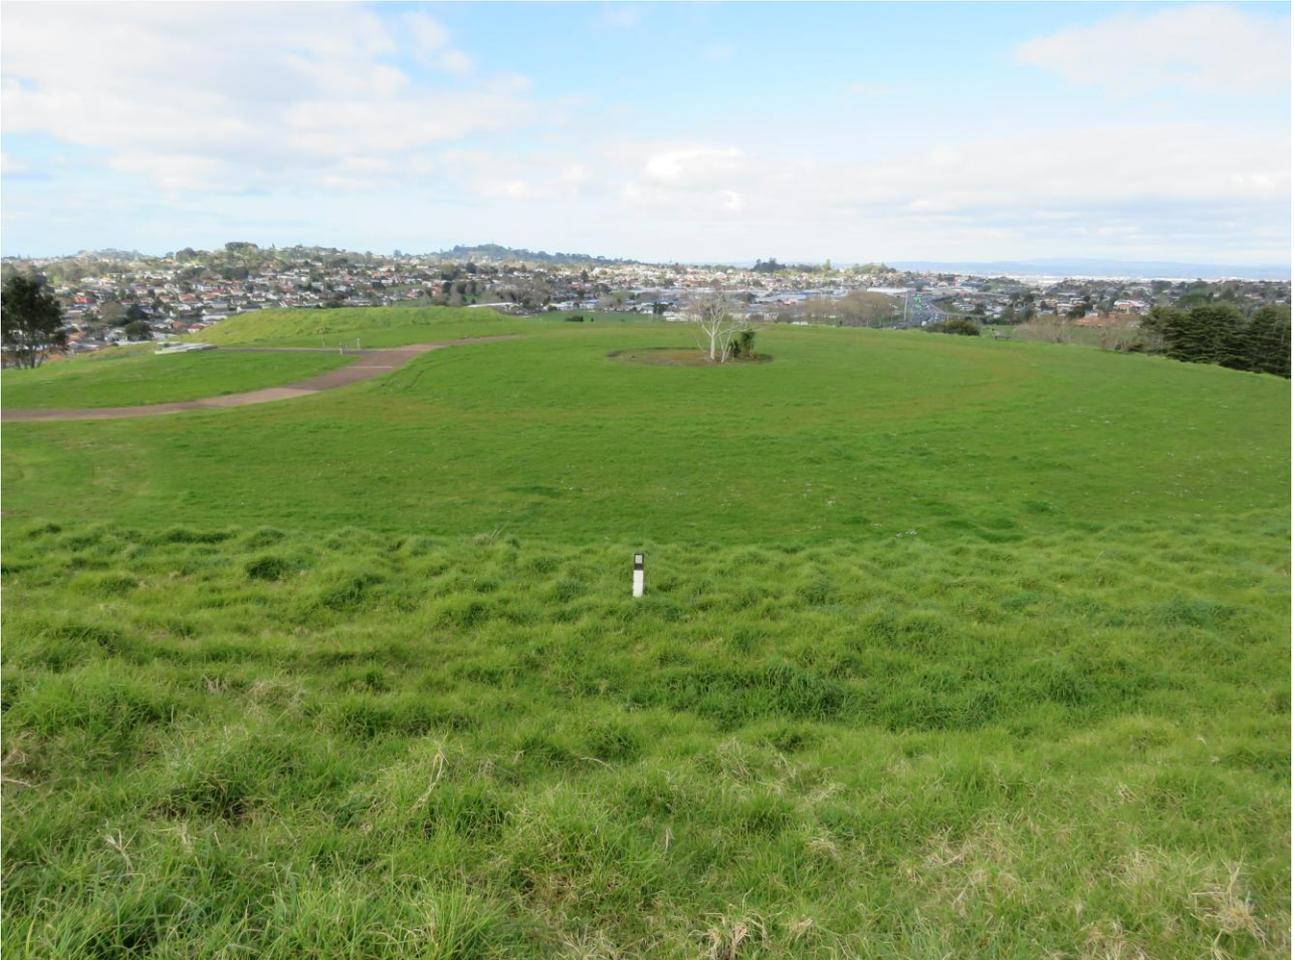
Plate 8. View from the southern edge of the Tihi, amongst the long grass on either side of this photograph as well as behind it are well formed pits, terraces and likely much subsurface archaeological evidence. The flat area in the fore and middleground of this upper area has been formed by the building of the reservoir below the entrance and will contain no archaeological evidence across its width until it reached the rise on the other side which also contains terraces, pits and likely a multitude of subsurface archaeological evidence. It is from within this modified area that the 1961 archaeological investigations took place (refer Figure 5).

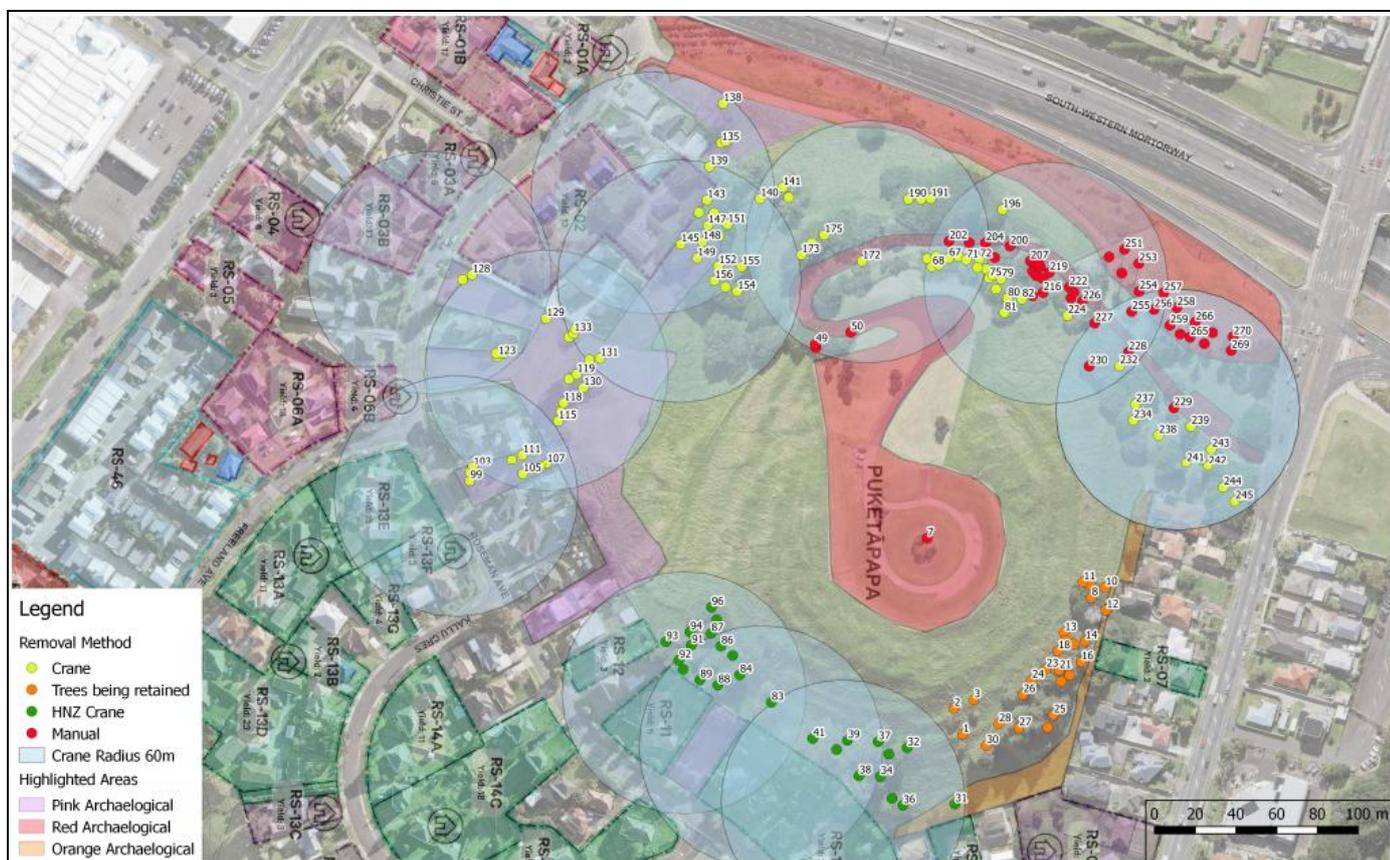
Figure 8. Tree Removal locations and areas as per the Arborlab Report

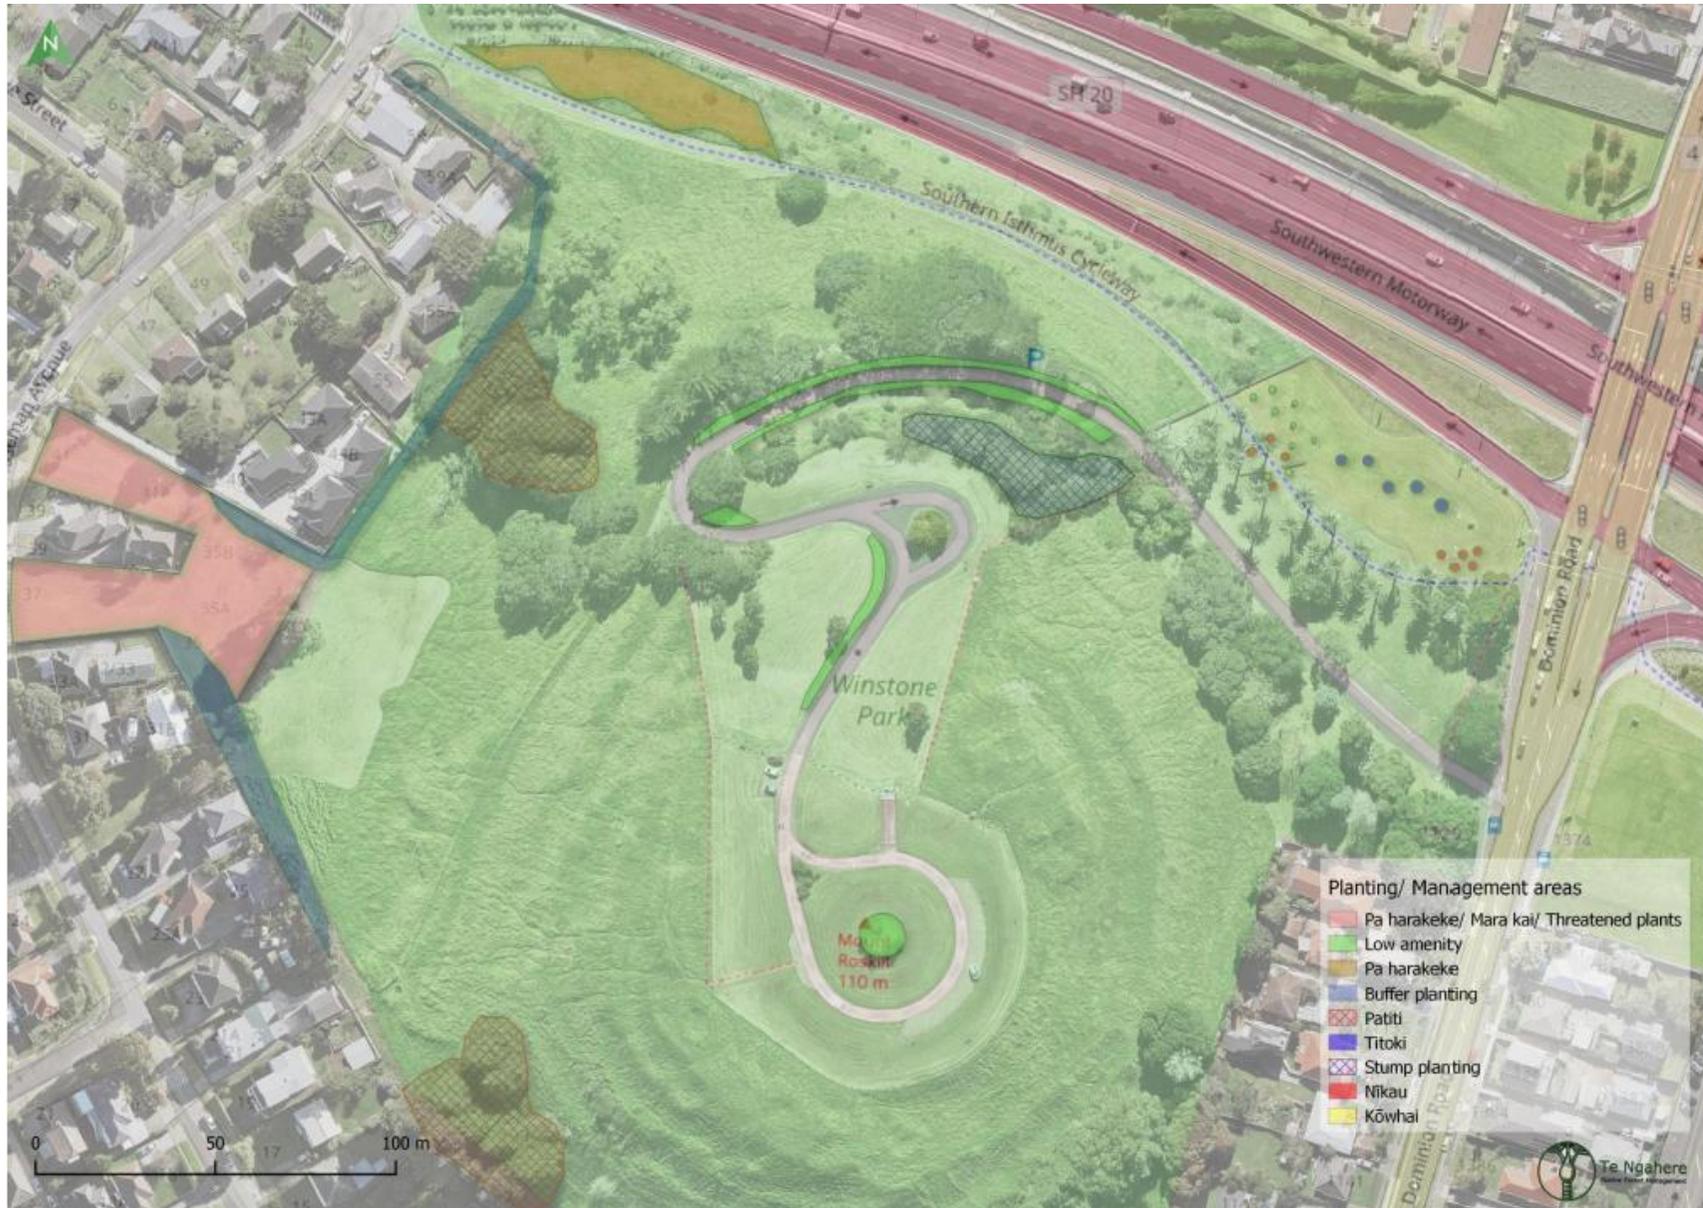
Figure 10. Proposed planting locations from Mairs (2019)

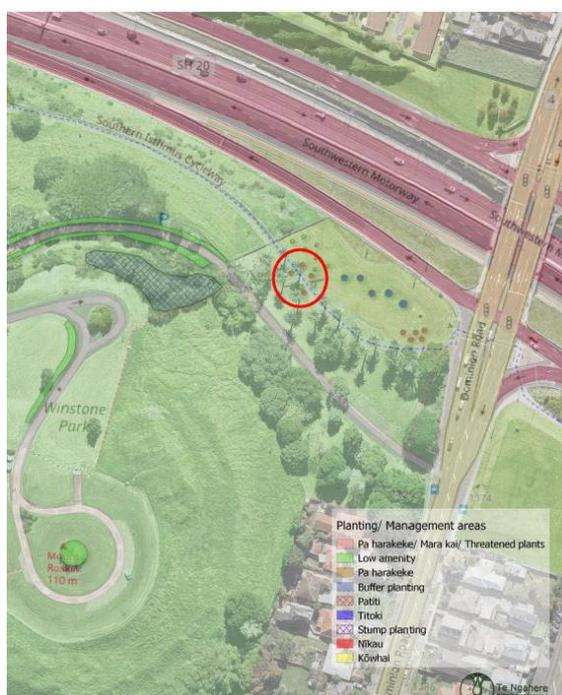
Figure 11. Part of the proposed planting locations from Mairs (2019) with the area with four Nikau and two Kowhai circled.

Here on the northern side much modification has occurred in the past and there would appear to be no archaeological issues, on the southern side there are no obvious archaeological features, though

years of reserve management is likely to have dulled the physical vestiges of any features should they once have been present. Examination of historic aerial photographs suggests that the land on the southern side has not been modified to the extent that the land on the northern side has. Disturbed archaeological evidence was found during monitoring of palm removals by Bikler and Farley (2010), which would indicate that this may also be the case where the combine nikau and kowhai planting are proposed. Although likely that no archaeological evidence would be found it is possible that unidentified in-situ archaeological evidence could be found here, it would therefore be prudent for any Resource Consent to require archaeological monitoring of these plantings and an Authority to be gained from Heritage New Zealand for these plantings.
