Tūpuna Maunga Authority

Heritage Impact Assessment of Proposed Tree Removals and Re-vegetation Planting Plan for Te Tātua-a-Riukiuta /Big King

January 2019

FOR : Tūpuna Maunga Authority
BY : Brent Druskovich - MA(Hons), BCom.
Consultant Archaeologist

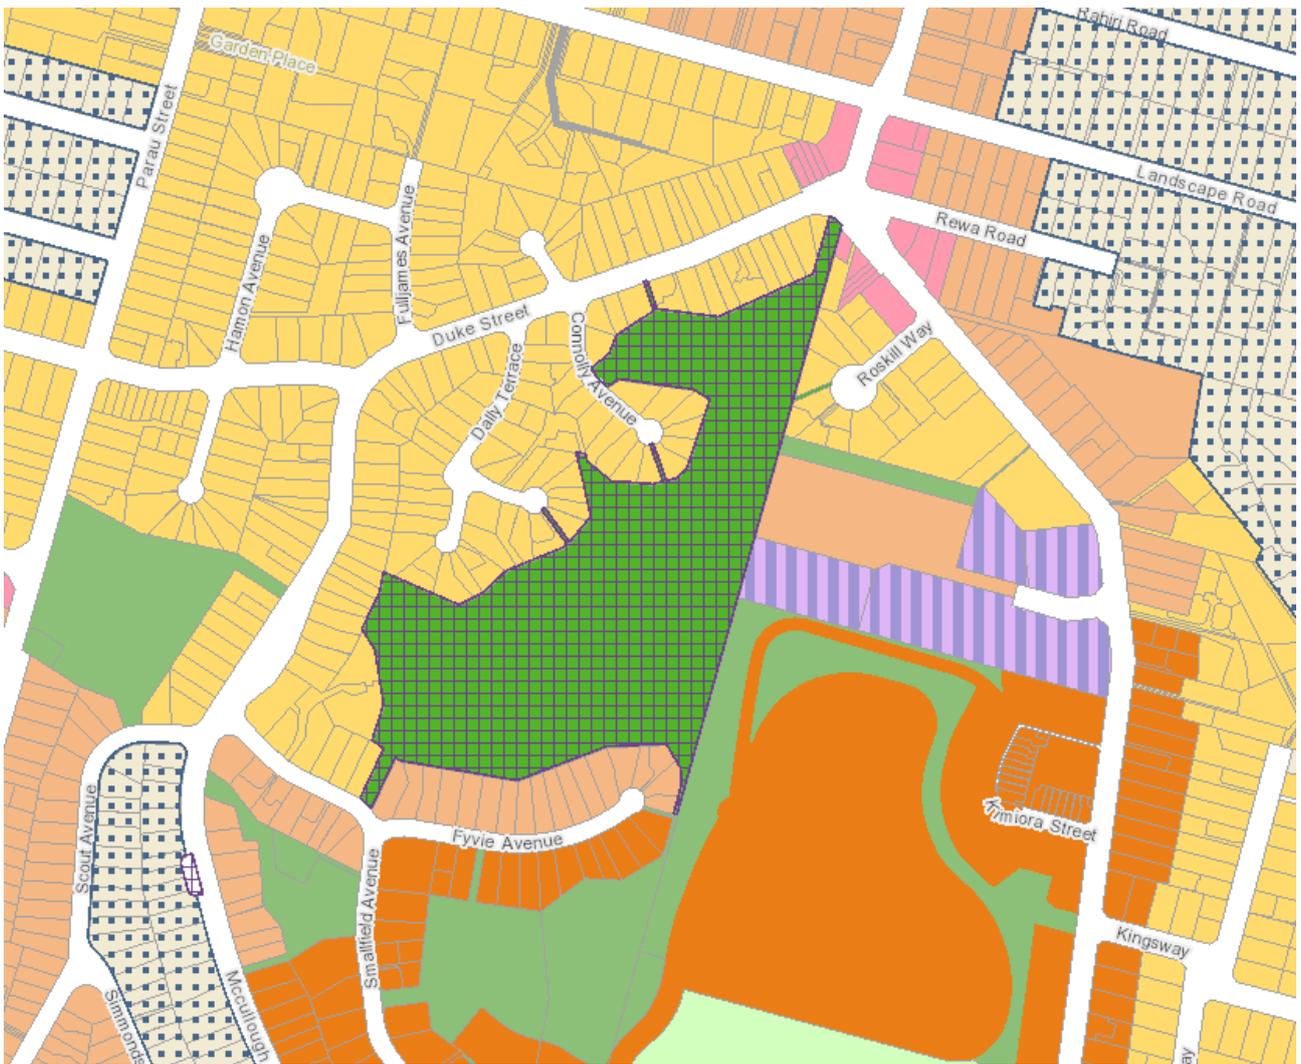
Figure 1. Area of Te Tātua-a-Riukiuta /Big King that is scheduled in the Auckland Council Unitary Plan as a Category B historic heritage place (the purple hashed area).

The majority of Te Tātua-a-Riukiuta /Big King is scheduled on the Auckland Council Unitary Plan as ID 1576 (Figure 1) as a Significant Historic Heritage Place. Te Tātua-a-Riukiuta /Big King is recorded on the Auckland Council Cultural Heritage Inventory (CHI) with the record number 11695 and recorded with the New Zealand Archaeological Association (NZAA) as site R11/18.

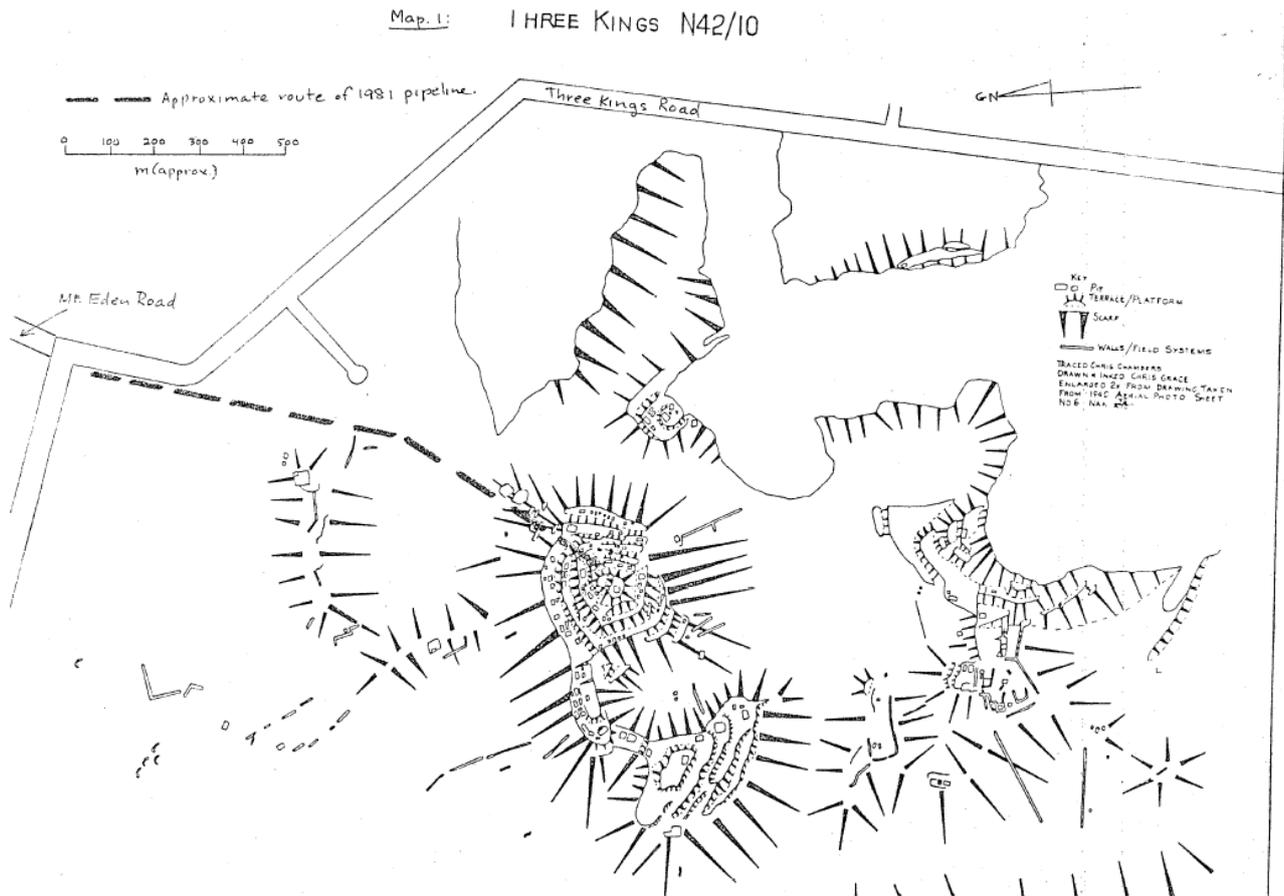
Figure 4. R11/18 Pa complex based on 1940 aerials, note site number is N42/10 – the number the site was originally recorded as using the old imperial maps. In 1940 quarrying had already begun, therefore this plan should not be viewed as complete for the whole complex. The remaining maunga is the one in the centre with the dashed pipeline route emitting from it. Note; Three Kings Road has now been renamed Mt Eden Road and acts as an extension to the original Mt Eden Road.

Chris Grace and Golda Kunin state that in 1981 a group of people (Grace and Kunin 1981:1) inspected the water pipeline route from the summit to Duke Street. They noted crushed midden at the summit and commented that in particular the western side of the pipeline route down the northern slopes is covered in dense scrub, particularly gorse and was difficult to penetrate. They found that the pipeline cuts through a series of terraces and pits and that midden was exposed directly beneath the midden in two places, with this record they also provided drawings of the pipeline in relation to the features. A plan was also drawn up of the overall complex of Pa based on the 1940 aerial (Figure 4).

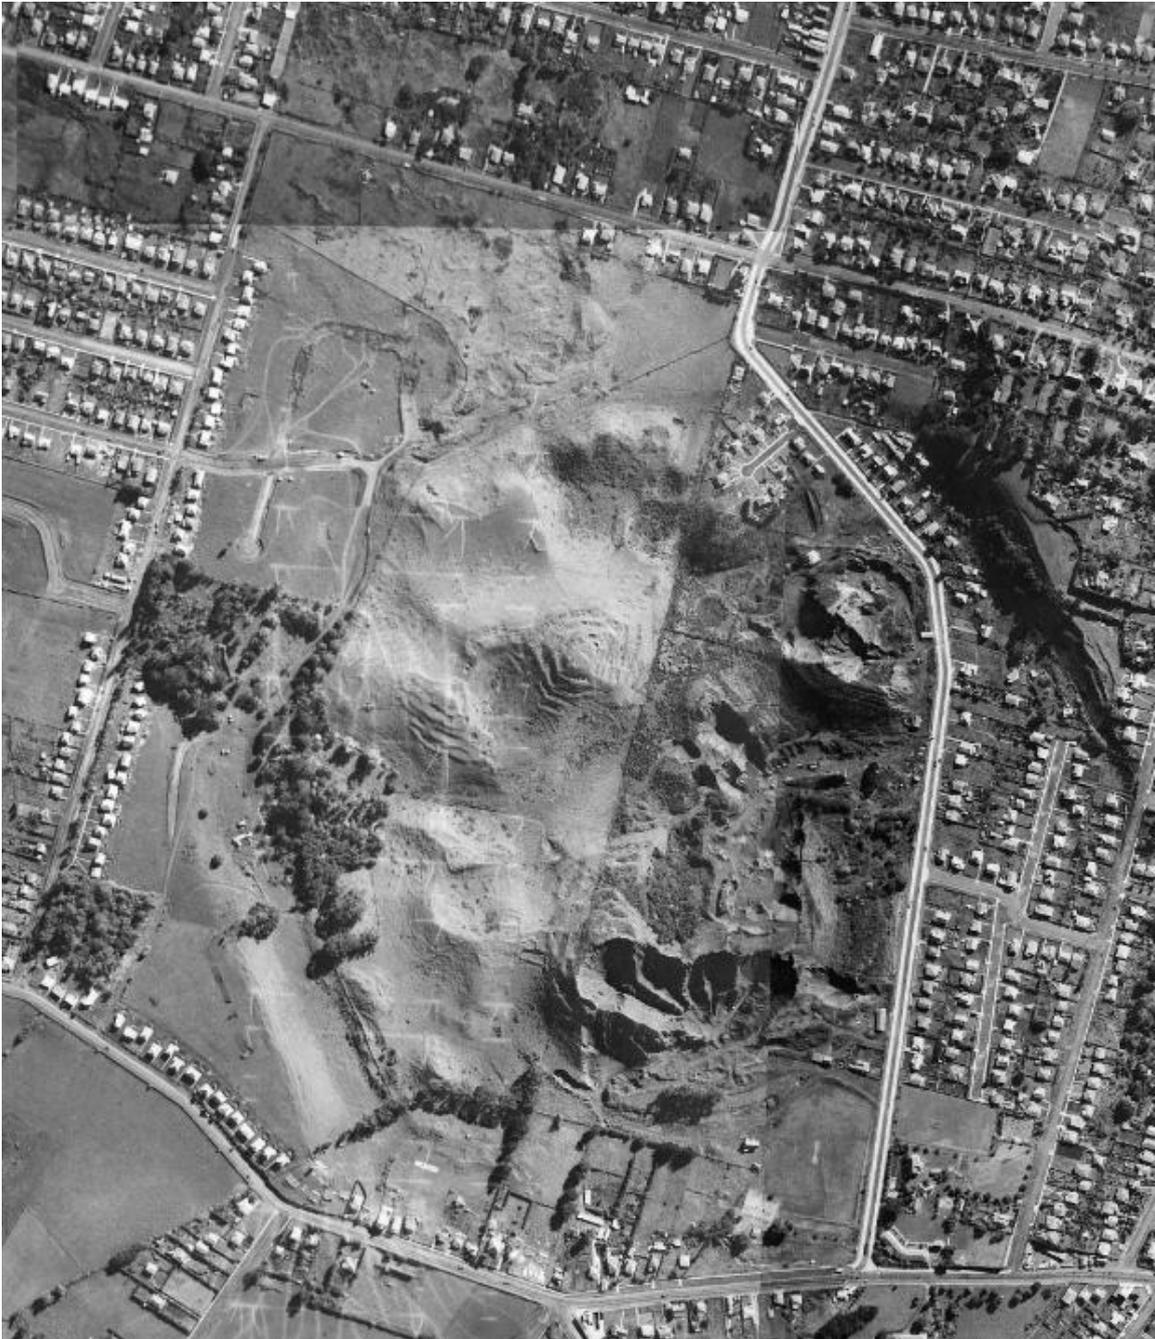
Figure 5. 1940 aerial photograph illustrating the archaeological and volcanic evidence, quarrying has been started and the first state houses and roading have started. The majority of the area is treeless including all of the Reserve area as we know it today.

In order to assess changes over time the series of aerial photographs available on the Auckland Council GIS were searched. The 1940 aerial (Figure 5) show the locations of the majority of the volcanic and archaeological features, quarrying has started

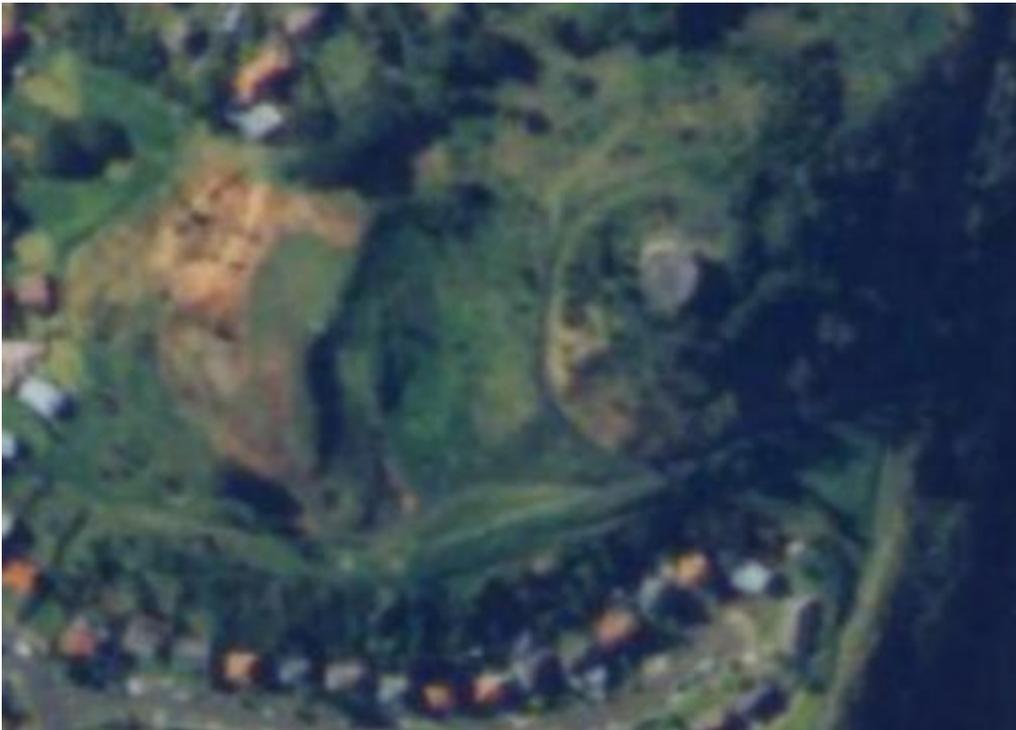
Figure 6. 1996 aerial photograph that appears to be showing an area of works and bare earth to the west and north of the western Reservoir (the flat green patch to the west of the main cone).

The next in the series is a rather out of focus 1996 aerial, these appear to show earthworks in the vicinity of the western reservoir (Figure 6). The mountain itself is no longer covered in scrub, but there are some trees, however the quality of the photograph precludes the ability to clearly define archaeological features where there is no cover. There are very few trees present in the western part of the reserve.

The WF7 infill plantings are proposed in an area that has been earthworked presumably by works associated with the Watercare reservoir (refer the out of focus aerials of 1996 – Figure 6). The western edge is close to intact terracing, pits and probable subsurface evidence relating to the Maori occupation of Te Tātua-a-Riukiuta /Big King. The project archaeologist should assist with the set out of these plantings to ensure that none occur within archaeologically intact areas. Furthermore to ensure that there is no root encroachment from unsuitable species (such as the proposed Puriri) and to limit the chance of self sown individuals within the archaeological areas, plantings within 10m of archaeological features should be limited to species listed by the Department of Conservation as suitable for planting on archaeological sites (Jones 2007).

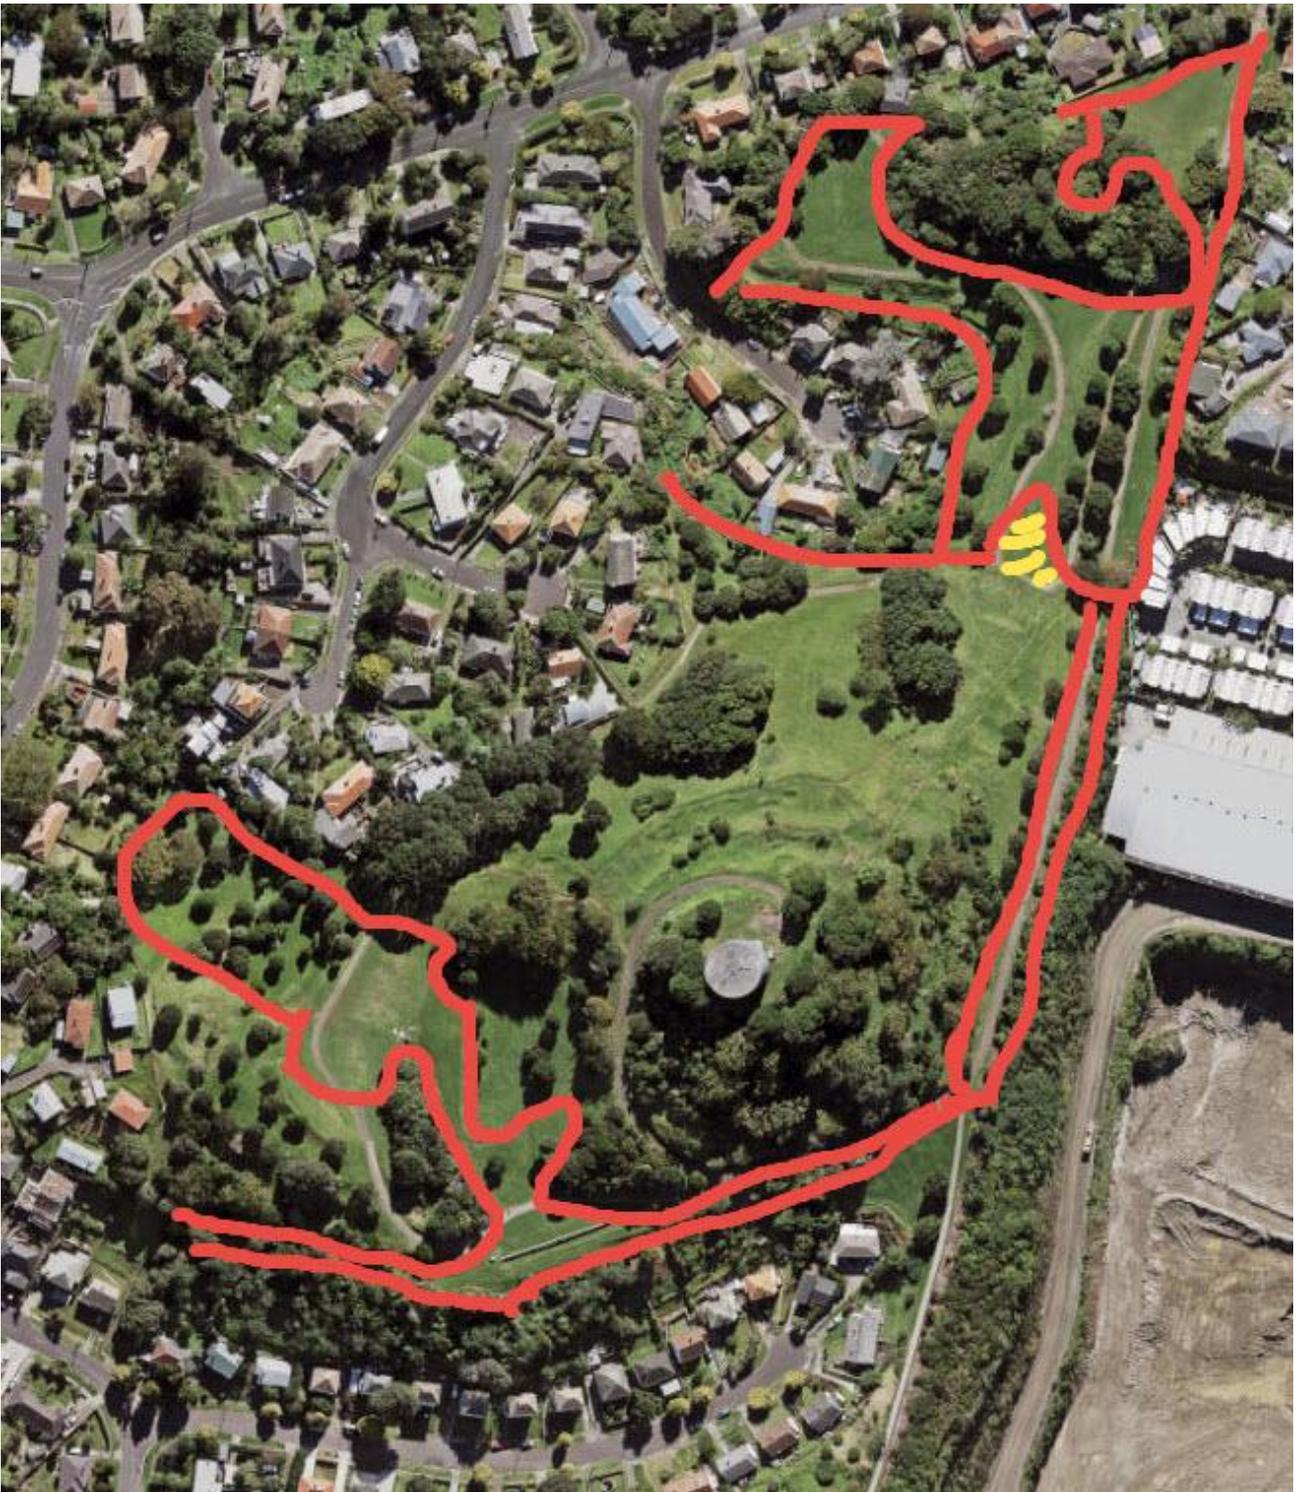
Figure 7. Areas on Te Tātua-a-Riukiuta /Big King where examination of aerial photographs and ground proofing indicate that all archaeological evidence will have been destroyed (within the red borders – indicative only). The area marked in yellow has been modified, however I could not determine whether all archaeological evidence in that area will have been destroyed. The summit area, the road up to it and pipeline route from it are assumed to have modified archaeological features and deposits but not destroyed all evidence.

During these inspections areas were identified where substantial past earthworks and or quarrying will have destroyed any archaeological evidence (Figure 7). I am of the opinion that the aerials do not show everything that has been modified.

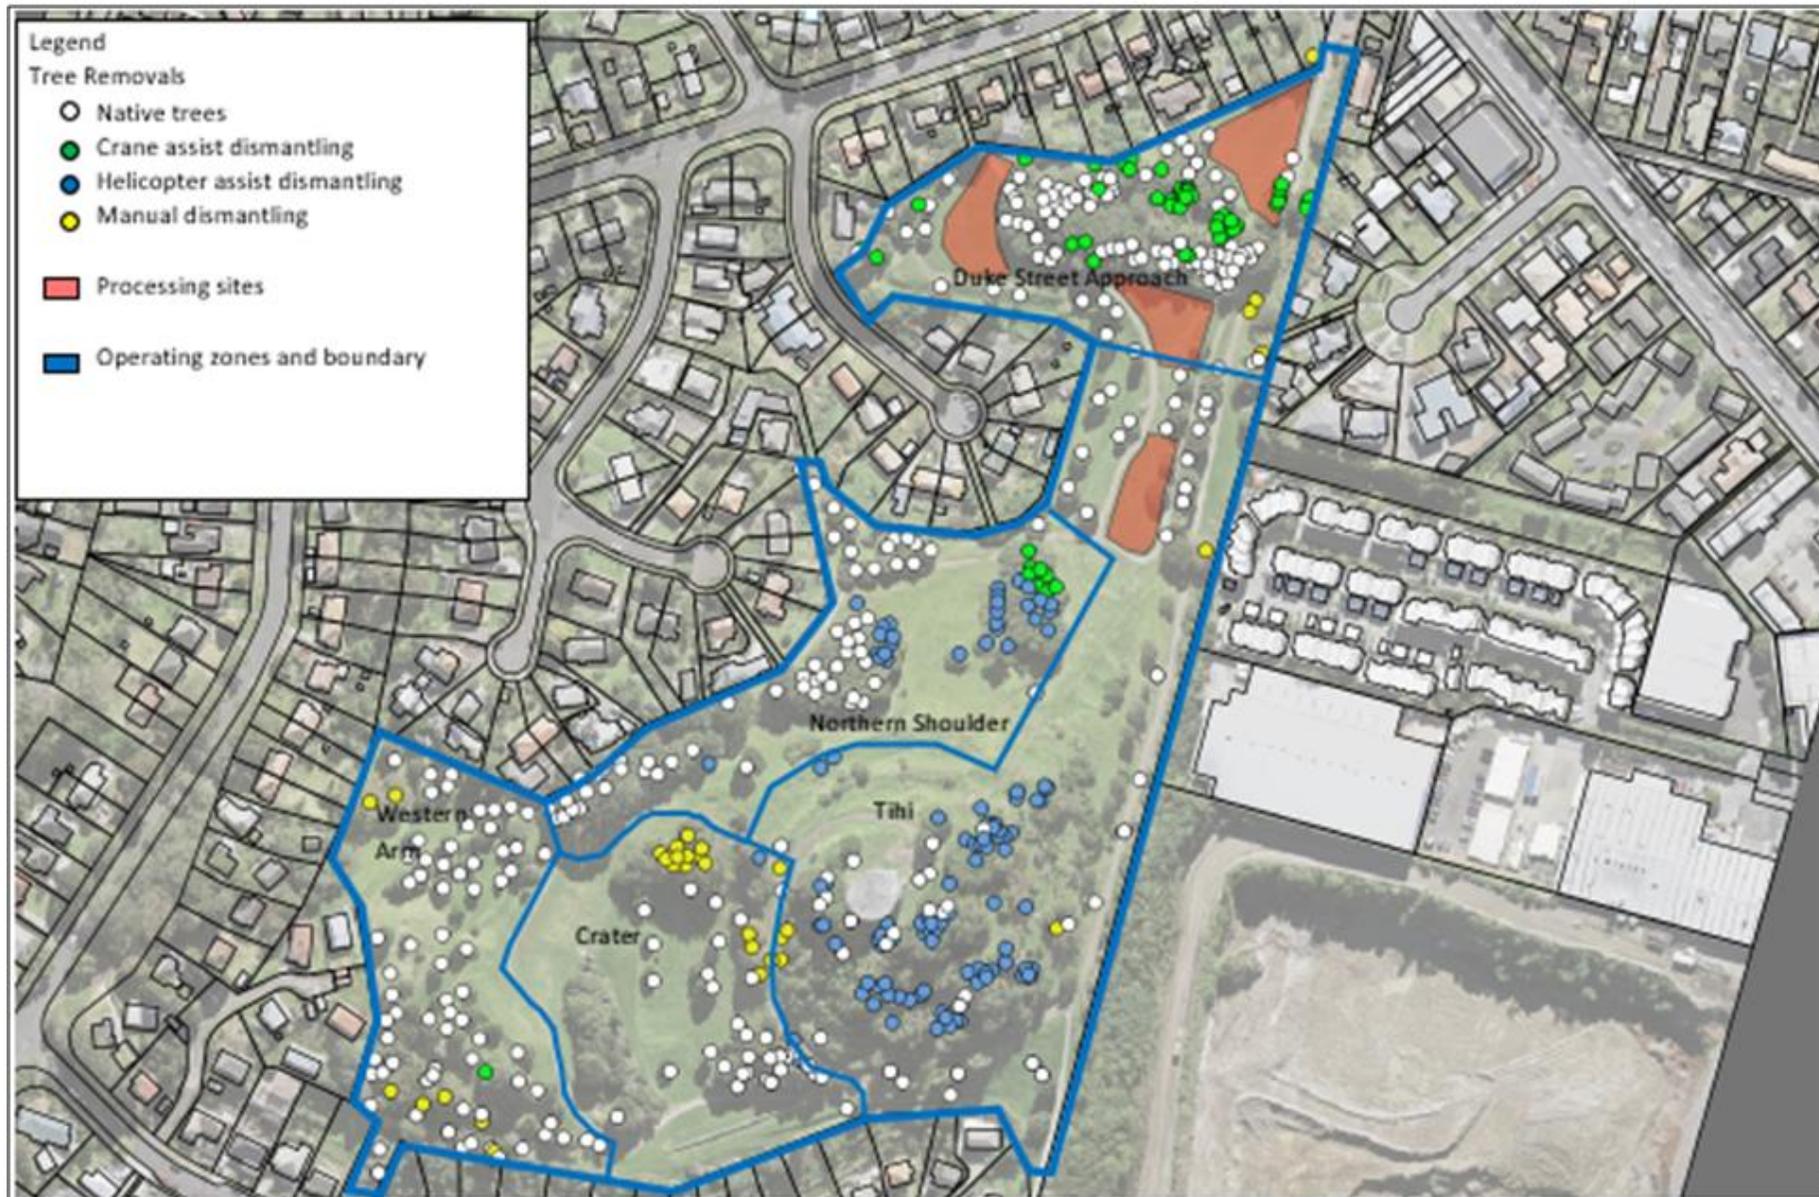
Figure 8. Tree Removal locations and areas as per Treescape Report

The following sections are based on the report by Treescape Ltd (2018) and their proposed tree removal methodologies, their proposed worksites on Te Tātua-a-Riukiuta /Big King. Conditions vary across the mountain as a consequence this section is divided into the areas as proposed by Treescape (Figure 8).

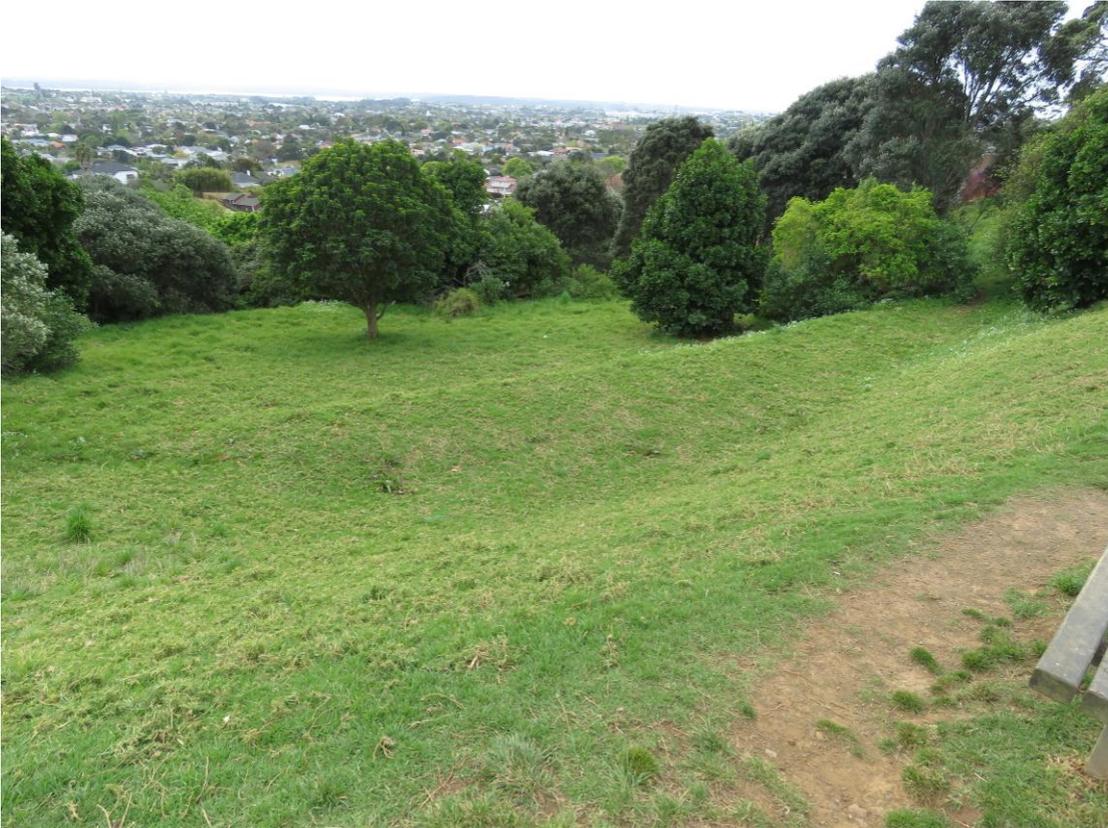
Plate 1. Modern earthworks terraces beneath the western reservoir in the Western Arm area.

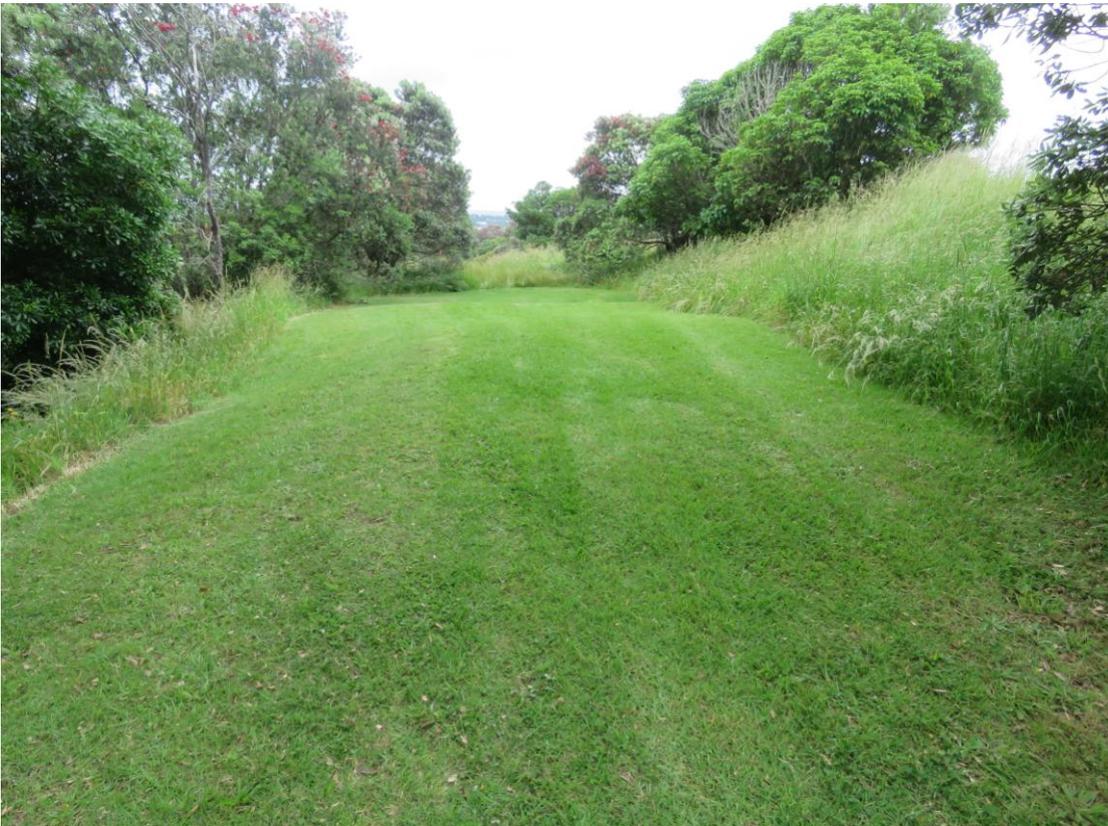
Plate 2. The terrace which Treescape propose to traverse across to access the Oaks. It appears to be a cultural terrace relating back to the time of Maori occupation of Te Tātua-a-Riukiuta /Big King that has later been modified by earthworks.

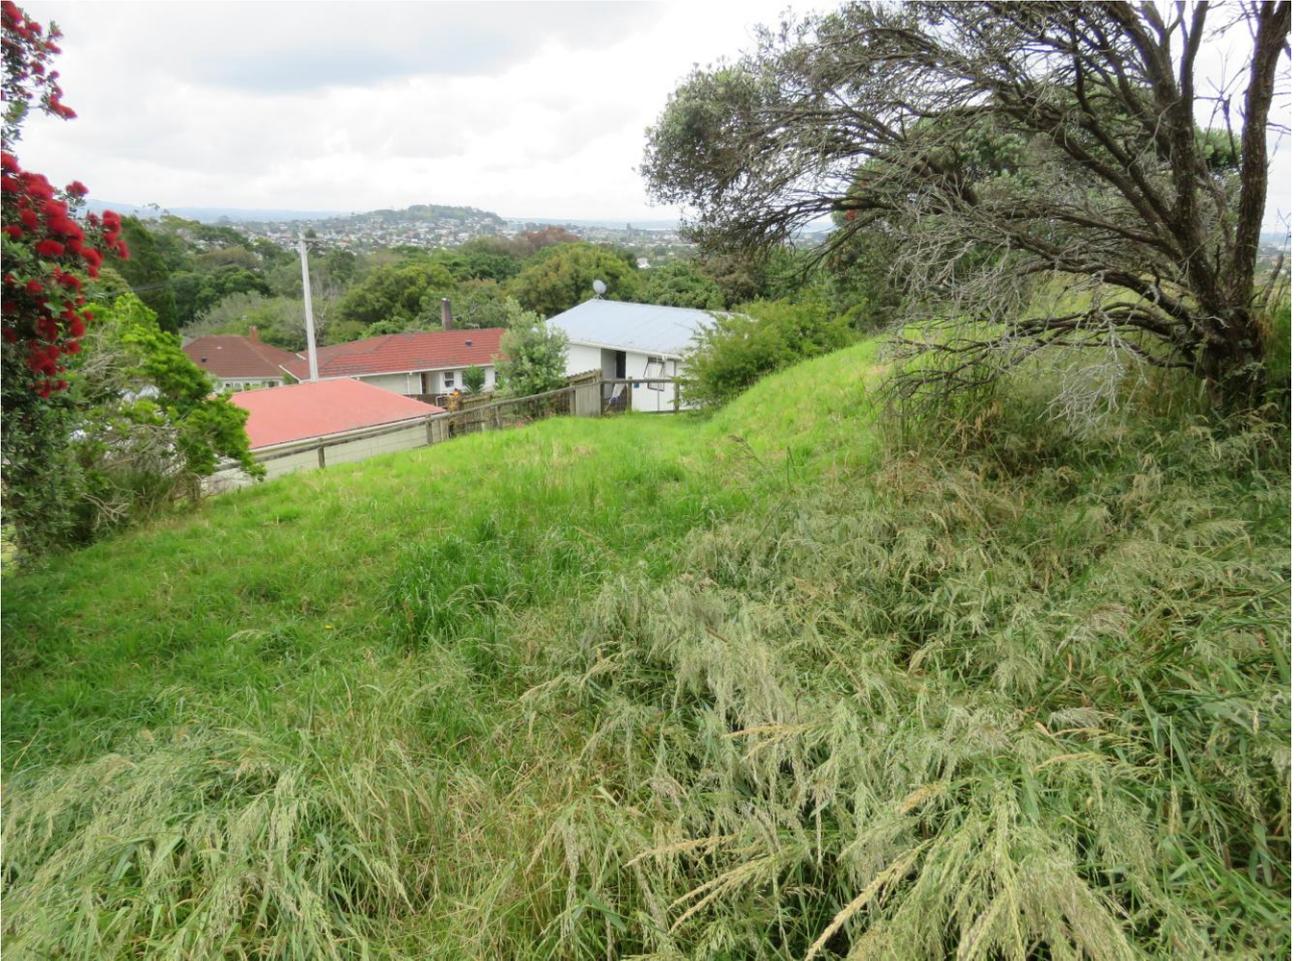
Plate 3. The bulldozed track that would be used to access the Oak trees.

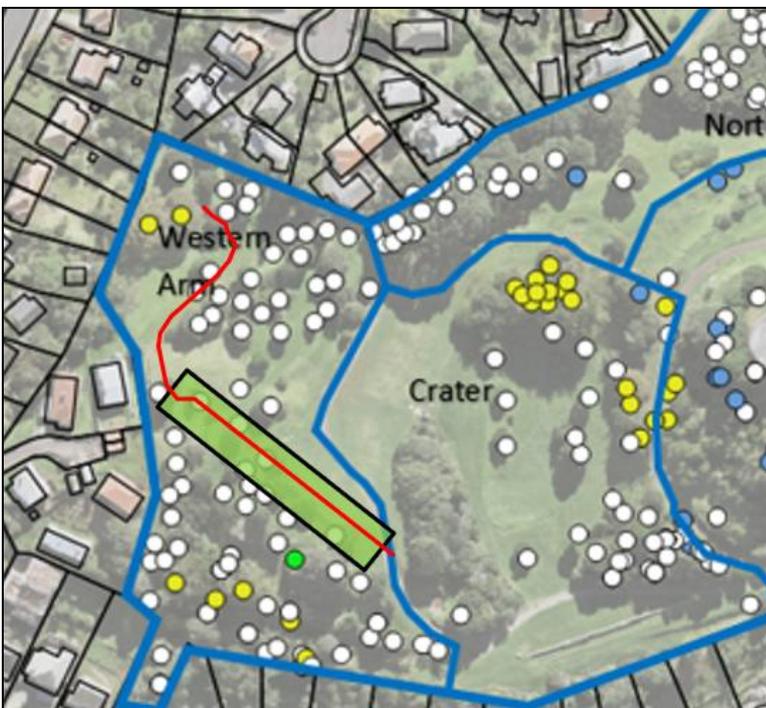
Figure 9. General tracking route for Oak trees (red line) and area requiring ground protection from machinery (green highlight)

- d) That processing area associated with c) above (Figures 9 and 10) for the removal of the Holm Oak utilises the same Trackmat protection.
- e) The use of the terrace in c) and d) above is to be limited to when ground conditions are dry.

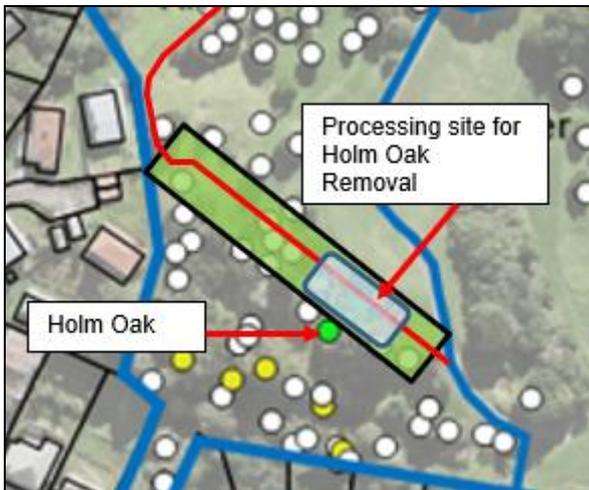
Figure 10. Location of the Holm Oak and proposed processing site.

Whilst the protection is in place Treescape also propose to use a small crane (2018:13) to remove and process a large Holm Oak (Figure 10). This would be undertaken on both the trackmat and with additional load bearing boards.

The addition of the protective track matting for traversing this area, as well as the additional load bearing boards for the processing site (Figure 10) should have no archaeological effects as long as these works are only undertaken when ground conditions are dry.

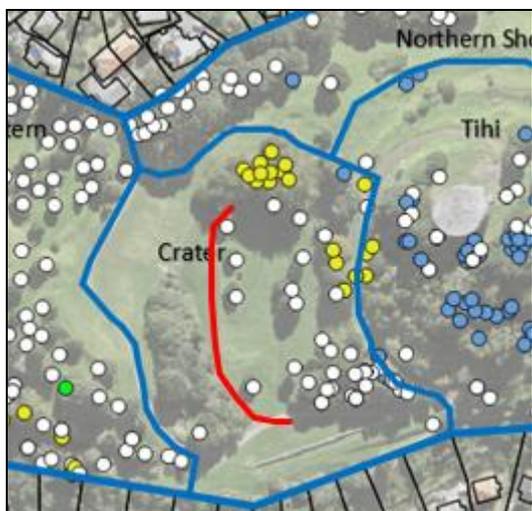
Figure 11. Route in the crater area for a chipper to access the trees on the northern edge. This route is along a modern terrace that was created during the construction of the water reservoir.

Trees here will be manually dismantled and then transported carefully by hand on top of a robust matting that will prevent scarification of the ground and protect the archaeology, some of which is midden scatter on the slopes between the trees and the chipper processing area. Matting will be

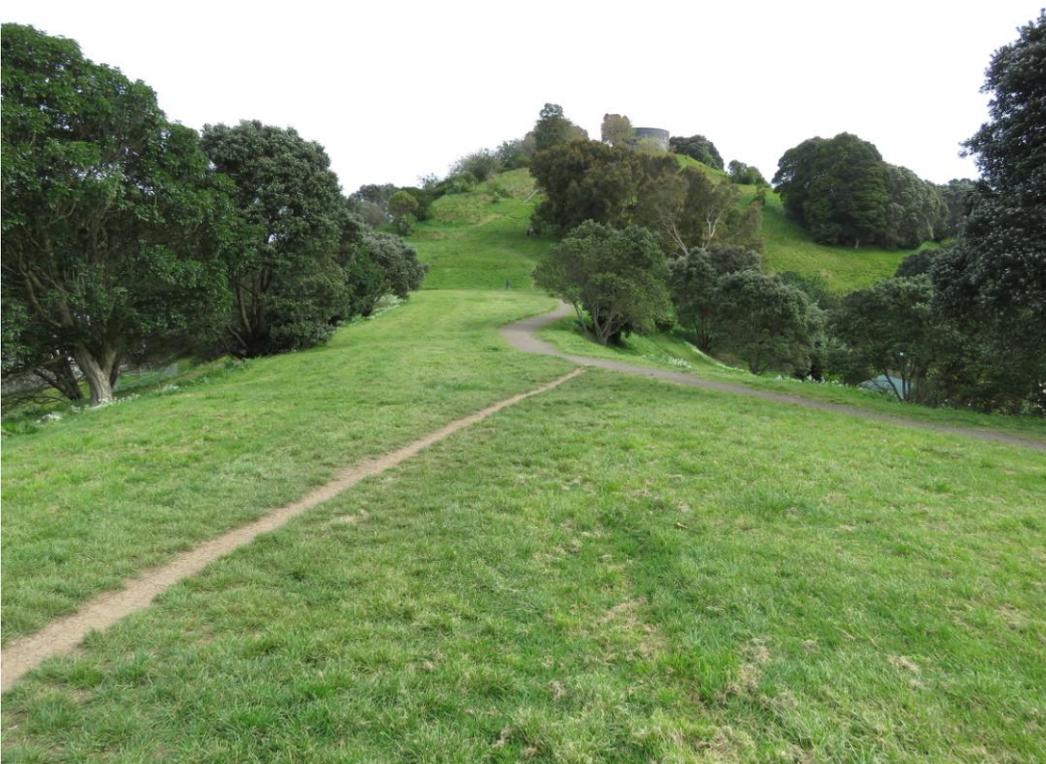
Plate 4. The southernmost Processing Site looking towards the Tihi and Northern Slopes areas. This processing site has been earthworked and flattened in the past, however it is not clear whether it has extended preserved deep subsurface evidence at the southern end (the far end of this plate).

The southernmost Processing Area (Plates 4 and 5) has been earthworked, cut and shaped, the earthworks appearing quite extensive on the 1959 aerials but are not clear enough for fine detail. There is a large rectangular pit shape present that is relatively shallow, visual examination suggests that it is the base of a Maori storage pit that was deeper than the earthworks that have occurred around it, however other possibilities exist for its origins and that it merely mimics the shape of an archaeological feature. Therefore it is unknown whether it is archaeological evidence or not without undertaking an archaeological excavation to investigate.

Treescape wish to use this location as a processing site and will need to park a crane in the vicinity to reach a grove of trees growing on the northern slopes above (visible on Plates 4 and 5).

- h) That the possible pit depicted in Plate 5 is protected and covered during the use of the southernmost processing area.
- i) That the use of the southernmost processing area depicted in Plates 4 and 5 be limited to when ground conditions are dry.

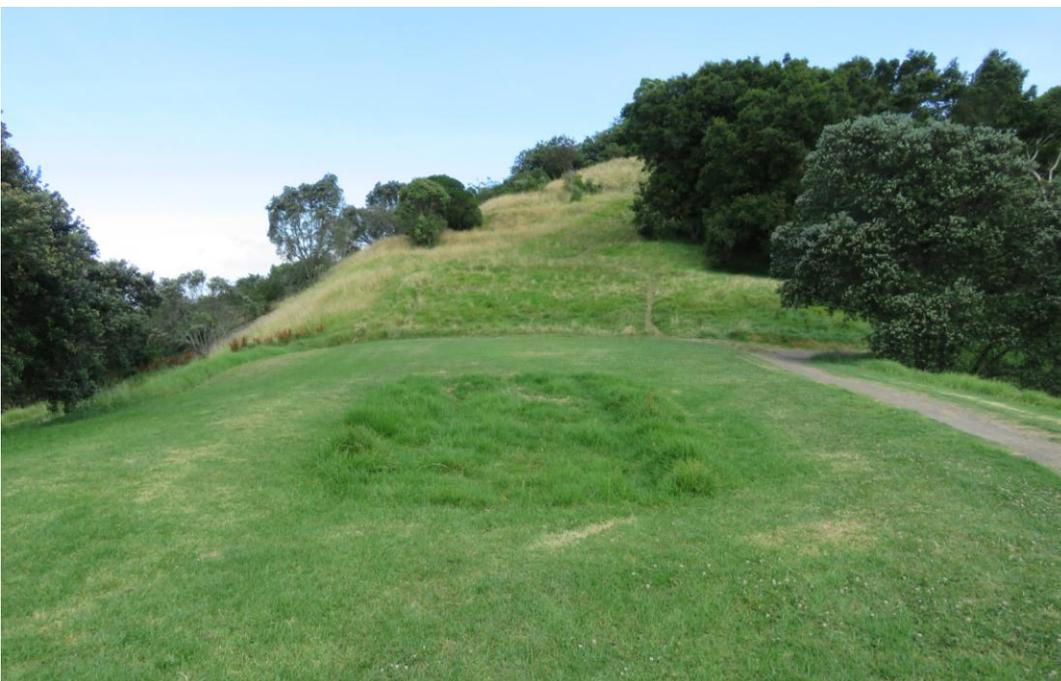
Plate 5. Close-up of the southern end of the Processing Area illustrating a cut at the base of the slope indicative of earthworks, the 1959 aerial photographs also indicate wide scale earthworks at this location, however the area of long grass is indicative of a pit being present, or at least the lower part of one from which the top has been taken off.

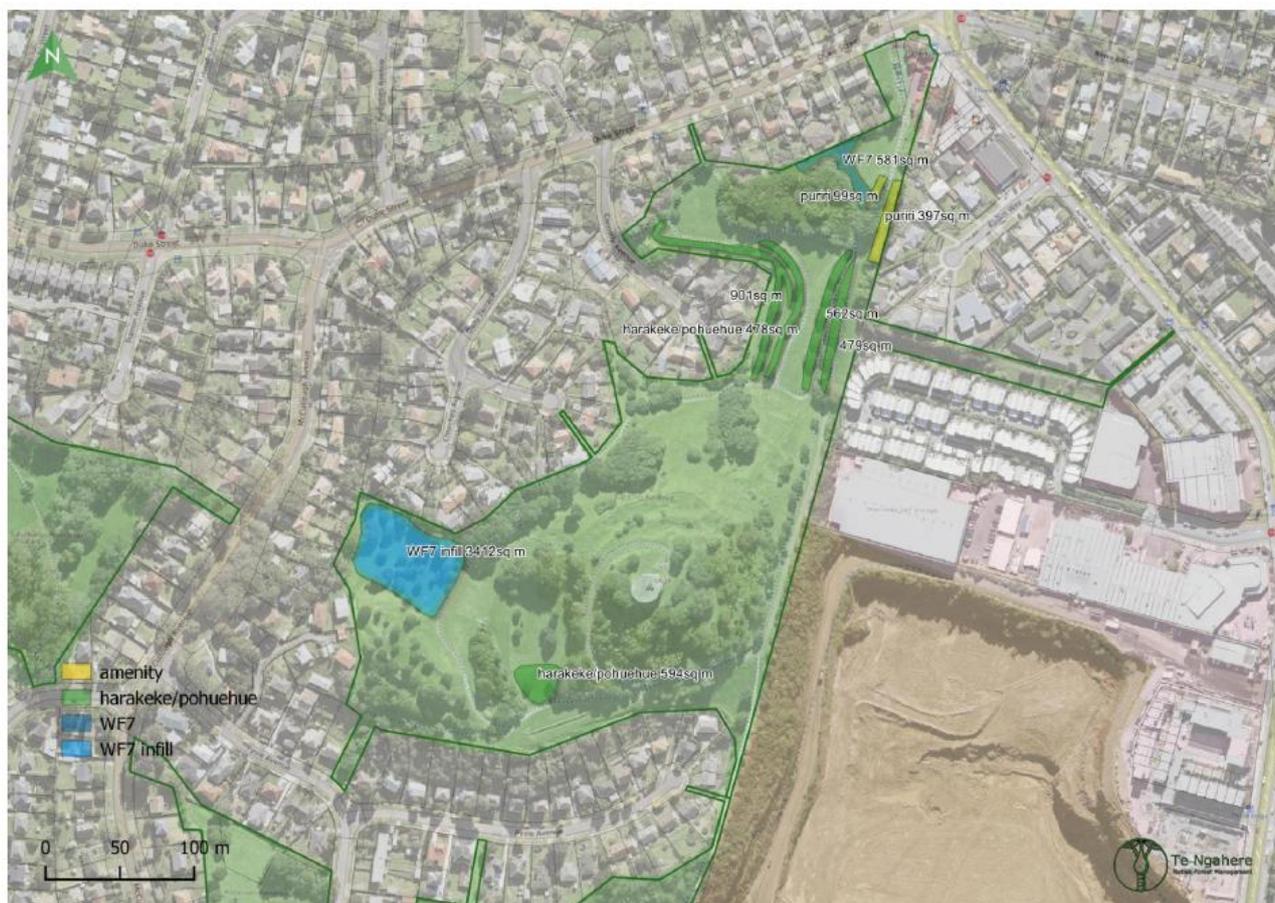
Figure 9. Proposed planting locations from Te Ngahere (2018)

The following sections are based on the report by Te Ngahere (2018) and their proposed methods and locations for restoration planting. Conditions vary across the locations; as a consequence this section is divided into the areas as proposed by Te Ngahere (Figure 9) and discussed from the North to the South.

This is in the area depicted in Figure 9, near the Duke Street entrance. This area has been totally modified and there will be no archaeological evidence in this area. There are no archaeological effects to planting in this area. As a precaution, as these plantings will be adjacent to the already existing plantings, many of which are on a modified mound that includes archaeological evidence, the project archaeologist should be involved in the set out to ensure that no new plantings encroach upon archaeologically sensitive areas.
